Article

Mapping Tribo-Corrosion Behaviour of TI-6AL-4V Eli in Laboratory Simulated Hip Joint Environments

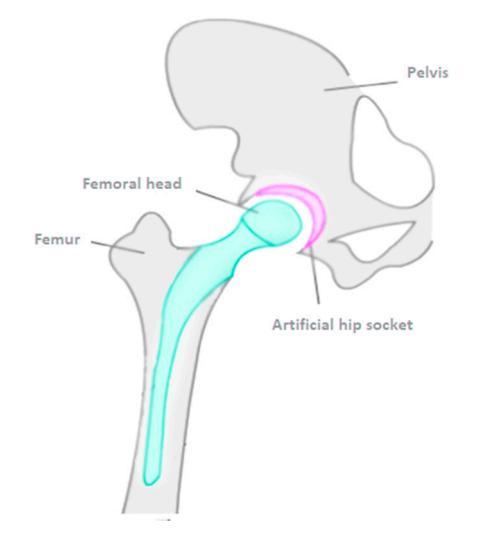
Figure 1. The area highlighted, susceptible to tribo-corrosion.

The hip joint, and in particular, the area highlighted in Figure 1, represents a significantly challenging environment in materials science. The literature shows that the load on the hip joint can be three times the body weight normally, which can exceed ten times of the body weight during jumping. In addition, hip bones are subjected to cyclic loading as high as 10⁶ cycles in 1 year [7]. To tackle this, new bone biomaterials need to be identified with suitable mechanical properties and the necessary biocompatibility. The biocompatibility of a material describes its behaviour toward human body tissues. The wider problems posed by biocompatibility are out with the scope of this study [8].

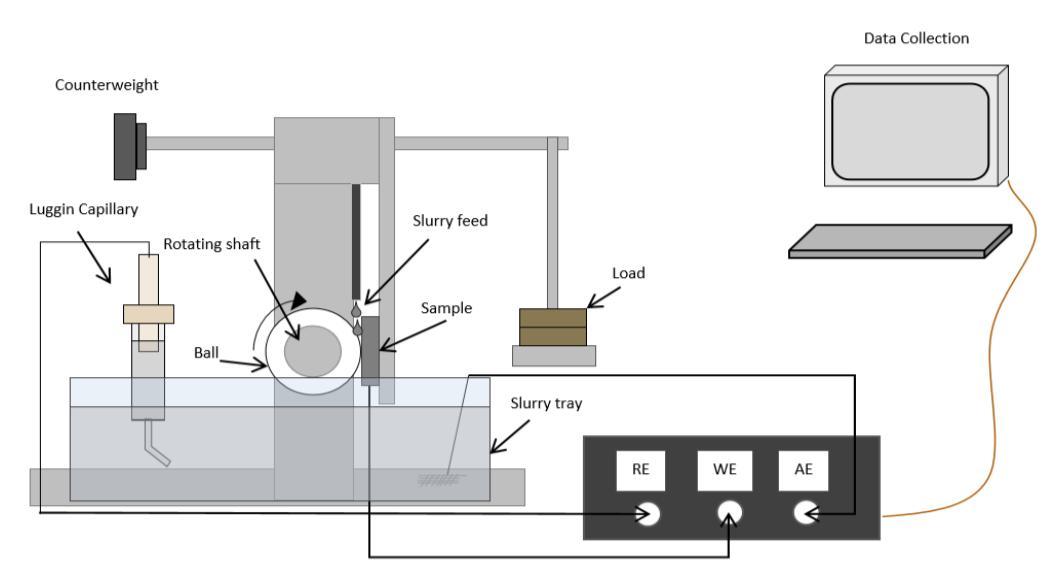
Figure 2. Schematic of tribo-corrosion experimental setup.

A micro-scale abrasion apparatus, in conjunction with corrosion monitoring equipment, was selected for simulating hip conditions, for several reasons. The experimental work was conducted on the apparatus, shown schematically in Figure 2; this consisted of a micro abrasion tester (Plint TE-66, Phoenix Tribology, Woking, UK) and an integrated Gill AC potentiostat (ACM Instruments, Woking, UK). The apparatus operates in accordance with British Standards EN 1071-6: 2007. A built-in counter controls the number of shaft revolutions and experimental time. The electrolyte solution was supplied to a point closely above the sample-ball contact, delivered by an integral peristaltic pump from a separate glass-container. An Al_2O_3 ball of 25 mm diameter was used as a counterpart, which was held between two co-axial shafts, which were rotating in unidirectional way by a variable speed DC electric motor.

The electrochemical interfacing consisted of a potentiostat and three electrode attachments. The working electrode (WE) was fixed to the back of the test sample, while the auxiliary electrode (AE) and reference electrode (RE) were placed in the solution bath. The reference electrode provided a stable, well defined potential, and was used to register the potential of the working electrode, i.e., the test sample. For the reference electrode, a saturated calomel electrode was used via a capillary tube, which was filled with the test solution. The auxiliary electrode was used to measure or control the current and is usually made of inert materials such as platinum, gold, or graphite [20]. A platinized- titanium (Pi-Ti) mesh formed the auxiliary electrode in this study. Sequencer software was used to carry out potentiostatic and potenti-dynamic tests. In this way, the applied voltage was monitored, polarization curves were created, and a data set was collected for the estimation of micro-abrasion-corrosion behaviour of this system.

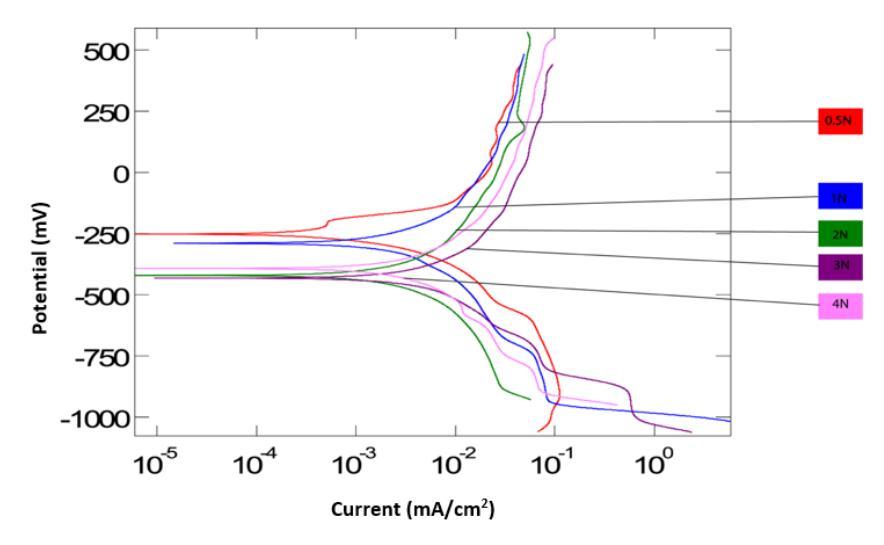
Figure 3. Polarization curves in pure Ringer's solution for -750 to +750 mV (1500 mV sweep).

Figures 3 and 4 are the polarization curves generated from the potentiodynamic tests for all applied loads, both without and with particles. On average, the corrosion potential (E_{corr}) for the tests with particles is lower than the tests without particles. This is supported by both tests at 3 N and 4 N, having values below -500 mV. This suggests that corrosion begins to take place at lower potentials when with an increase in load in the presence of abrasive particles. This could be due to abrasive particles accelerating the removal of a protective oxide layer from the surface of the Ti-6AL-4V, hence the corrosion process begins earlier, at 3 N and 4 N. Both curves suggest that the surface electrochemical activity is reduced at lower applied loads. The polarization curve at 0.5 N applied load for both conditions is observed to remain towards a corrosion potential of around -250 mV, indicating the lowest electrochemical activity. Figure 3 displays more uniformity in E_{corr} values for all loads in the absence of abrasive particles. In the case of the solution without abrasives, E_{corr} appears to have remained relatively unchanged over the range of applied loads, unlike the solution with particles. This indicates that the corrosion potential is more unpredictable in the presence of particles.

The corrosion current densities are relatively similar in both, suggesting that the corrosion rate is the same in the presence of abrasive particles as it is in the absence of abrasive particles. However, as the load increased for the abrasive solution, the maximum currents tended to increase. The highest current densities were recorded for 2 and 4 N, suggesting an increasing corrosion at those loads. As the applied load reached 4 N in the case of abrasives, a cathodic shift is observed. Over the spectrum of applied loads, it appears that electrochemical activity at the contact surface may be enhanced at higher loading; it is likely that a transition in lubrication mode occurs as a result of changing the contact pressure, which may explain the cathodic shift at 4 N.

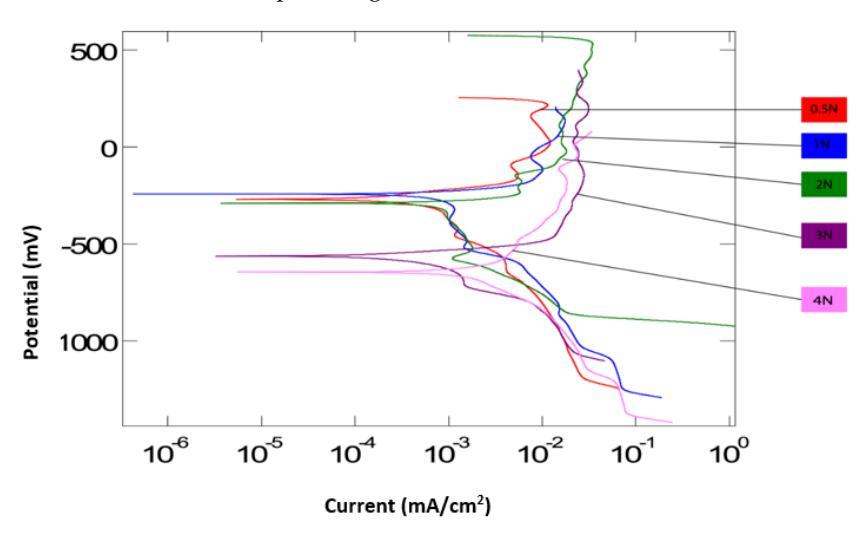
Figure 4. Polarization curves in pure Ringer's solution plus SiC particles slurry for –750 to +750 mV (1500 mV sweep).

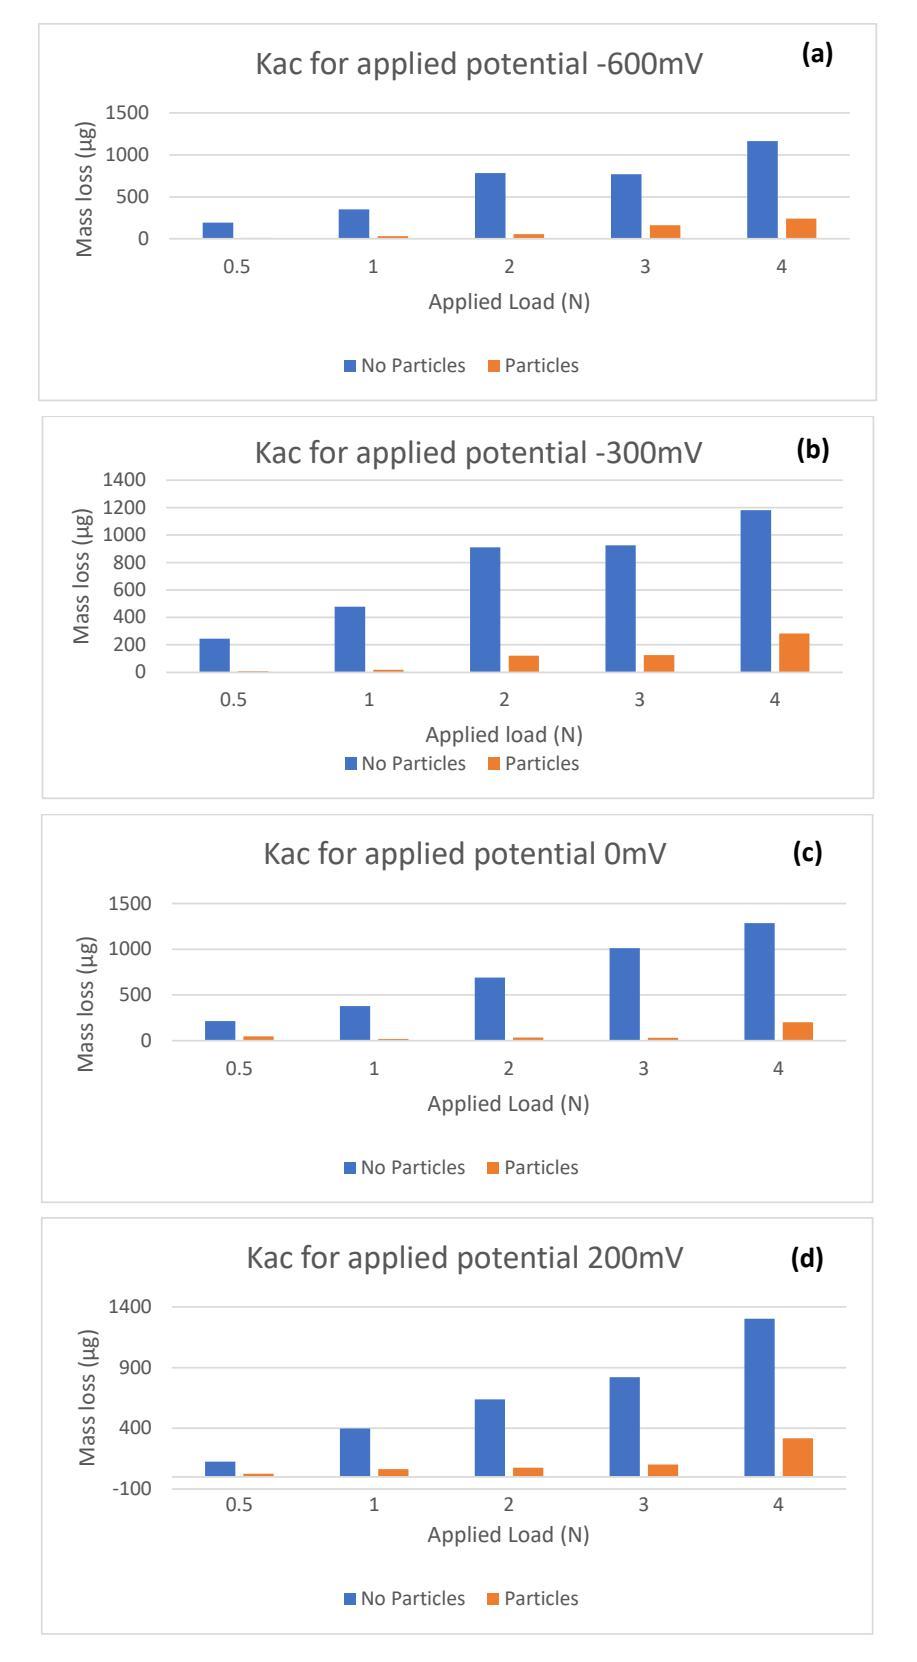
According to Figure 5, the mass loss (K_{ac}) is considerably higher for the solution without abrasives across all applied potentials. This suggests that the two-body abrasion is the dominant wear mode in the case without particles. This reinforces that two-body abrasion is the more severe mode of wear. In the presence of SiC, hard solid particles were embedded in the contact area of the specimens to form a composite layer, thus reducing the total mass loss. It can also be seen that mass losses in both solutions tended to increase as applied load was increased; consistent with Archard's wear model, which states that the wear rate of the material is proportional to the applied load and sliding distance.

The wastage map in the presence of abrasive particles Figure 8b shows that, over the cathodic range of potentials, the wastage regimes remain low despite increasing load. In the cathodic region at loads below 1 N, no significant corrosive effects appear to take place. In comparison to an earlier study [12], there is some similarity, where a high wastage regime dominates for increasing loads with anodic potentials. The map demonstrates that the low-medium wastage regime is dominant. As a result, any variation in material loss due to corrosion had no significant effect on total wear in both cases (with and without particles). This is further evidenced by the highest wastage occurring at 4 N and the lowest wastage occurring at a load of 0.5 N Figure 5.

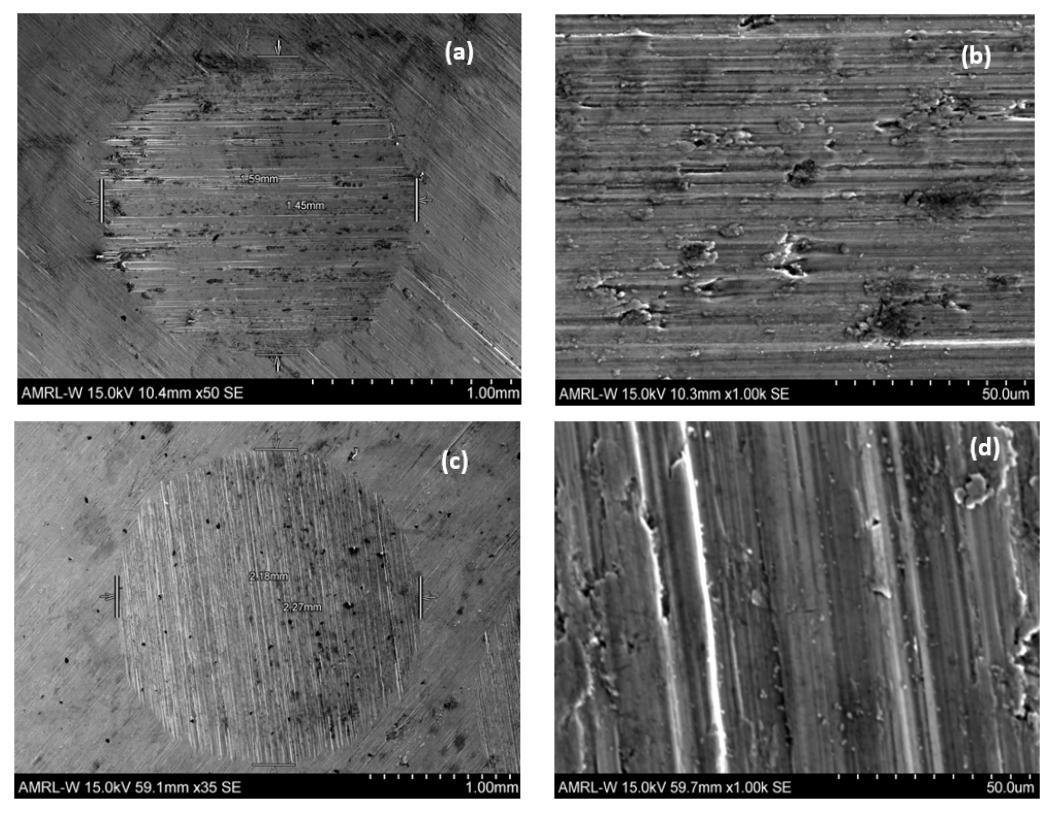
Figure 6. SEM images of the wear scars in Ringer's solution, (**a**) at 0.5 N without abrasive particles (**b**) 'a' at ×1000 magnification, (**c**) at 4 N without abrasive particles (**d**) 'c' at ×1000 magnification.

Figures 6 and 7 allow for a comparison of different applied loads, with and without abrasive particles. In Figure 6a,b, there is clear evidence of directional grooving, indicating a uniform dominant two-body abrasion. However, in the presence of particles Figure 7a,b, there is no evidence of this phenomenon. Wear scars are showing embedded abrasive particles and plastic deformation, suggesting the formation of a composite layer, which results in a reduction in abrasive mass loss due to the presence of solid particles wear scars. This is consistent with the conclusions reached from the mass loss data in Figure 5. The diameter is also almost double in the absence of abrasive particles, indicating that two-body abrasive wear is more severe than that in the presence of solid particles.

Figure 6c,d show how the change in applied load can affect the type of wear that is produced and how, at some intermediate load, a transition must take place between the wear mechanisms. In these figures, the exaggeration of the parallel grooves as the applied load is increased is visible. This suggests a transition to a two-body dominated regime as the particles become entrained in the cratering ball, resulting in a grooving. Additionally, the reduction of surface ridges could contribute to this transition. In Figure 7a–d, fine SiC particles appear embedded across wear surface, including larger agglomerated particles, signifying that a deposition effect occurs across a range of applied loads. An increased number of agglomerated particles are present at the higher load, suggesting that there is a positive relationship between organic deposition and applied load. From these microscopy results, it can also be noted that the substrate material did not exhibit any form of uninform corrosion or pitting, again demonstrating the corrosion resistance of grade 23 Ti-6Al-4V alloy.

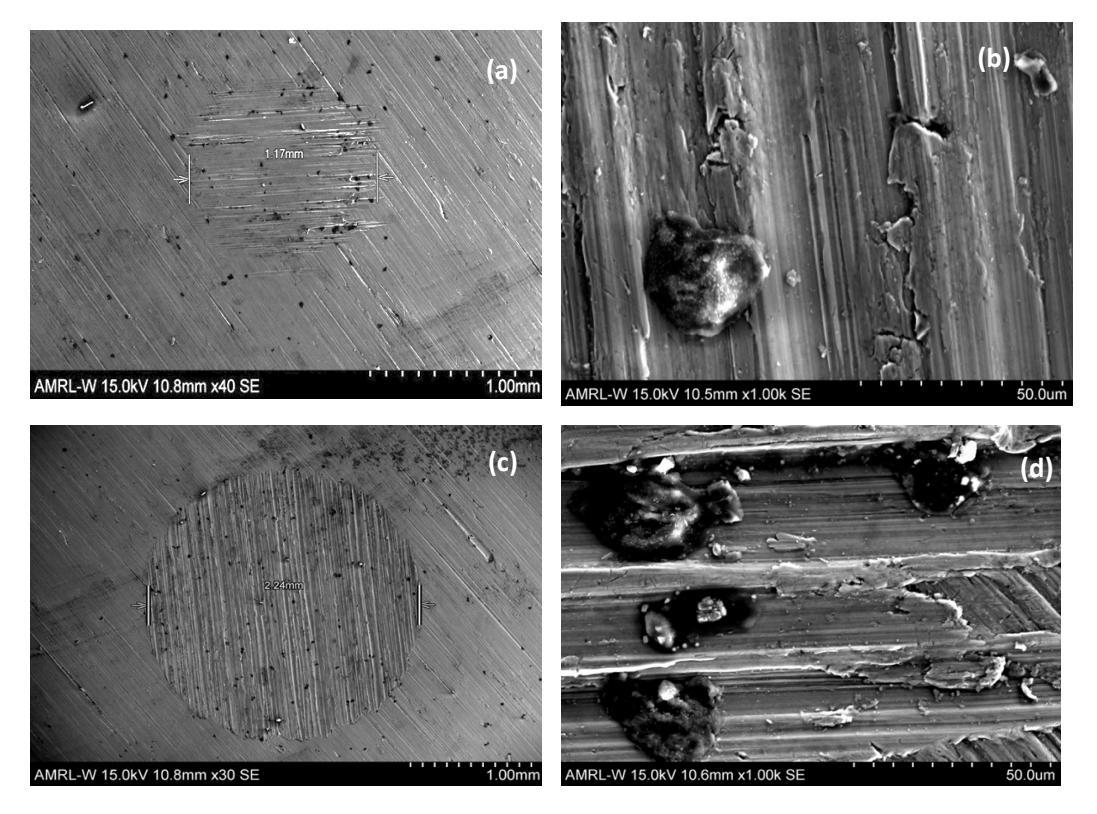
Figure 7. SEM images of the wear scars in Ringer's solution, (**a**) at 0.5 N with abrasive particles (**b**) 'a' at ×1000 magnification, (**c**) 4 N with abrasive particles (**d**) 'c' at ×1000 magnification.

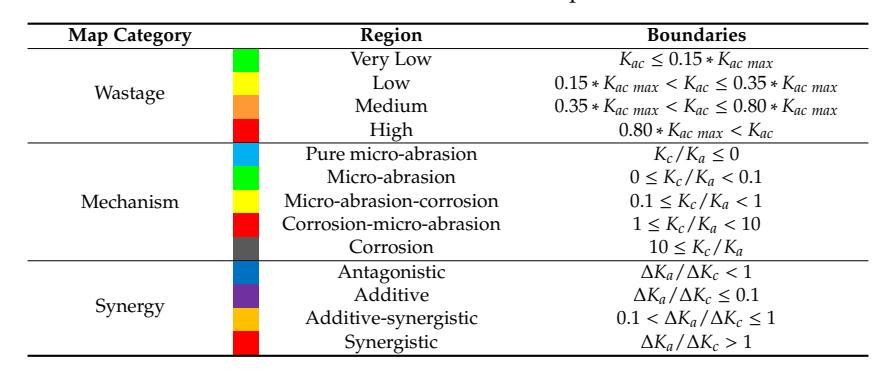
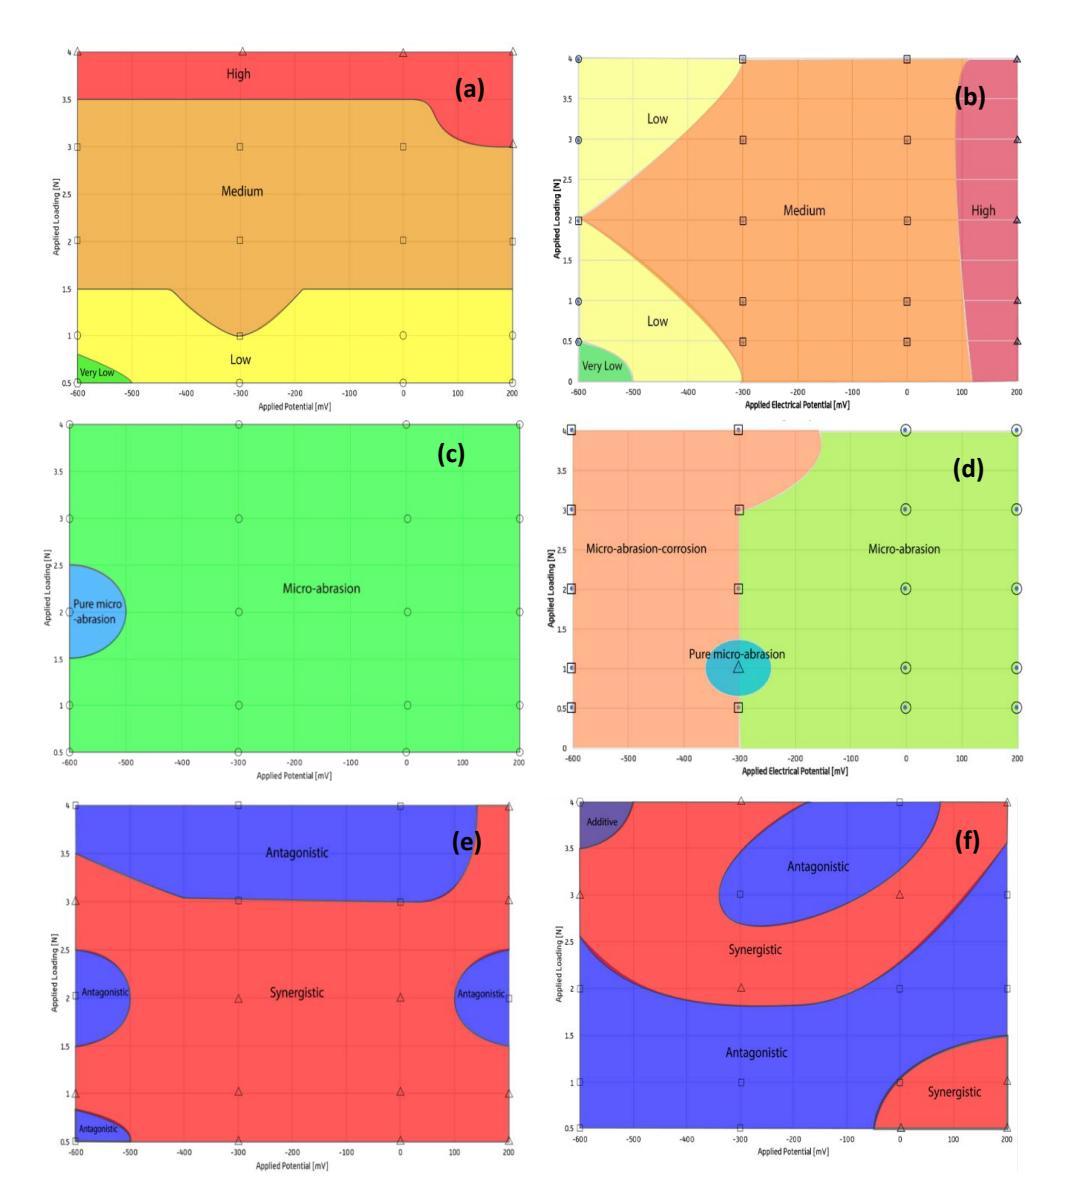
Figure 8. Wear maps corresponding to pure Ringer's solution Versus Ringer's solution plus SiC abrasive particles, (**a**) wastage map for pure Ringer's solution, (**b**) for pure Ringer's solution plus SiC particles, (**c**) mechanism map for pure Ringer's solution, (**d**) for pure Ringer's solution plus SiC particles, (**e**) synergy map for pure Ringer's solution, and (**f**) synergy map for pure Ringer's solution plus SiC particles.

The wastage map in the absence of abrasive particles Figure 8a demonstrates that the applied electrical potential clearly has no significant effect on the total wear compared to the applied load. This is due to the fact that the amount of material loss caused by corrosion was much lower than micro-abrasion.

The mechanism map of Ti-6Al-4V without particles, Figure 8c, is entirely micro-abrasion dominated, reinforcing the titanium alloys strong corrosion resistance. The mechanism map in the presence of particles Figure 8d is also micro-abrasion dominated, but displays different behaviour at cathodic potentials. At an electrical potential of -600 mV and for the range of applied loads, a micro-abrasion-corrosion region is present. This could be due to a deposition effect on the surface, as the system is cathodic, and the fact that oxide reduction occurred at low electrical potentials and low applied loads.

In the non-abrasive synergy map Figure 8e generally, as the applied load is increased, the wear tends to change from a synergistic regime to an antagonistic regime. This could be the result of oxide layers forming a protective barrier to wear, which is then mechanically removed at higher loads, which has been observed in previous corrosion studies [21,25,27]. The synergy map for the abrasive solution Figure 8f has a significant antagonistic coverage in comparison to Figure 8e, where abrasive particles are not present. Possible reasons for this could be increased solution viscosity, improving the lubrication regime and reducing the effect of corrosion–wear due to additional particles. In addition, hard SiC particles are likely to have been embedded on the surface of the softer specimen; therefore, underlying a transition to a two-body abrasion regime towards the center of the contact zone [21]. In Tribo-Corrosion, when the wear mechanism is in the antagonistic wear regime, i.e., micro-abrasion and corrosion in this case, work against each other, instead of together. Synergistic maps, Figure 8e,f, suggest that the antagonistic behaviour of micro-abrasion and corrosion is dominated in both cases, i.e., with and without abrasive particles.
