Abstract: Past research has shown that as skewed bridges change temperature, additional lateral movement or forces will occur along with the elongation of the bridge. Even though past research has documented this behavior, lateral movements of semi-integral bridge superstructure associated with temperature effects on bridge skewness have not been well predicted. In this study, the seasonal movements of a 24-year-old semi-integral bridge caused by temperature effects with skewed abutment have been investigated by conducting a series of field measurements on bridges subjected to various environmental climates. The measured data showed that as the bridge heated up, the superstructure tended to move toward the acute corner of the bridge, and the bridge would contract towards its obtuse corner with a negative temperature change. During warm weather, the cracks on the end diaphragm tended to open with a positive temperature change and close with a negative temperature change, which was much more predictable than the cold weather behavior. This behavior confirms that even though the bridge moves linearly with temperature, the end diaphragm response to the temperature depends on the season

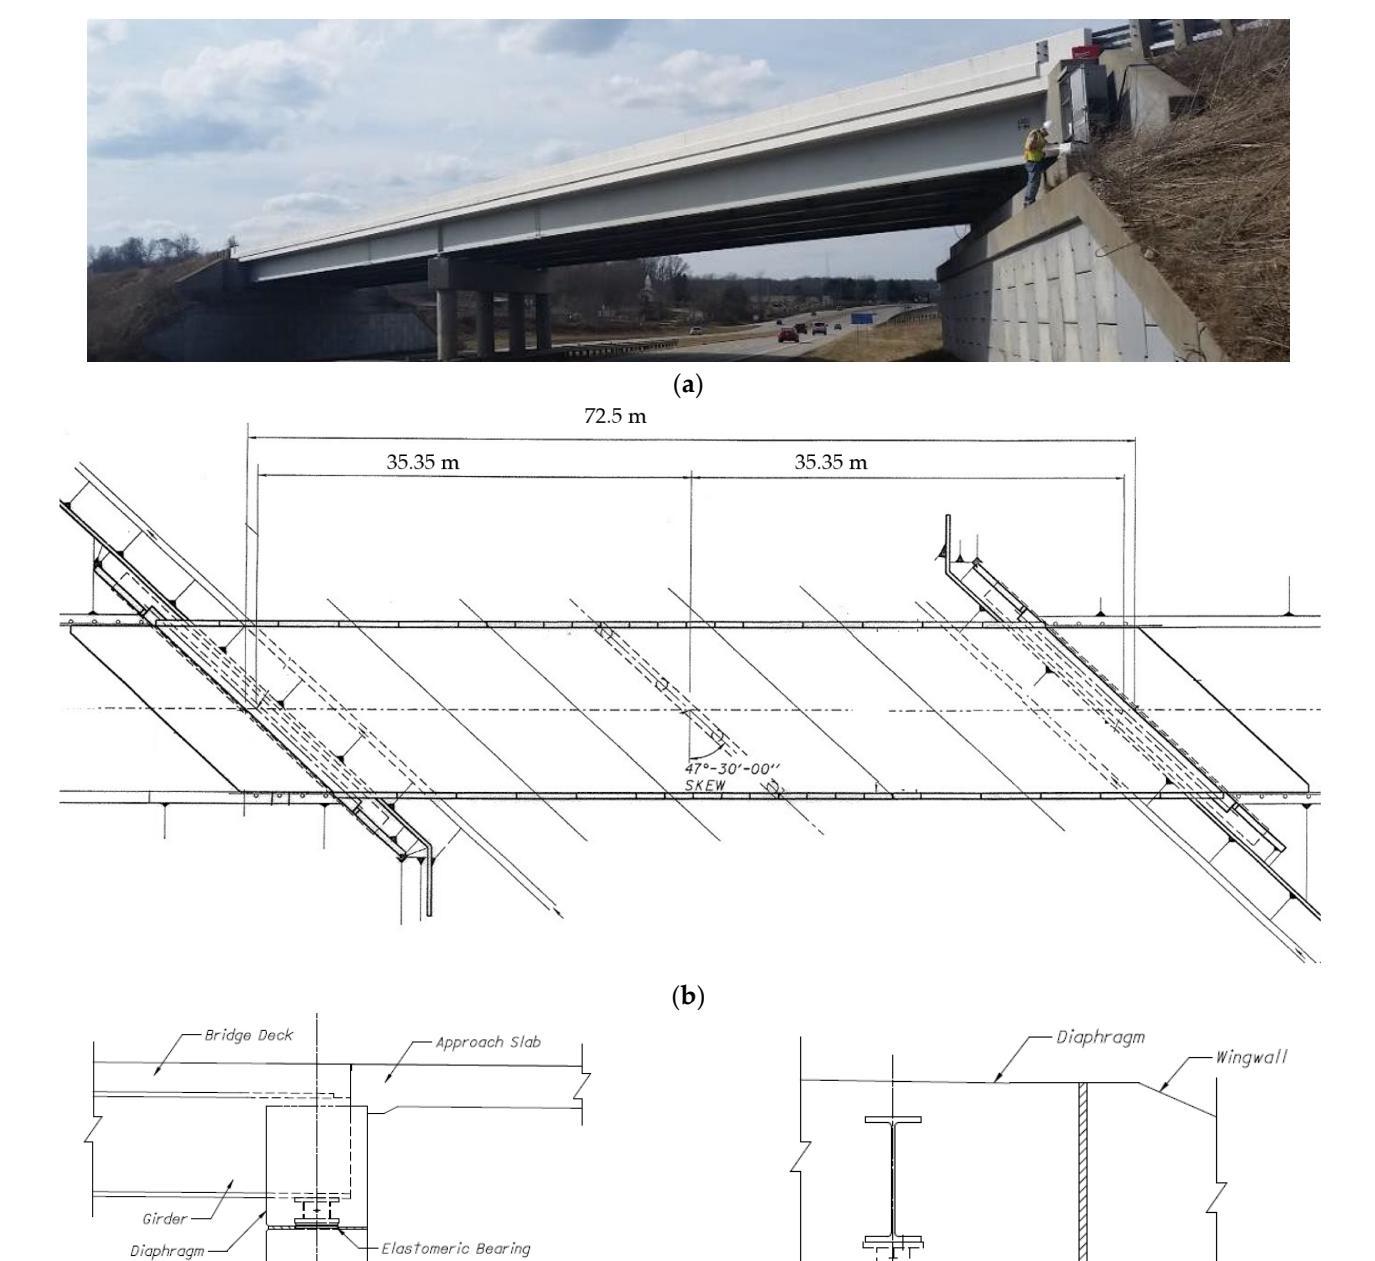
The bridge instrumented in this study is located near Logan, Ohio, on State Route 180, which overpasses U.S. Route 33, as shown in Figure 1. The bridge is a two-span semi-integral bridge with a concrete pier at the mid-span and was constructed during the summer of 1994. Each span is 116 feet long with five steel plate girders, which are shear connected to its concrete deck. The bridge is skewed 47.5 degrees with integral approach slabs, and a bridge deck width of 47 feet. The five steel girders were integrally cast into a concrete end diaphragm, which sits on elastomeric bearing pads. These bearing pads allow the superstructure of the bridge to move laterally while transferring the vertical loads. Styrofoam was placed in the gap between the end diaphragm and the bridge abutment and neoprene sheeting was used to prevent water from flowing through the soil and into this gap. The wing walls of this bridge were integrally cast into the abutment. Expansion joints with2-inch gaps were placed between the side of the end diaphragm and wing wall

Figure 1. Bridge details (**a**) bridge overview, (**b**) plan view, (**c**) abutment cross section, and (**d**) elevation view.

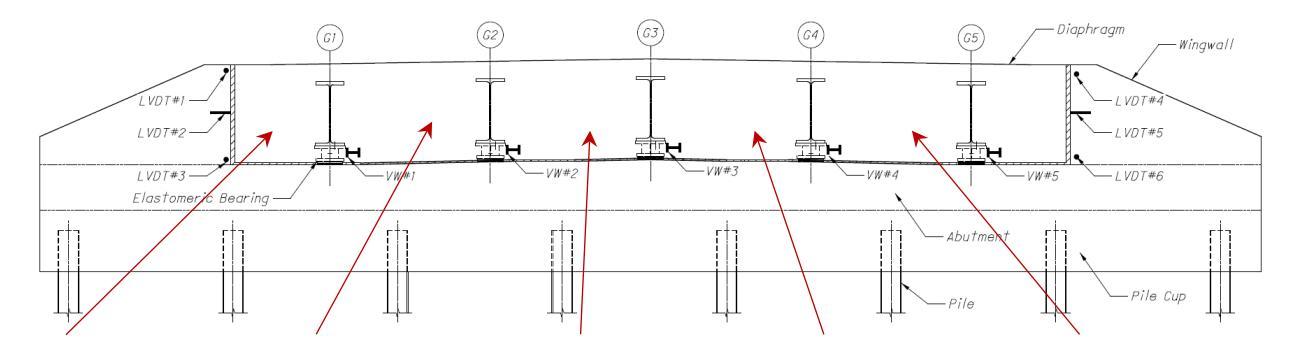
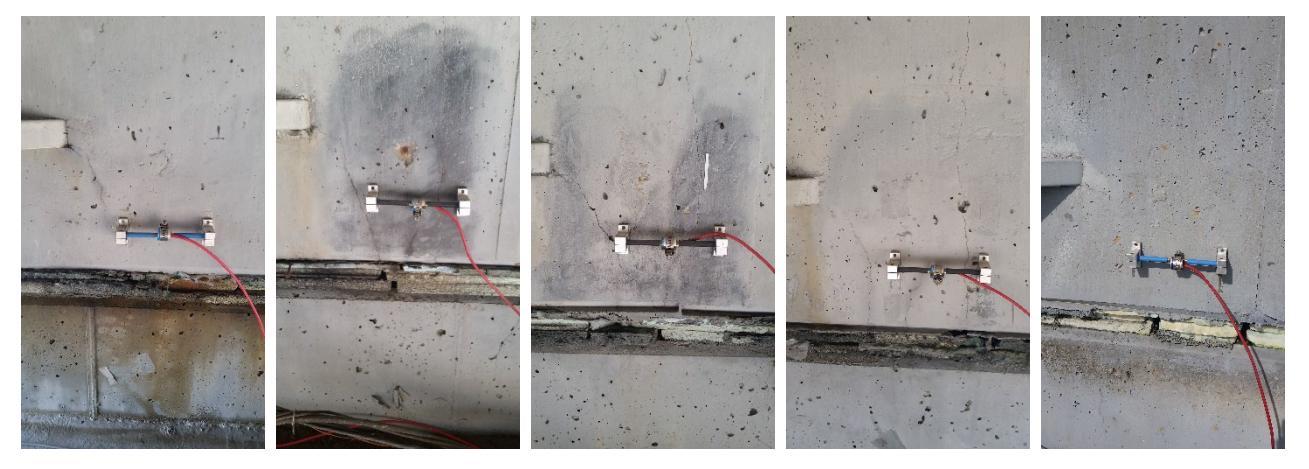
The VW strain gauges were installed across the vertical cracks, which were located along with the end diaphragm beside each girder. These cracks developed at the centerline of the bridge girder bearing pads and projected out perpendicular to the face of the end diaphragm. To measure the relative opening and closing across the concrete cracks at these locations, brackets were fixed to the bridge end diaphragm. With the proper brackets installed, strain gauges were secured into place with set screws to measure the relative opening and closing of the cracks. Figure 2 shows a strain gauge after it was installed near girder #4. The VW strain gauges can measure both temperature and strain, which will both be used to measure opening and closing across the cracks of the end diaphragm as the bridge heats and cools. These strain gauges were numbered and placed across the cracks of each corresponding girder. Figure 2 shows the locations of each VW strain gauge. The VW strain gauges have a resolution of plus or minus 0.1 micro-strain within the gauge's range of measurement. The relative displacement of the strain gauge ends, measured as strain, are used to quantify the movement across the discontinuity (cracks) on the face of the end diaphragms.

Figure 2. Instrumentation Layout and Strain Gauges Located at Girders.

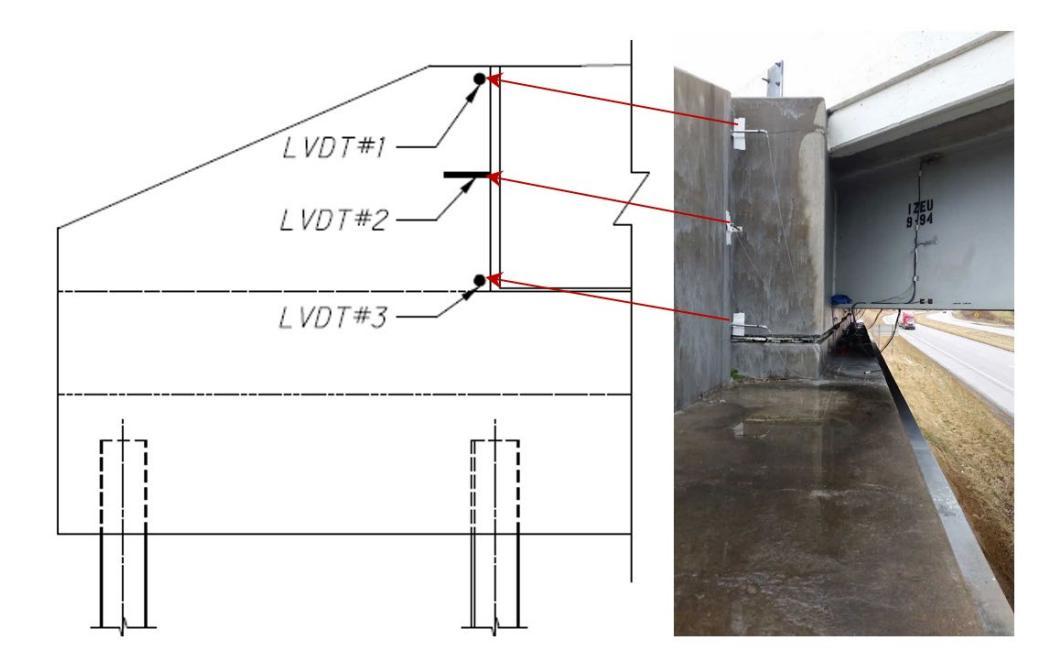
The LVDTs were placed at the interface between the sides of the wing walls and the sides of the end diaphragm to measure the relative displacement between them. The displacement of the end diaphragm is not the absolute movement of the superstructure, but rather the measured relative displacement between the superstructure and substructure of the bridge. LVDTs (#1, #3, #4, and #6) were placed near the top and bottom of the end diaphragm on both sides of the foreword abutment to measure the longitudinal displacement of the bridge superstructure. To measure the transverse movement of the bridge superstructure, LVDTs (#2 and #5) were placed on both ends of the end diaphragm parallel with the face of the bridge abutment. Figure 2 shows the locations of the LVDTs on the foreword abutment of the bridge. Figure 3 shows LVDTs #1, #2, and #3, located on the obtuse corner of the foreword abutment.

Figure 3. Instrumentation Layout and LVDTs Located at Wingwall.

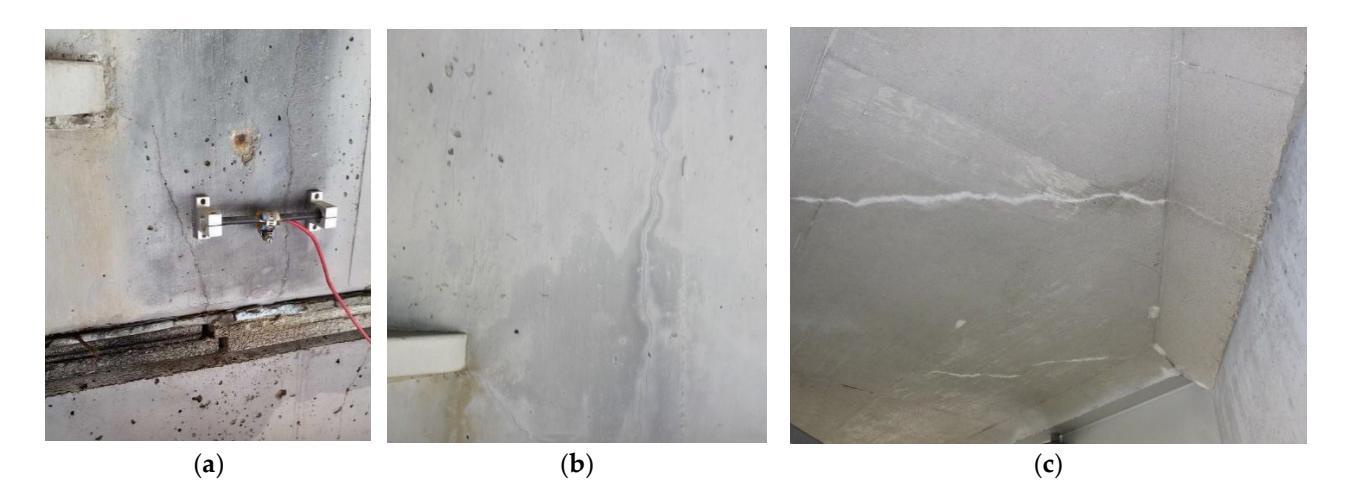
Each end diaphragm had a length of $76'-8^{1/2}$ " a width of 3'-9" and a maximum depth of 6'-8" at the outermost points. This large piece of concrete encased the ends of the five steel plate girders so that the bridge superstructure behaved as one piece. After the bridge was constructed in 1994, cracks developed in the end diaphragms at the bearing pads, which projected perpendicularly to the end diaphragm surface. Figure 4 shows the vertical cracks in the end, diaphragm located at the projected centerline of the girder bearing pad.

The number and length of each crack vary, but each crack starts at the bottom of the diaphragm and propagates towards the bridge deck. In some locations, these cracks reached the bridge deck, which is shown in Figure 4. The progressive cracking along the end diaphragm could potentially damage the deck enough that it would need to be replaced in the future. The surface of the bridge deck appeared to be an inadequate condition with no major cracking noticed. It should be noted that the bridge deck was resurfaced in 2012 with no issues related to replacement of the deck surface, as reported by ODOT [24,25]. To prevent future issues associated with the deck, the cracks on the bottom of the deck should be monitored.

Figure 4. Typical cracks at each girder (**a**) vibrating wire strain gauge located near girder #2, (**b**) cracks forming in diaphragm (**c**) cracks forming in bridge deck.

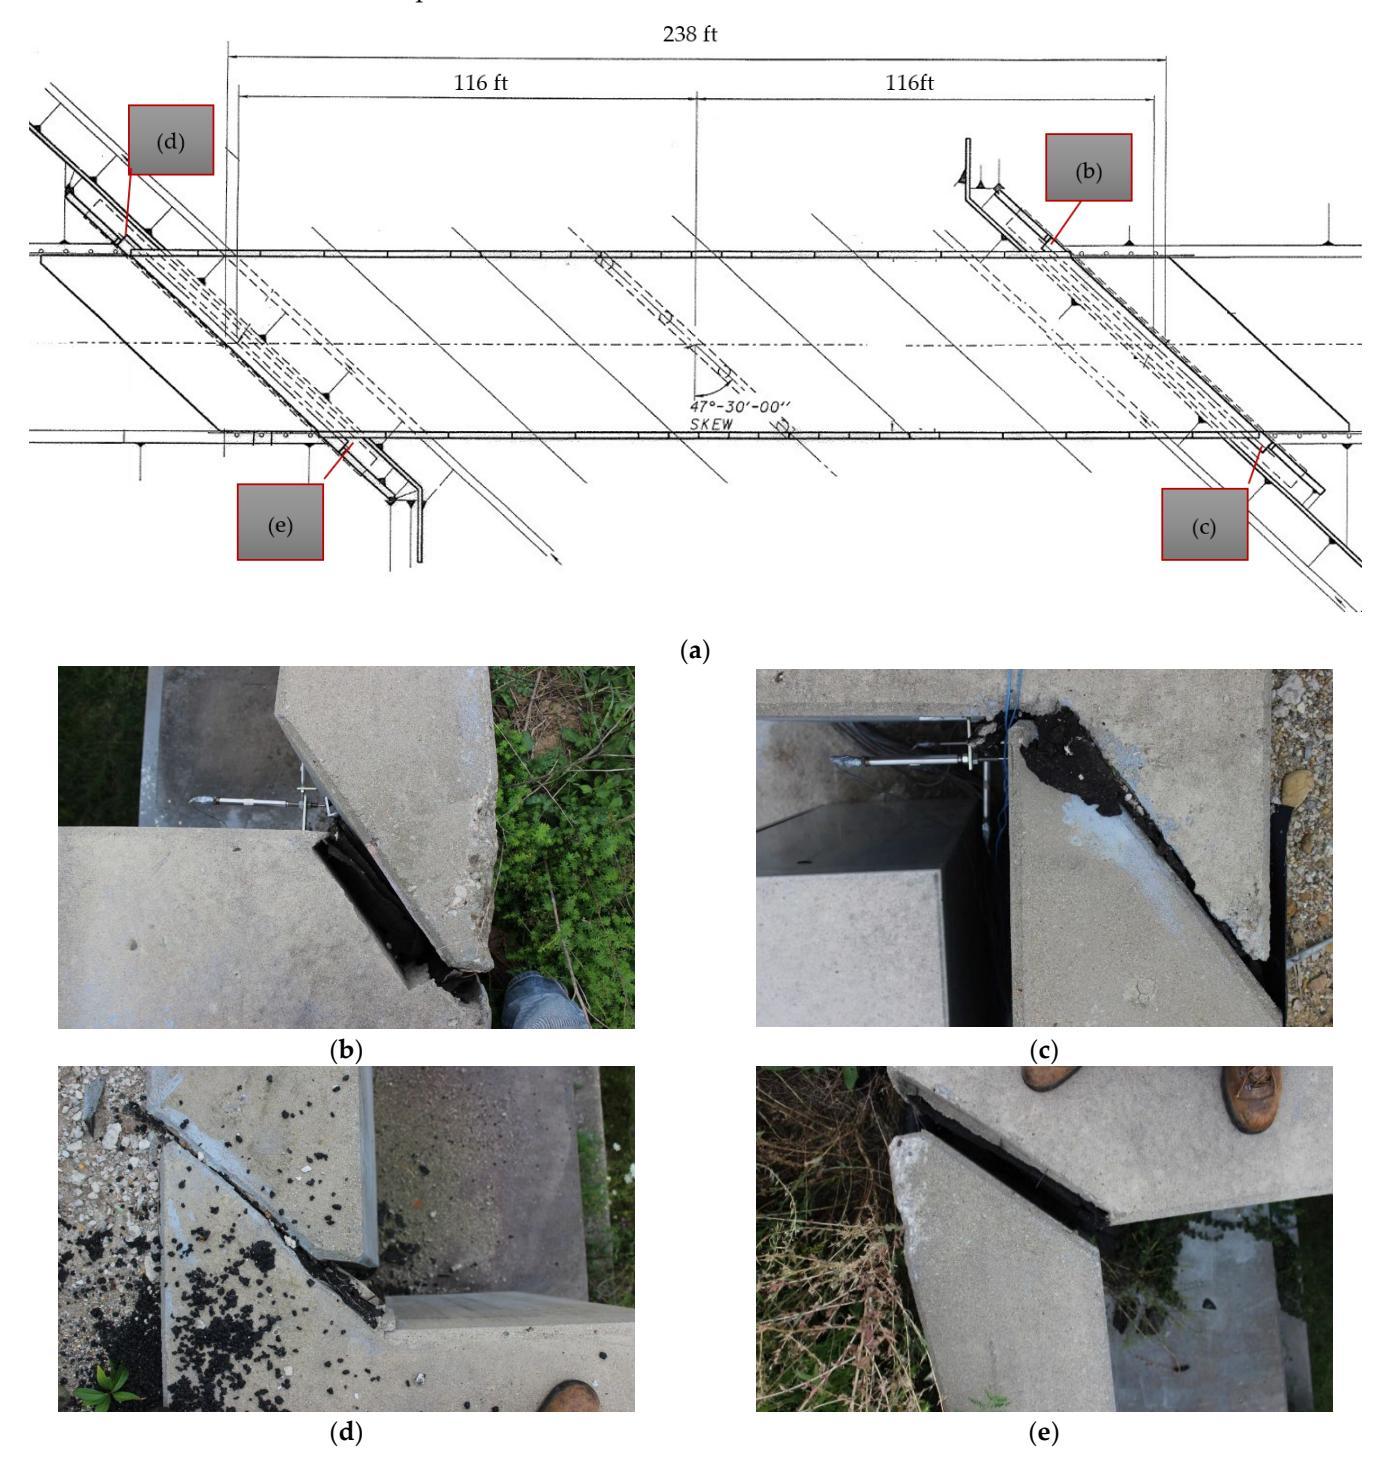
The initial inspection of the bridge shows that the bridge superstructure has displaced significantly since it was initially constructed. Figure 5 shows the current condition of the expansion joint between the end diaphragm and the wing walls. The expansion joints between the wing walls and end diaphragm were originally 2 inches thick, but after excessive lateral movement, they have deformed over time. Table 1 shows how much each expansion joint has been opening and closing.

Figure 5. Wingwall joint opining: (a) overview; (b) forward obtuse corner of bridge; (c) forward acute corner of bridge; (d) rearward acute corner of bridge; and (e) rearward obtuse corner of bridge.

As the bridge superstructure is heating up and expanding, it tends to rotate away from its abutments, which it is supported. The opening of the obtuse corner expansion joints and the compression of the acute corners of the bridge shown in Table 1 illustrates this finding. The relative displacements of these expansion joints do not appear to be recoverable. As the bridge heats and cools, these joints move cyclically back in forth in small increments. However, it appears that the large displacements of over half their thickness will not be reversed but will continue to be deformed over time. It is debatable if this deformation has reached a state of equilibrium or if the bridge superstructure will progressively move laterally.

For movement of bridge superstructure, the initial inspection of the bridge shows that the bridge superstructure has displaced significantly since it was initially constructed. The expansion joints located between the wing-walls and the end diaphragm have started to deteriorate from seasonal bridge movement and weathering. As the bridge superstructure has been moving over time, the expansion joints located at the acute corners have started to be over-compressed while the expansion joints located at the obtuse corners have been falling away from the bridge. This opening and closing of expansion joints can visually show how the bridge is moving and demonstrates the relative displacements between the bridge wing walls and end diaphragm. The widths of the expansion joints were originally 2-inch-thick pre-molded expansion joint filler (as shown in the plans) before they were deformed over time. The acute corner expansion joints were compressed 1.78 inches for the rearward side of the bridge and 1.29 inches for the forward side of the bridge. While the obtuse corner expansion joints opened 1.28 inches for the rearward side of the bridge and 1.81 inches for the forward side of the bridge.

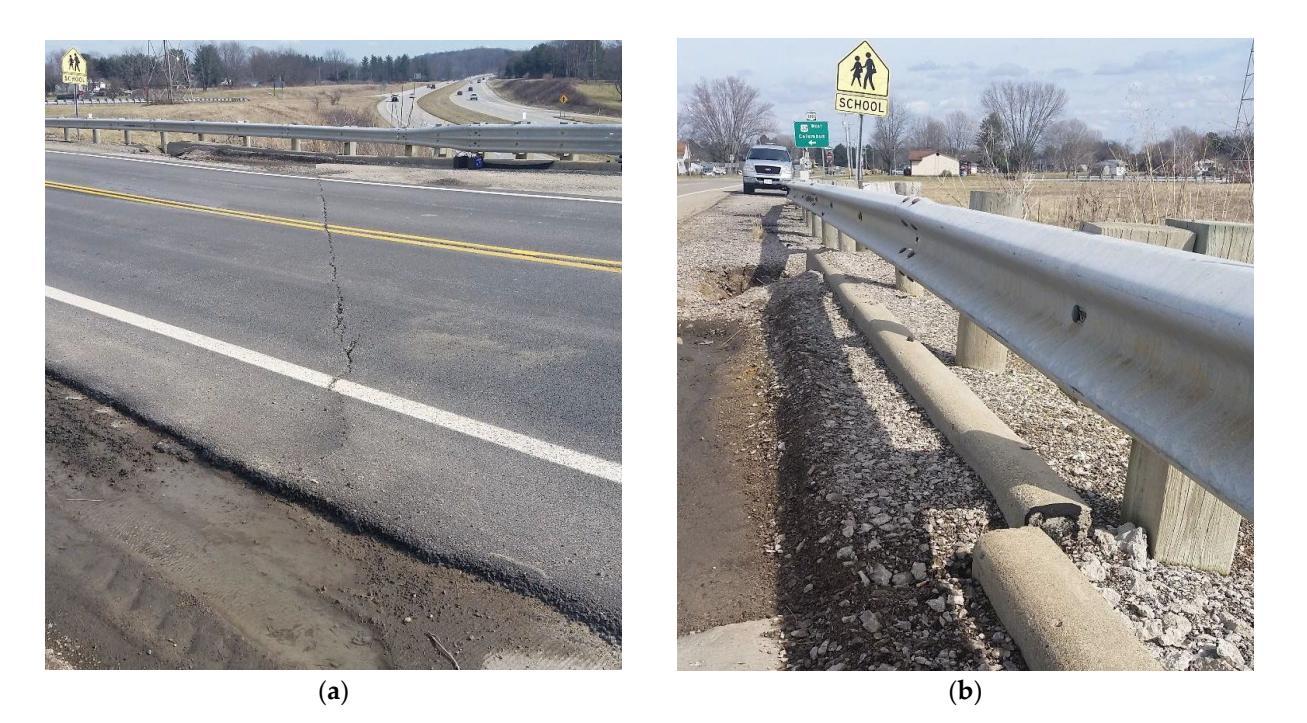
The primary problems occurring at this bridge have been caused by the horizontal rotation of the bridge driven by the temperature effects with skewed abutment. This rotation of the bridge superstructure has been causing problems for parts of the bridge other than the girders, deck, or end diaphragm. The approach slabs of this bridge are integrally reinforced with the bridge deck and end diaphragm so that the approach slab acts concurrently with the superstructure. It is for this reason that when the bridge superstructure rotates from the temperature effects with skewed abutment, the approach slab must also rotate. This rotation of the approach slab caused it to dip vertically overtime at

the asphalt/concrete interface, and for the curbs at the sides of the slab to be displaced horizontally. This behavior can be seen in Figure 6. For this reason, asphalt pavement was placed by maintenance crews on top of the beginning of the approach slab. The added asphalt provides a continuous elevation for vehicles to travel across, but it does not fix the issue of the approach slab movement. Currently, the approach slab condition is not a structural problem, but it should be monitored in the future to ensure that it does not turn into a problem.

Figure 6. Approach slab deformation (**a**) pavement cracks at end of approach slab and (**b**) bridge curb displacements.

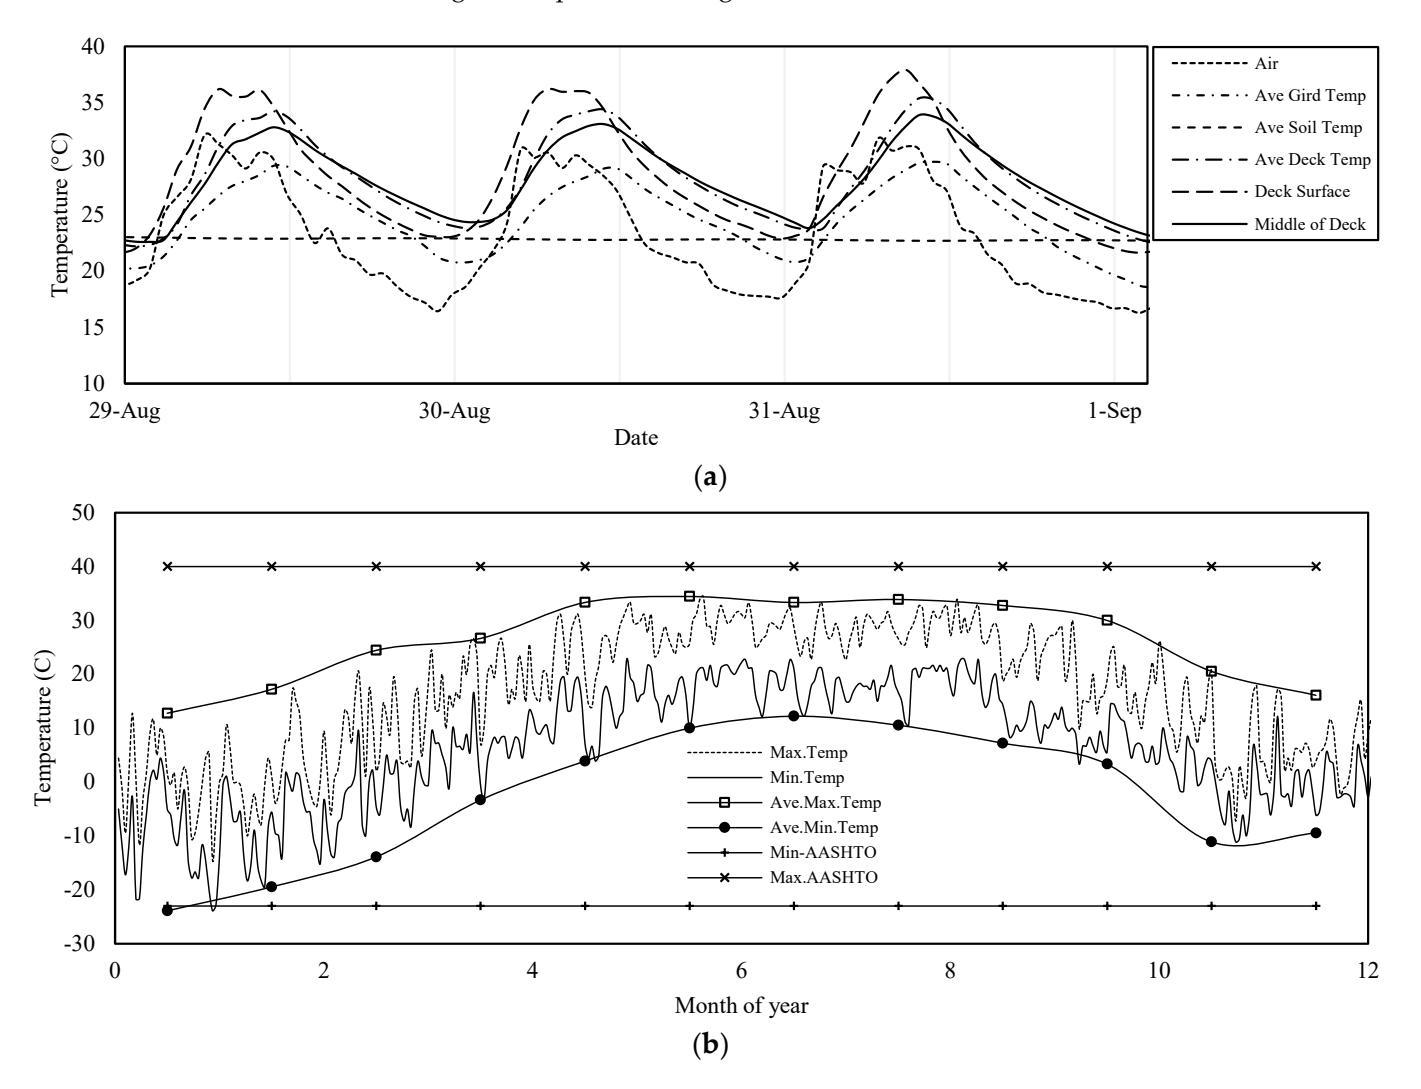
In order to compare the results measured with the LVDTs and strain gauges, the temperature change of the bridge site overtime was required. Thermocouples were placed in the deck, and a thermocouple was used to measure the ambient air temperature around the bridge. The thermocouples and the temperature component were used to quantify the temperature gradient across the site better. Figure 7 shows the distribution of temperatures measured during a period of warm weather along with AASHTO [26] temperature limitations.

Figure 7. Measured temperatures (a) warm weather temperature variation (b) daily temperature data.

In order to understand the overall performance of the end diaphragm, temperature and displacement measurements were discussed here. From Figure 7, the deck temperatures reached higher values than the ambient air temperatures reached. This occurs because of the additional heat from thermal radiation, which the girders are mostly protected from. The behavior of the bridge depends on the temperature of the soil and structure as much as the air temperatures. The temperature of the soil was used as a baseline to understand what kind of temperatures the bridge structure is dealing with relative to the air temperature measured. The air temperature data collected from Highland Park Weather Station [27] near Logan, Ohio and is shown in Figure 7. This temperature data from a local weather station helps to support and confirm the temperature measurements that were collected.

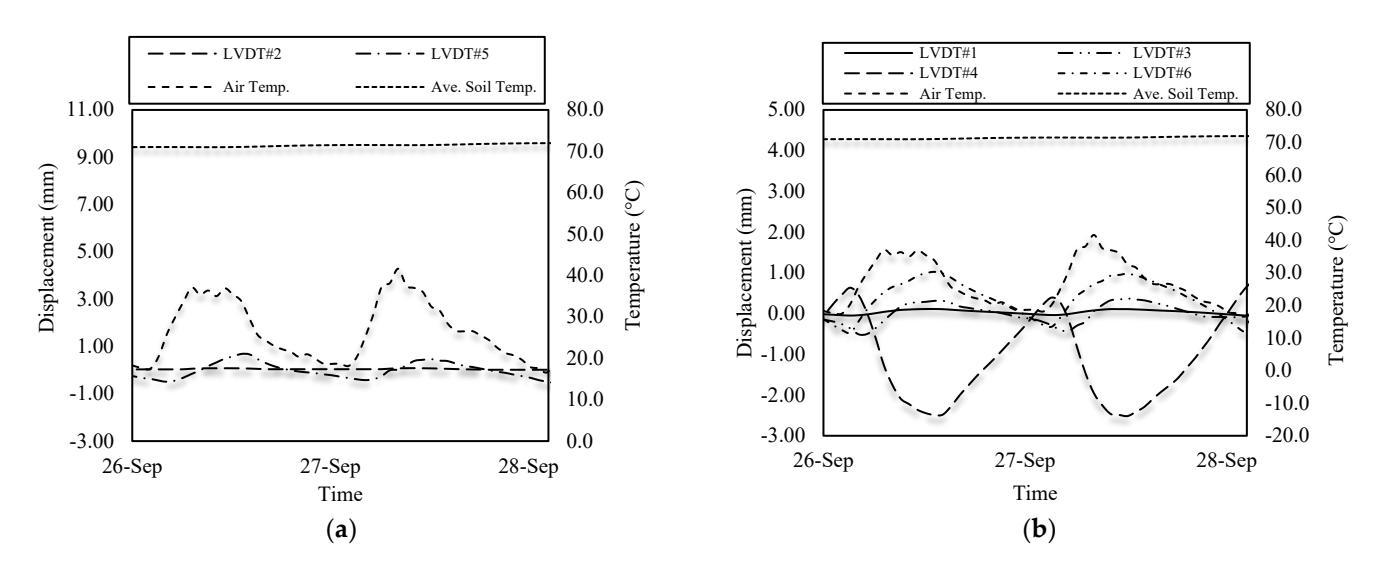
In order to measure the daily temperature-induced movements of the bridge end diaphragm, LVDTs were placed between the wing walls and end diaphragm. This relative displacement demonstrates how the bridge superstructure is affected by both daily heating and cooling as well as the seasonal heating and cooling. During periods of rapid changes in temperature, the bridge displacements are prone to behave more erratically. To better demonstrate the general behavior of the bridge, Figure 8 shows the typical lateral and longitudinal displacement trends of the bridge on a warm day.

The reason LVDT #2 and #5 have opposite directions is because the LVDTs are oriented in opposite directions. LVDT #2 and #5 are measuring the lateral relative displacements between the end diaphragm and the wing walls on the obtuse and acute corners, respectively, of the forward side of the bridge. When LVDT #5 moves positively and LVDT #2 moves negatively, this means the bridge superstructure is moving towards the acute corner. Figure 8 shows that as the bridge heats up in warm weather, the end diaphragm moves towards the acute corner of the bridge, as shown by the displacement of LVDT #2 and LVDT #5, which mirror the movements of the other in the same direction. However, it can also be noted that there is a slightly more lateral movement noticed at the acute corner of the bridge (LVDT #5) than the obtuse corner of the bridge (LVDT #2).

Figure 8. Measured temperatures and displacements (**a**) warm weather lateral displacement (**b**) warm weather longitudinal displacement.

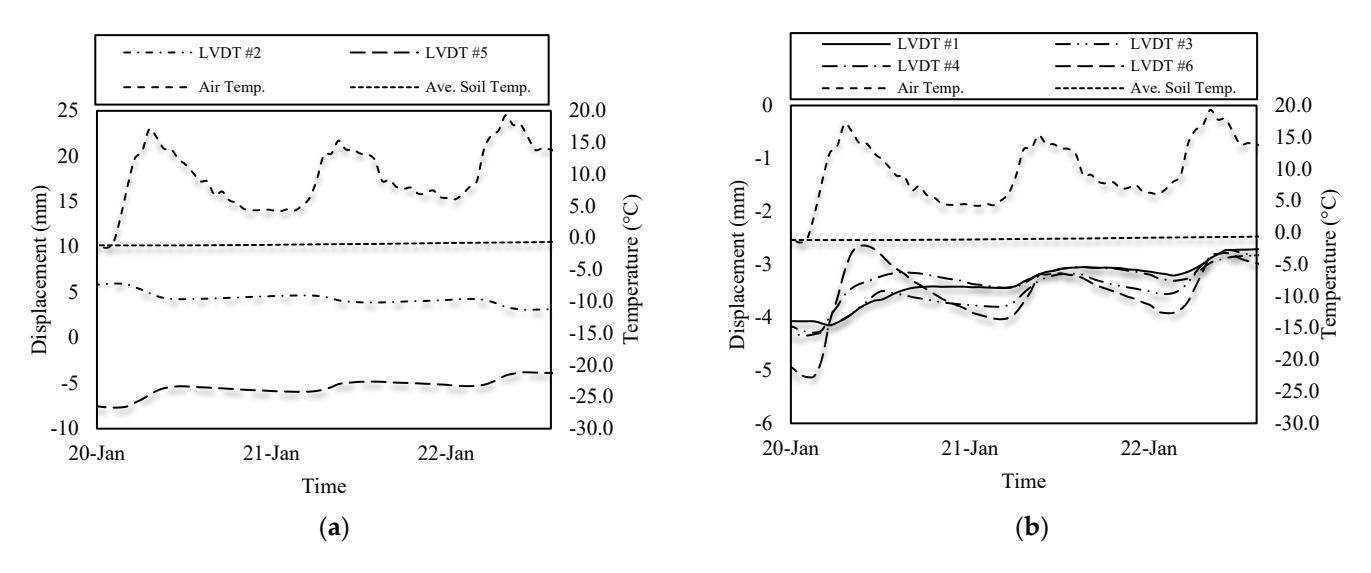
Figure 9 shows the longitudinal movement of the end diaphragm as it heats and cools during typical warm weather. As the temperature increases, LVDT #3 and LVDT #6 show more longitudinal movement at the bottom of the end diaphragm than the top portion with LVDT #1 and LVDT #4. This is caused by the steel girders heating and cooling quicker than the concrete deck does. The more longitudinal movement was also noticed on LVDT #4 and LVDT #6 because this side of the bridge would have direct sunlight as the sun started to rise. Figure 9 shows the longitudinal expansion of the bridge superstructure on a typical period of cold weather.

Figure 9. Measured temperatures and displacements (**a**) cold weather longitudinal displacement (**b**) cold weather lateral displacement.

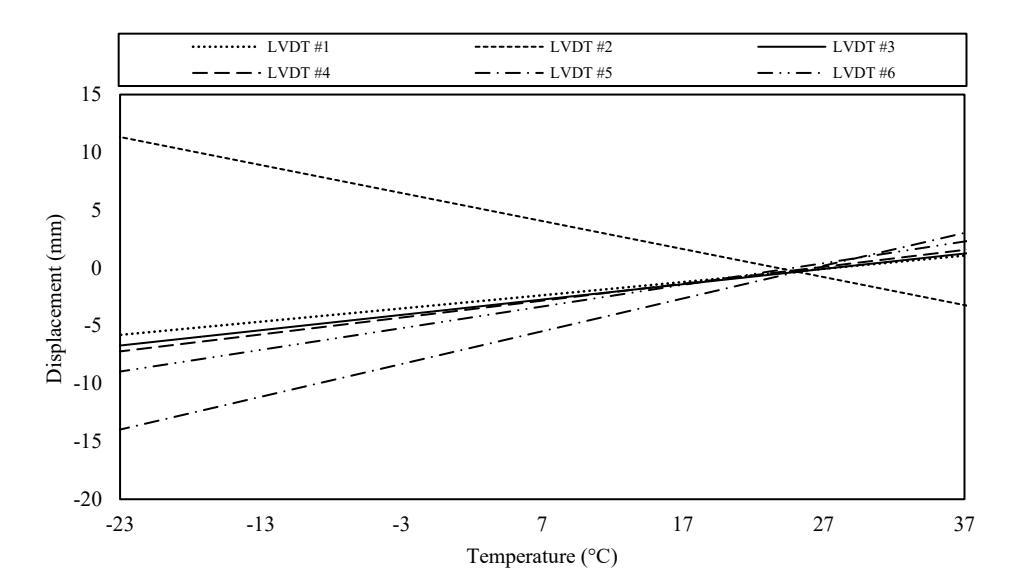
The data in Figure 10 confirms this behavior because the movements are symmetric and decrease with the positive temperature change. The movements of the bridge end diaphragm appear to trend linearly with temperature, which is shown in Figure 10. The comparison of temperature and displacement of each LVDT is shown in Figure 11 along with the linear fit between temperature and displacement. The linear fit of the LVDTs had an average R² value of 0.8, which demonstrates the consistency of the movement relative to temperature. Figure 12 also confirms the linear behavior noticed because each LVDT returns to zero at the same installation temperature they were zeroed.

Figure 10. Average LVDT Displacement vs. Temperature.

The data in Figures 10–12 confirms this behavior because the movements are symmetric and decrease with the positive temperature change. The movements of the bridge end diaphragm appear to trend linearly with temperature. The linear fit of the LVDTs had an average R^2 value of 0.8, which demonstrates the consistency of the movement relative to temperature. The linear behavior noticed because each LVDT returns to zero at the same installation temperature they were zeroed. The displacements measured on the acute side of the end diaphragm (LVDT #4, #5, #6) appeared to be slightly larger than

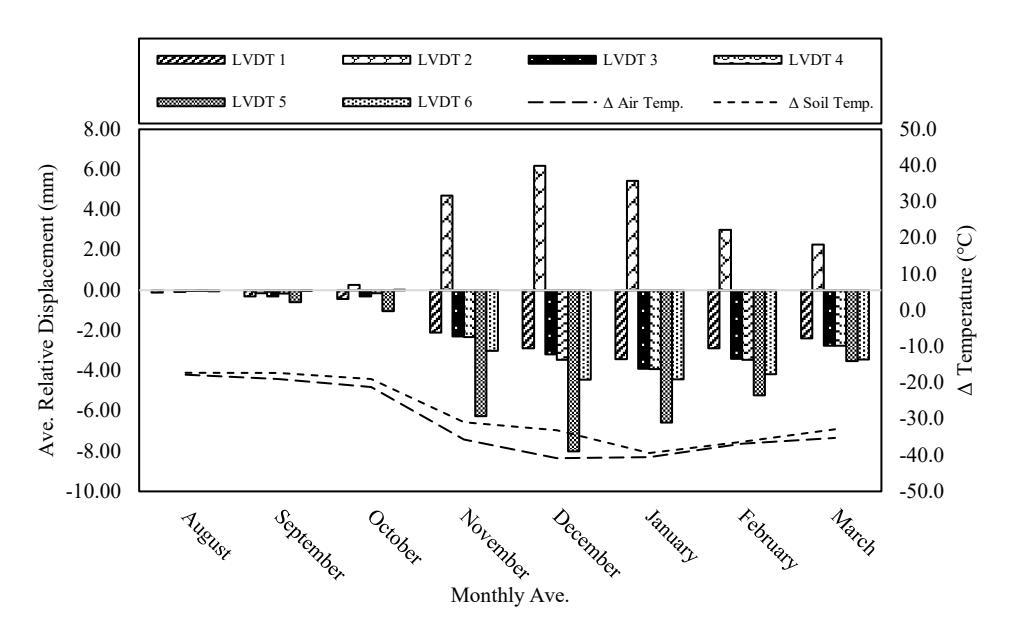
Figure 11. LVDT Monthly Ave. Relative to Temperature.

those measured on the obtuse side of the bridge (LVDT #1, #2, #3). The average movement of the bridge as the temperature varies from its initial installation temperature. However, when the temperatures started to drop, the bridge started to contract and move more. This helps to show how movement in the warmer months varies from that which is seen in, the colder months.

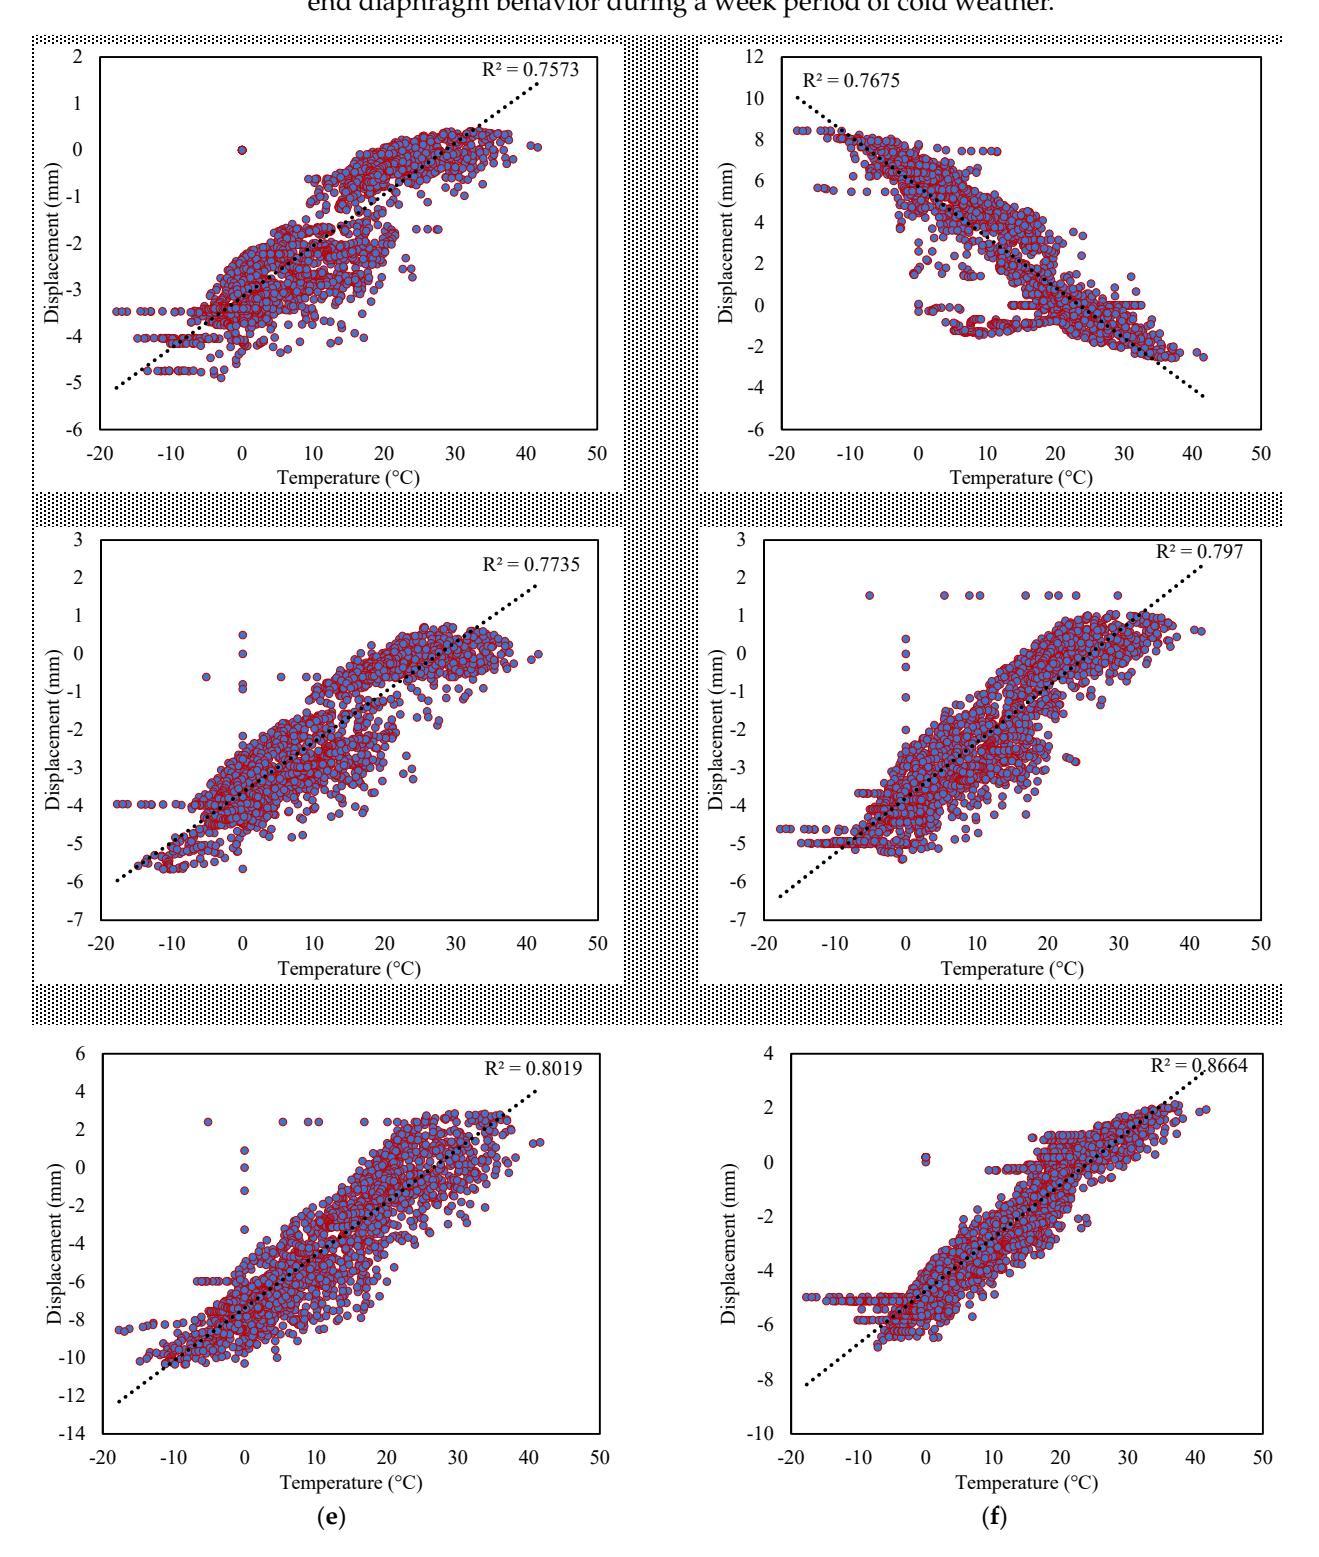
Figure 12. Measured temperatures and displacements (**a**) LVDT #1, (**b**) LVDT #2, (**c**) LVDT #3, (**d**) LVDT #4, (**e**) LVDT #5, and (**f**) LVDT #6.

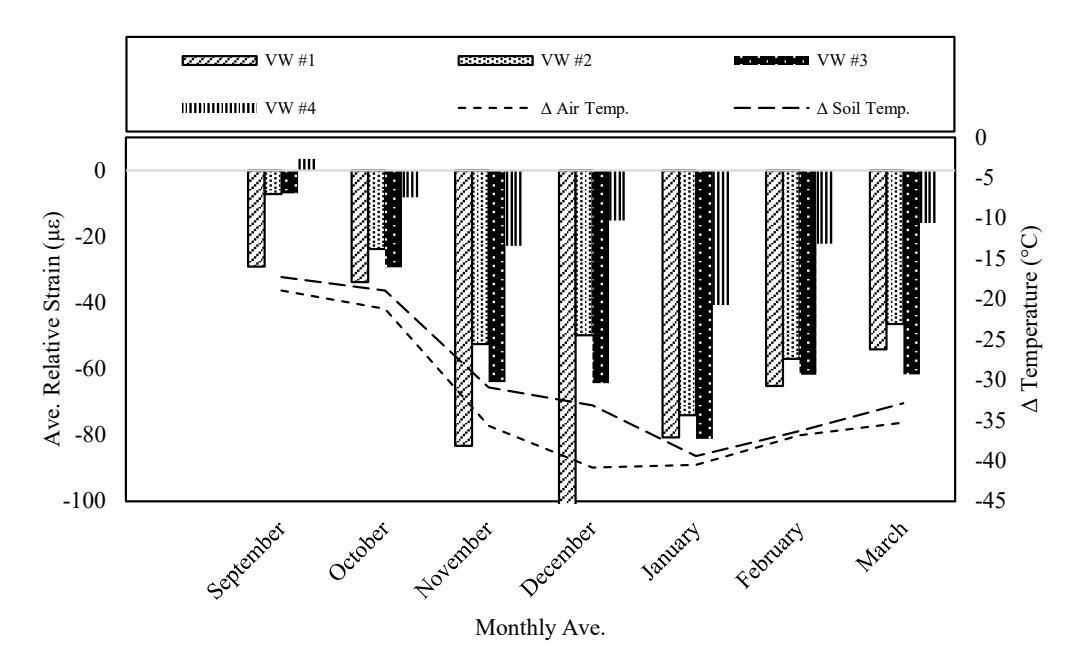
Figure 14. Strain Gauge Monthly Ave. Relative to Temperature.

From strain measurements, it appears that the cracks near the girders closest to the acute corner (VW #4) contract the least, and the cracks near the girders closest to the obtuse corner (VW #1) contract the most. When the relative opening and closing of the cracks during the winter is compared with magnitudes of the summer, the end diaphragm cracks have been contracting as the temperature has decreased. The end diaphragm is contracting as the seasonal temperature drops, but the thermal response of the cracks changes as the season changes. It is thus shown from the data collected that the behavior of the bridge is influenced by the change in temperature of the structure as well as the overall ambient temperature. Although the movement of the bridge superstructure is linear, the bridge behaved differently for the same change in temperature, depending on the season.
