# Article **Tropical Cyclone Impacts on Headland Protected Bay**

# Daniel Wishaw <sup>1,2,\*</sup>, Javier X. Leon <sup>1</sup>, Matthew Barnes <sup>3</sup> and Helen Fairweather <sup>1</sup>

**Abstract:** The response of headland protected beaches to storm events is complex and strongly site dependent. In this study, we investigated the response of several headland protected beaches in Noosa, Australia to a tropical cyclone event. Pre and post topographical surveys of all beaches were completed using both pole-mounted RTK-GNSS and structure-from-motion (SfM)-derived elevation models from survey-grade drone imagery to assess sediment volume differentials. Coastal imaging was used to assess shoreline development and identify coastal features while a nearshore wave model (SWAN) was used to project waves into the study site from a regional wave buoy. Obliquely orientated swells drive currents along the headland with sediment being eroded from exposed sites and deposited at a protected site. Elevated sea-levels were shown to be a strong force-multiplier for relatively small significant wave heights, with 10,000 m<sup>3</sup> of sediment eroded from a 700 m long beach in 36 h. The SWA

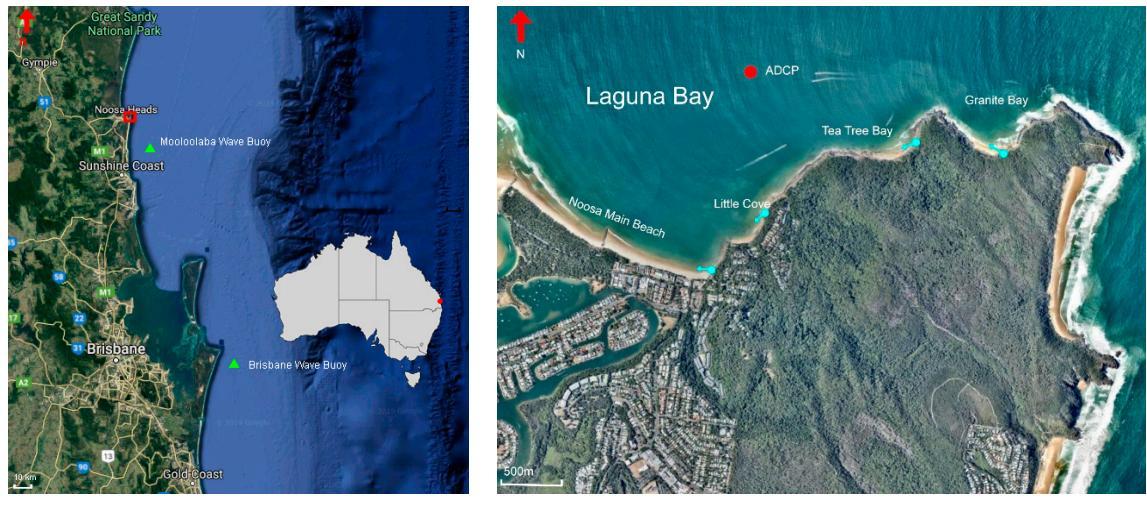
**Figure 1.** Noosa Headland with instrument locality for south-east Queensland (**a**) and Noosa Headland (**b**). The location and direction of monitoring photo sites is shown in (**b**) with light blue arrows. Source: Google maps (**a**) and Nearmaps.com.au (**b**).

Noosa is located on the south-east coast of Queensland, Australia, approximately 120 km north of Brisbane (Figure 1). Protected by a large headland, the beaches of Laguna Bay, Noosa include several headland-bay beaches; Granite Bay (320 m), Tea Tree (245 m) and Little Cove (290 m), as well as the Noosa Main Beach, which is split evenly into 700 m long eastern and western sections by an intermediate rock groyne.

During TC Oma, regional wave data was collected from two sites operated by the Queensland Government; offshore of Mooloolaba and Brisbane (Figure 1). Both of these permanent sites utilise Datawell 0.9 m GPS Waverider, directional wave buoys, with the Mooloolaba wave buoy located approximately 20 km south-southeast of Noosa in 32 m of water and the Brisbane buoy is located approximately 130 km south-southeast of Noosa in 70 m of water [29].

The comparison of shorelines extracted from rectified phots taken on 18 January 2019 and 8 March 2019 are in line with the survey results above, with recession observed at Granite Bay, Tea Tree Bay and Noosa Main Beach and accretion observed at Little Cove (Figure 6a–d). Photo locations are shown in Figure 1b.

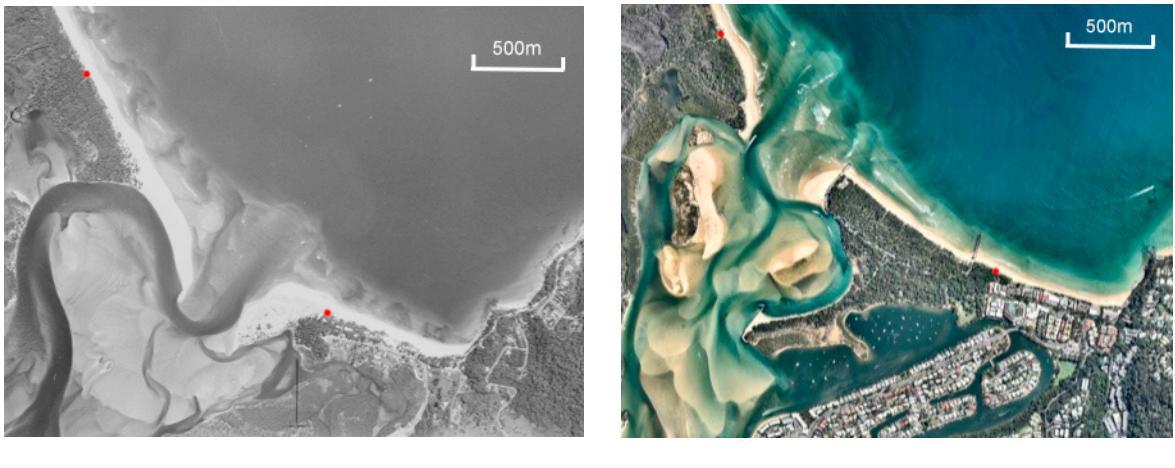
**Figure 2.** Comparison of Noosa Main Beach, May 1958 (**a**) to March 2019 (**b**). Two location markers (red points) have been added on each photo for comparison. Note the relocation of the river, narrowed beach and two prominent groynes. Source: QImagery (**a**) and Nearmap.com.au (**b**).

The response to the erosion in the 1950s and 60s was haphazard; unplanned protection works were installed by the local community. A rock revetment wall was formally constructed by the Queensland Government in 1968–1969. Further coastal intervention has included sand nourishment (1978, 1983, 1988 and 1990), an artificial relocation of the river mouth and construction of the spit groyne (1978), construction of the central Noosa Woods groyne (1982) as well as the installation of a permanent sand recycling system (2009), which collects sand from the intertidal zone of the beach side of the spit groyne and deposits it in the eastern end of the Main Beach. The development in Noosa between 1958 and now has been considerable, which can be seen below in Figure 2.

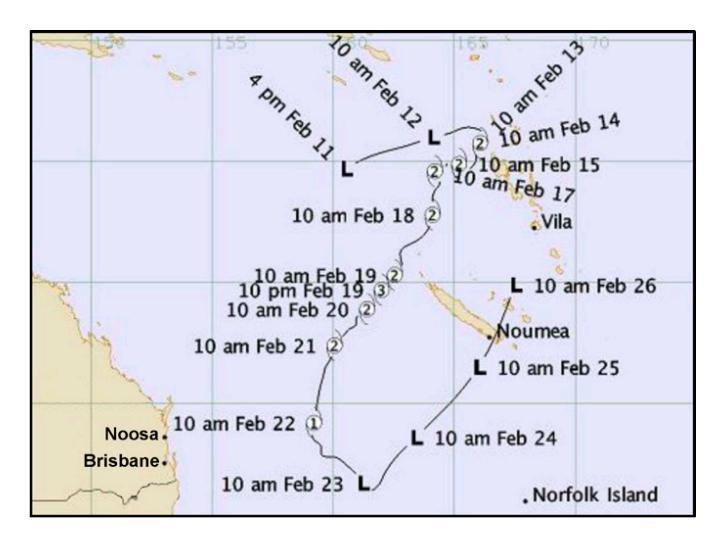
Figure 3. Tropical cyclone Oma track map. Source: Bureau of Meteorology.

Tropical cyclone (TC) Oma developed in the South Pacific basin near Vanuatu between 7 and 15 February 2019, reaching its peak intensity on 19 February as a category 3 system. From Vanuatu, Cyclone Oma tracked south-west, passing New Caledonia to the north-west and tracking towards the northern New South Wales coast. On 21 February the storm began to slow and lose intensity, being downgraded to a category 1 system on the morning of 22 February, approximately 800 km east of Noosa. Following this, it turned south-east and continued to lose intensity before finally turning north on the evening of 23 February as a tropical low [28] (Figure 3).

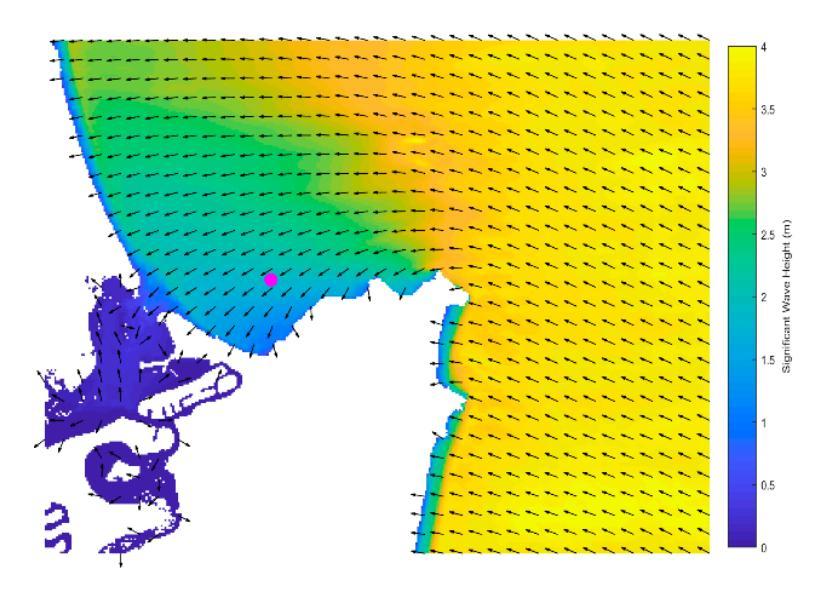
**Figure 4.** SWAN wave model output from 10:00 22 February 2019 (the ADCP in Laguna Bay is shown by the pink dot).

The regional observed and modelled wave conditions during TC Oma show that Noosa Main Beach was protected from the most energetic conditions of the event. The cyclone track of TC Oma (Figure 3) shows that the storm passed to the east and then south of Noosa, with the maximum significant wave height ( $H_s$ ) of the event being from the south east. Consequently, while the Brisbane wave buoy recorded significant wave heights approaching 7 m, Laguna Bay was partially sheltered by Noosa Headland (Figures 4 and 5a). During the event, the maximum modelled significant wave height was 2.1 m within Laguna Bay.

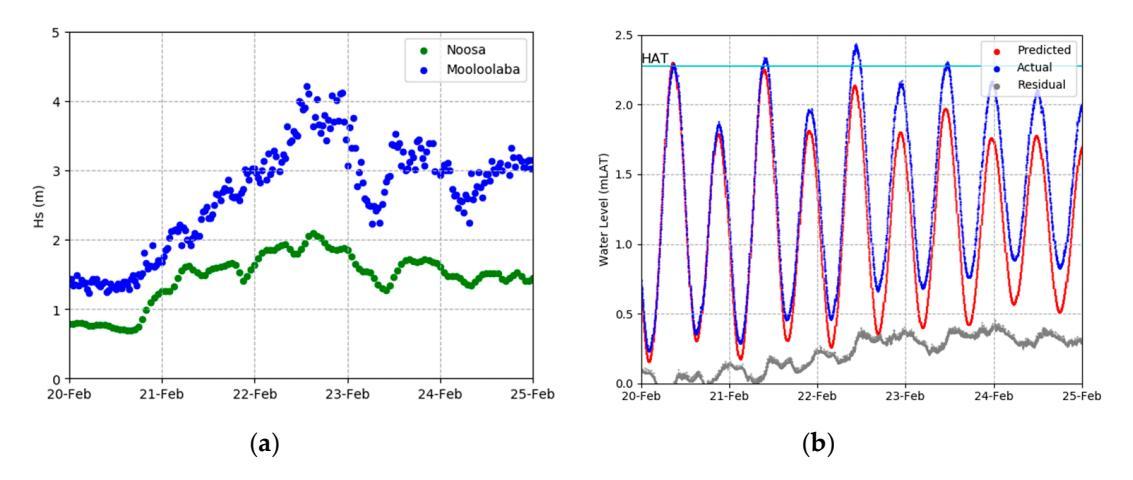
**Figure 5.** (a) Significant wave heights at Mooloolaba wave buoy (recorded) and Laguna Bay (Noosa) (modelled), and (b) predicted and recorded tidal levels for Noosa Main Beach, as projected from Maroochydore tide gauge.

Mooloolaba and Maroochydore water level measurements were projected into Laguna Bay and compared with the results from the rapid deployment tide gauge within Noosa River. The Mooloolaba tide gauge recordings underestimated the observed water level within Laguna Bay, while the projected Maroochydore observations were consistent with local observations. As such, the projected Maroochydore observations were adopted for this research, with the maximum water level of 2.44 m above lowest astronomical tide (LAT) recorded at 10:33 on 22 February, which approximately coincided with the maximum wave heights (Figure 5a,b).

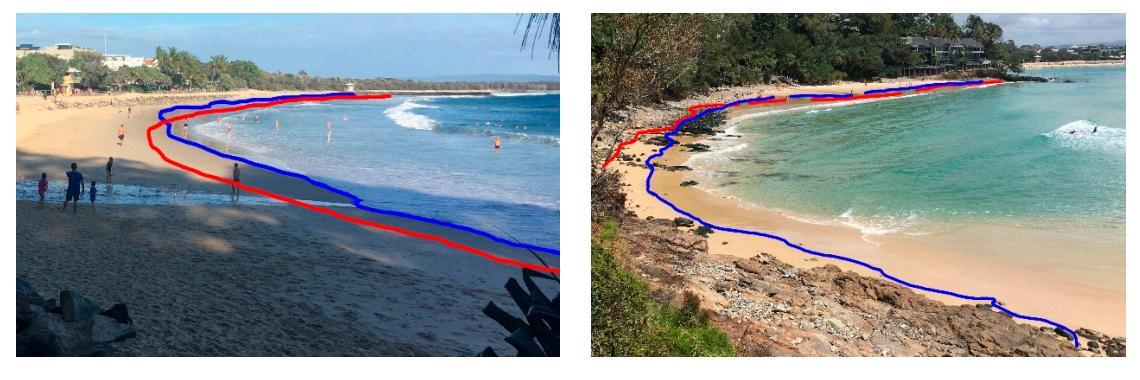
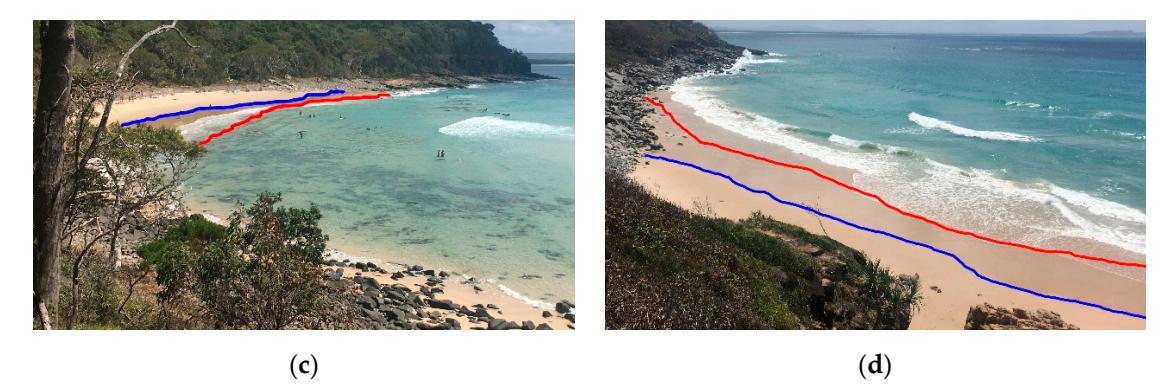
**Figure 6.** (a) Main Beach shoreline comparison. The red line indicates the 18 January 2019 shoreline position while the blue line and photo are from 8 March 2019. Little Cove (b), Tea Tree (c) and Granite Bay (d) shoreline comparison.

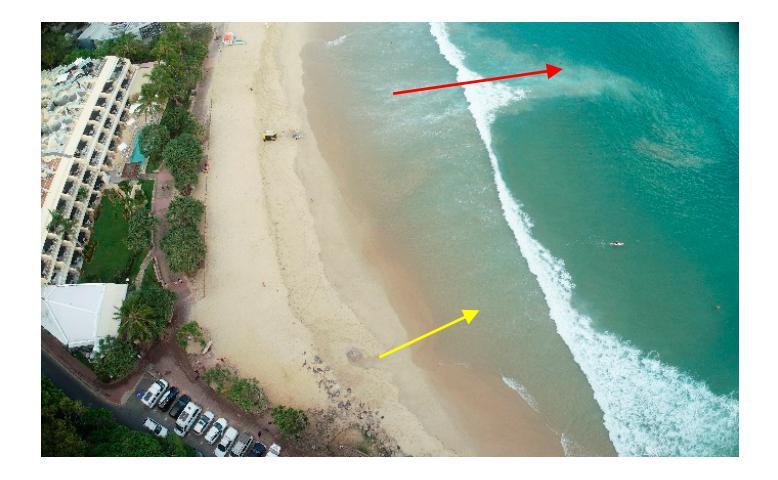
**Figure 7.** Aerial view of the eastern corner of Noosa Main Beach on 21 February 2019 at 6:19 a.m. with a large rip clearly present (red arrow). The outlet of the sand recycling system is shown (yellow arrow) and is located up-current from the observed rip.

An embayed cellular rip at Noosa Main Beach was observed during this study, in contrast to previous work at this site. The proximity of this rip to sand replenishment operations on Noosa Main Beach warrants the consideration of modifying the outlet location to avoid potential loss of nourishment through this rip system.

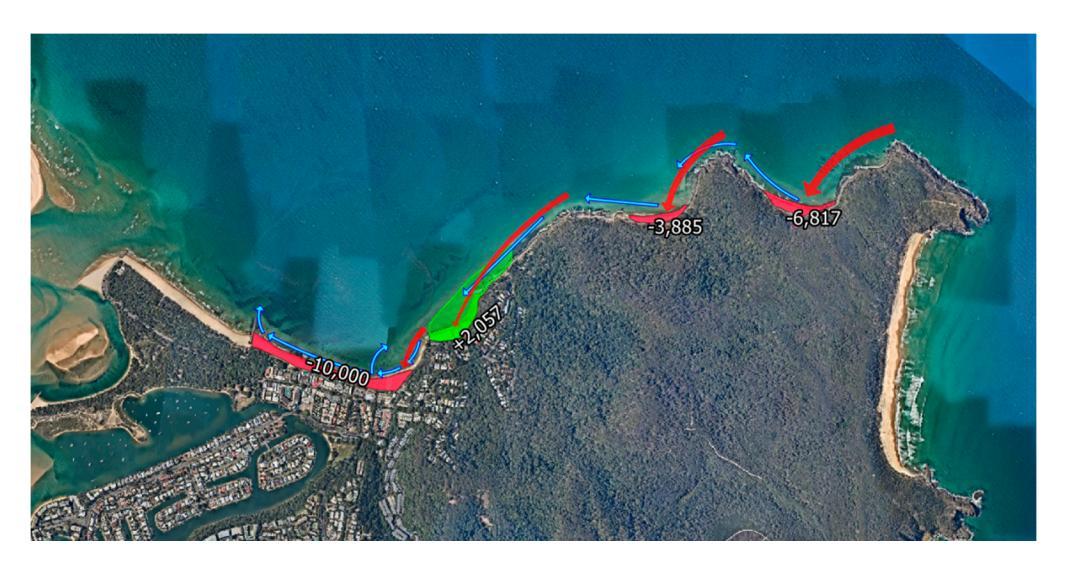
**Figure 8.** Conceptual model of erosion (red areas), accretion (green areas) and observed current flow directions (blue arrows) under progressively sheltered easterly (red arrow) storm wave conditions. Erosion was recorded at Granite Bay ( $-6817 \text{ m}^3$ ), Tea Tree Bay ( $-3885 \text{ m}^3$ ) and Noosa Main Beach ( $-10,000 \text{ m}^3$ ) with accretion observed at Little Cove ( $+2057 \text{ m}^3$ ). Note 1: The hashed green area indicates the area of accretion that was surveyed in the post-survey that was outside the area of the pre-survey extent and could not, therefore, be used for volume. Note 2: The thickness of the red arrow qualitatively describes the observed wave height, although the wave model was not precise enough (bathymetry and refraction limitations) in modelling refraction to be relied on this close to shore.

Headland [52]. Based on our beach surveys, modelling and coastal observations, we have proposed a conceptual model (Figure 8), with sediment moving out of Granite Bay, as a result of currents generated by oblique wave breaking, and transported west, through the protected bays on the north side of the headland. The observations showed a reduced wave energy between Granite Bay, Tea Tree Bay and Little Cove, although we were not able to rely on the wave model to support this due to limitations of the bathymetry and refraction capabilities, however, this observed change in wave energy would explain why we recorded reduced erosion between the more exposed Granite Bay and Tea Tree, with accretion observed at Little Cove. Due to the orientation of Noosa Main Beach, incident waves required less refraction and were observed to be larger than at Little Cove, as well as breaking approximately shore-normal. This increased wave energy combined with the strong longshore current that was set up, firstly along the headland, and then turned along Noosa Main Beach resulted in strong erosion of this beach. A mechanism for sand moving into Granite Bay is not yet fully understood and further investigation is therefore required to describe transport around the Noosa Headland into the north facing protected bay beaches.
