Article High-Temperature Erosion of SiC-NiCrAlY/Cr₃C₂-NiCr Coating

Abstract: High-temperature erosion is a detrimental phenomenon in industries where particle flow exists, in which the search for new materials and mixes to increase the lifespan of mechanical components exposed to erosion is crucial. The present work studied the erosion resistance of two coatings at 25 °C (RT) and 900 °C in a sandblast-type rig. The coatings were fabricated with cermet-type powders: (C1) commercial Cr₃C₂-NiCr and (C2) commercial Cr₃C₂-NiCr mixed with a laboratory-conditioned powder consisting of NiCrAlY (linking matrix) and SiC (ceramic phase). Both coatings were applied on an Incoloy 330 substrate using an HVOF thermal spray process. The C2 coating was 11% harder than C1 but had a 62.2% decrement in its K_{IC} value. The erosion test results at RT and 900 °C showed better erosion resistance on C1 than C2 at both testing temperatures and the three impact angles (30°, 60°, and 90°); this was attributed to the minor K_{IC} induced by SiC hard particles and the bigger propagation of inter-splat and trans-splat cracks in C2. The erosion mechanisms at RT and 900 °C were similar, but at high temperature,

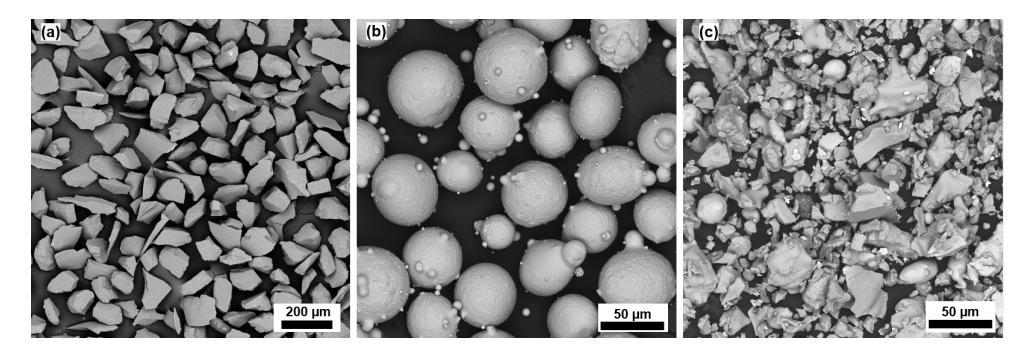
Figure 1. Micrographs of (a) SiC particles, (b) NiCrAlY powder, and (c) Cr₃C₂-25NiCr powder.

The SiC-NiCrAlY cermet was synthesized in a planetary ball mill (PQ-N2, Across International), using a ball and material weight ratio of 20:1 at 300 rpm. First, industrial-grade SiC of a 180 mesh grain size (Figure 1a) was milled for 4 h; then, 3 wt.% of ZrB₂ nanoparticles (80–100 nm Nanoshell) was added to stabilize the SiC during thermal spraying [23] and milled for 2 more hours. This mixture was added to NiCrAlY metallic powders (Oerlikon Metco (Figure 1b), with a relation of 21:79 wt.%, respectively, by milling for 8 h. Finally, additional SiC (32 wt.%) was added to the resulting SiC-NiCrAlY cermet to increase the carbide content. This carbide was ground for approximately 1.5 h to avoid the production of a finer powder, followed by a superficial chemical treatment at 400 °C for 30 min with Triethoxy(ethyl)silane (Sigma Aldrich) to stabilize the SiC [24,25], in order to reduce its decomposition during the spraying process. The low density of the final powder generated in the laboratory detrimentally affects its fluidity, making it difficult to feed it during the spraying process. This difficulty was resolved by adding commercial Cr₃C₂-NiCr (Amdry) powder (Figure 1c) in a proportion of 30:70 wt.%, respectively. These final conditions were defined after a series of preliminary tests to reach a minimum hardness of ~690 HV on the coating.

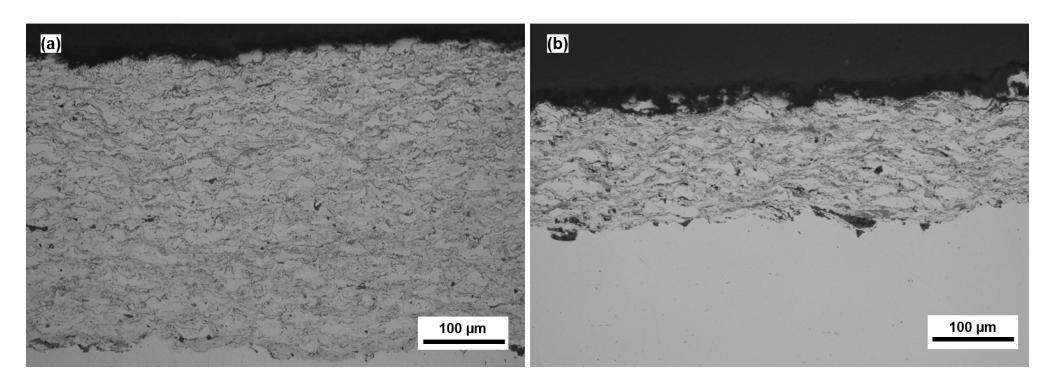
Figure 2. Cross-section of (a) C1 coating and (b) C2 coating.

Incoloy 330 was used as a substrate for coating deposition. The surface to be coated was conditioned by grit-blasting up to $R_a \approx 7.2 \ \mu m$ and acetone cleaned. The Cr_3C_2 -NiCr (C1) and SiC-NiCrAlY/Cr_3C_2-NiCr (C2) coatings (Figure 2) were fabricated at the SURESA company facilities with the HVOF (XPOJET 5000) spraying process; the spraying parameters are shown in Table 1. The coatings' thicknesses were approximately 350 μm for C1 and 162 μm for C2. The difficulties associated with the fluidity of the C2 powder affected its feeding during the spraying process, making it difficult to grow past 150 microns. Once

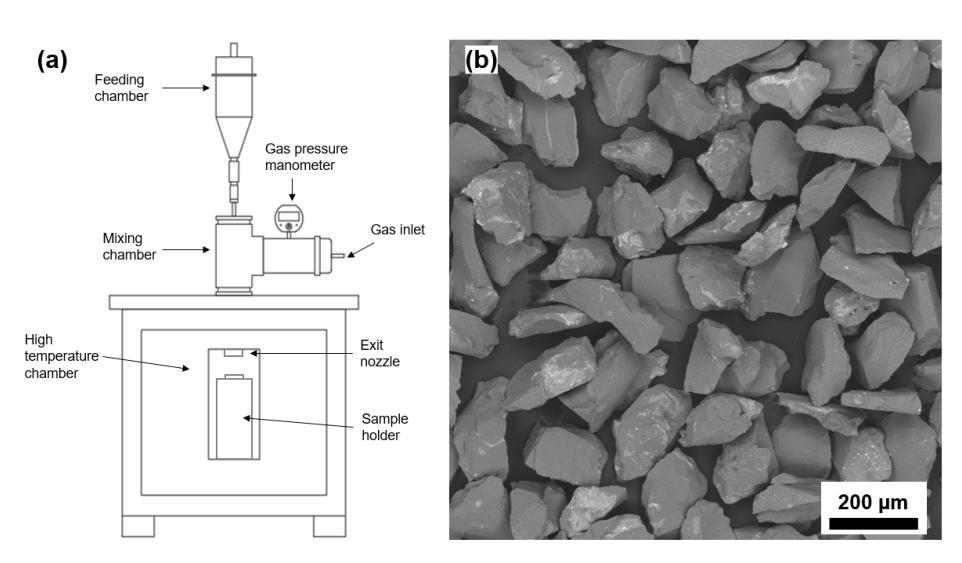
Figure 3. (a) High-temperature erosion test rig. (b) Alumina erodent particles.

The erosion test at both temperatures (900 °C and room temperature (RT)) were carried out in a sand-blast type erosion test machine (Figure 3a). Semi-angular alumina (Figure 3b) of 125–150 μ m, sieved, was used as erodent. Drag air with a dew point of -45 °C was used as the carrier fluid and accelerated through a 1.5875 mm diameter outlet nozzle. The erosion parameters are listed in Table 2. Particle velocity was measured by the double-disc method. Surface specimens were prepared to obtain a roughness $\leq 1 \mu$ m, according to ASTM G76 [1], and ultrasonically cleaned in an acetone bath for 10 min before and after the erosion. The mass loss was measured using a 0.01 mg precision analytical balance (Sartorius ATILON). Each condition was repeated twice to confirm the result, performing a third test if the difference between the values was greater than 8% [28]. The volumetric erosion rate was calculated by [29,30]:

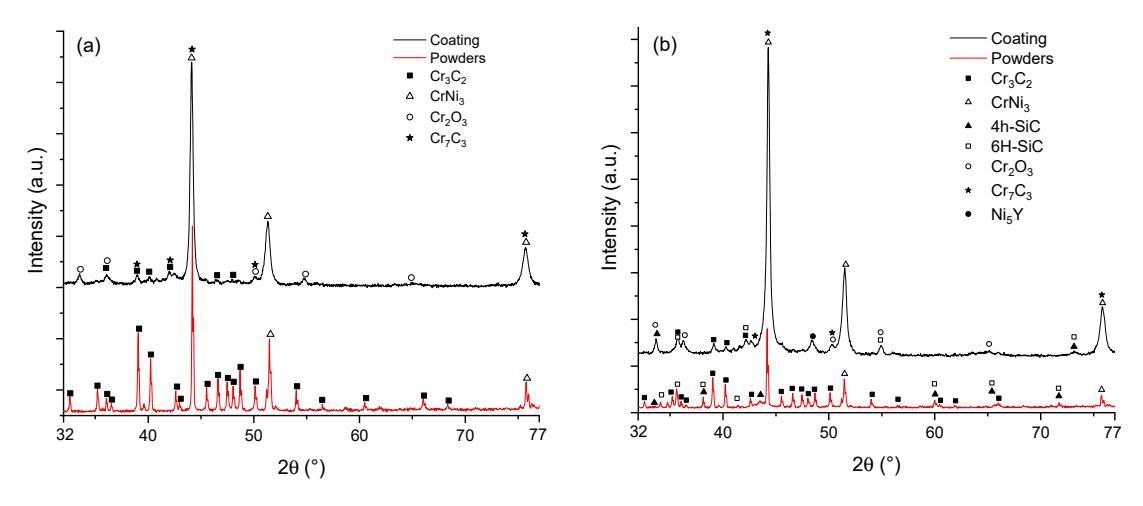
Figure 4. Diffraction patterns: (a) Cr₃C₂-NiCr and (b) SiC-NiCrAlY/Cr₃C₂-NiCr.

The diffraction patterns of the C1 coating and powders are shown in Figure 4a. CrNi₃ peaks are observed in both conditions; the coating pattern shows secondary Cr_3C_2 peaks with less intensity, and some disappear (not detected) compared with the powder pattern. This phenomenon is due to the decarburization of Cr_3C_2 and the Cr oxidation processes that the material experiences during the spraying process (formation of Cr_7C_3 and Cr_2O_3 , respectively) [31–37]. Due to the high content of Cr_3C_2 -NiCr (70 wt.%) the C2 material contains, the diffraction patterns of both powders and coating (Figure 4b) are similar to those observed for the C1 material, only showing additional peaks corresponding to SiC phases and Ni₅Y related to NiCrAlY [38]. The absence of SiO suggests that the SiC maintains its stability during the spraying process. Additional peaks related to the NiCrAlY were not identified due to a possible overlap with the CrNi₃ peaks.

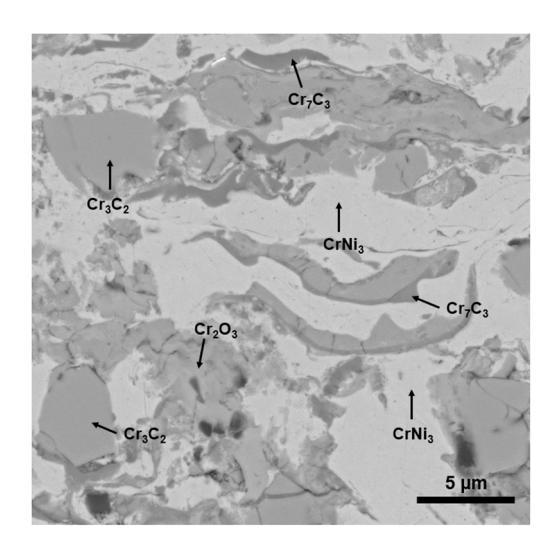
Figure 5. Cr₃C₂-NiCr coating microstructure.

The cross-section of C1 (Figure 5) shows the typical microstructure generated with the HVOF process consisting of a dense Cr_3C_2 -NiCr splat-like structure (chromium carbides distribution in the nickel–chromium (CrNi₃) matrix). The porosity percentage was less than 1%, as is expected for this type of coating [33,35,36].

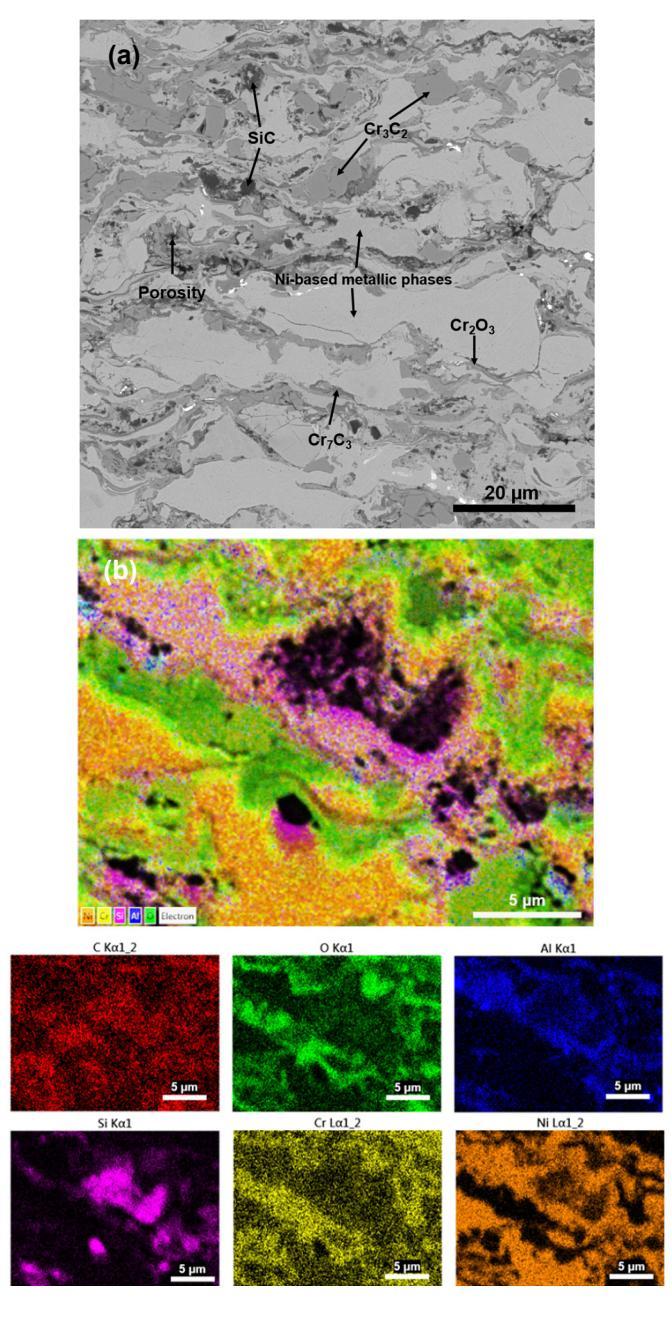
Figure 6. SiC-NiCrAlY/Cr₃C₂-NiCr coating (a) microstructure and (b) EDS analysis.

The C2 coating (Figure 6a) has a more complex microstructure than C1. It contains two metallic phases (NiCr and NiCrAlY) that are indistinguishable from one another using

backscattered electrons because Ni is the principal element. The darker particles observed are associated with the SiC. The rest of the splat-like Cr_3C_2 -NiCr structure and the porosity (less than 1%) are similar [33,34]. An EDS elemental mapping analysis (Figure 6b) revealed the distribution of the phases mentioned above. In this image, it is possible to identify the NiCrAIY because of the presence of aluminum. The oxygen-rich areas are associated with decarburized and oxidized Cr_3C_2 splats.

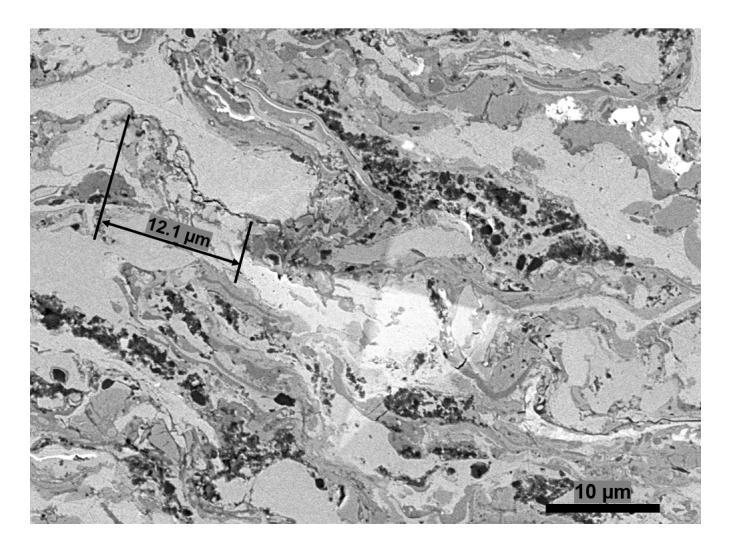
Figure 7. Indentation mark for K_{IC} measurement in the C2 coating.

toughness, since it had greater hardness values (from 825 to 1050 HV) and therefore more brittleness [6,31,35,39]. The low fracture toughness of the C2 coating can be attributed to poor inter-splat cohesion, promoted by the silicon carbide grains. When seeking to stabilize these particles during the thermal spraying process, they did not soften enough to achieve good cohesion with the other phases, and as a result, generated areas that facilitated the propagation of cracks. Figure 7 shows an indentation mark and the crack length for the K_{IC} measurement, in which can be observed the inter-splat crack propagation.

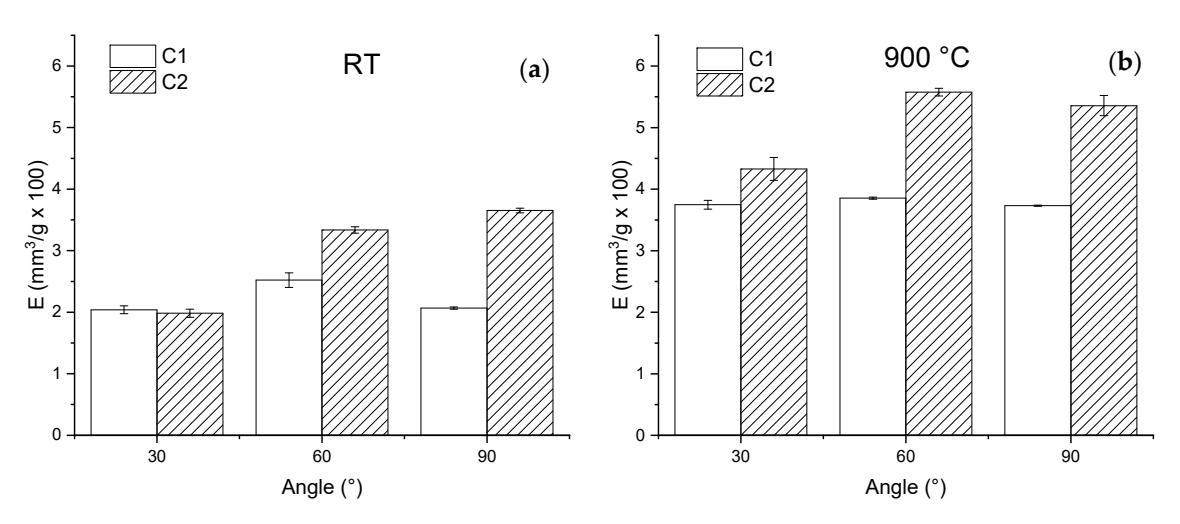
Figure 8. Volumetric erosion rate plots (a) at room temperature and (b) at 900 °C.

The erosion rate graphs of all the studied conditions are shown in Figure 8. From Figure 8a, it can be observed that at 25° C (RT), the erosion of C1 has a brittle tendency, with maximum wear at 60°. Similar results were reported by Z. Li et al. and X. Zhang et al., where their Cr₃C₂-NiCr coatings achieved maximum erosion at middle impact angles (60° or 70°) [40,41]. M.A. González et al. [42] and H. Zhang et al. [43] reported in cermet-type materials that this ductile-brittle behavior of the Cr_3C_2 -NiCr coating could be attributed to the preferential erosion of the binder phase (NiCr). The continuous impact of particles induces considerable plastic deformation and embrittlement of the binder, promoting its detachment by cracking; then, the exposed Cr_3C_2 particles fracture rapidly due to their subsequent impact. On the other hand, C2 showed a completely brittle behavior (maximum erosion rate at 90°). At 30° , these two coatings have no notable difference in their erosion rate, but at medium (60°) and normal (90°) impact angles, the erosion rate of C2 samples increases, experiencing maximum wear at normal impact angles. These C1 and C2 behaviors can be explained in terms of their hardness and toughness properties and the impact angle. At a low impact angle, the normal load component of the impact is low. Both coatings' metallurgical condition (hardness) is such to impart good erosion resistance (a somewhat lower erosion rate is observed for the harder cermet, C2). As the impact angle increases, so does the component of the normal load. The impact load effect reaches deeper splats, not just the superficial ones. In this sense, it is important to consider the effect of the K_{IC} , as was presented earlier. C2 possesses lower values, which is assumed to affect its erosion resistance under medium or high impact angles (medium or high normal load). On

the other hand, C1 displayed higher K_{IC}, which means that under repetitive particle hitting (cyclic load) C1 will possess better erosion resistance.

As was expected (Figure 8b), at 900 °C, the erosion rate of both systems increases for all impact angles compared to room temperature, e.g., an increment of 83.8% for C1 and 118.4% for C2 at the impact angle of 30°. The erosion behavior of C1 showed a constant erosion rate at the three impact angles (3 % biggest difference) and presented better erosion resistance than C2 in all test conditions. This behavior could be explained by the increment of ductility that the materials experience at this temperature, inducing major material removal at low erosion angles (increasing the ductile erosion behavior) [44]. This change in erosion tendency is more notorious for the C2 material, shifting its maximum erosion rate from 90° at RT to 60° at 900 °C, also by comparing the erosion rate difference between 30° and 90° at room temperature (84.2%—brittle tendency) and 900 °C (23.7%—brittle tendency) reduced considerably).

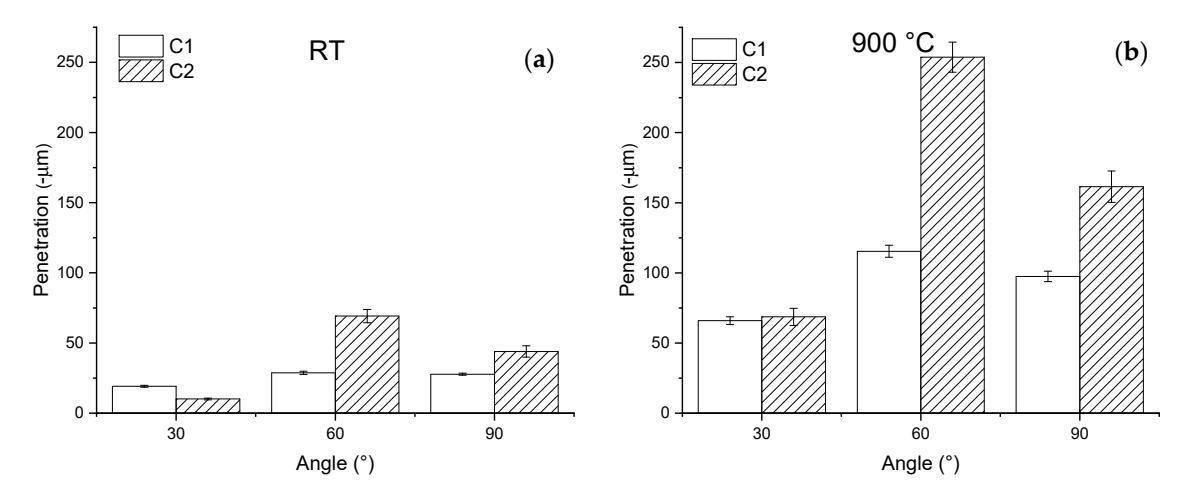
Figure 9. Average of erosion penetration plots (a) at room temperature and (b) at 900 °C.

It is worth mentioning that in many applications, the remaining life of a component is determined by its thickness loss and not by the volumetric loss, so it is important to analyze the erosion penetration in the material. Figure 9 shows the maximum penetration profiles obtained by profilometry from both specimens. Let us take the case of C1 at 900 °C with impact angles of 30° and 60° ; the difference in erosion rate was only 2.8. %, while the penetration difference was 75% (see Figure 10a,c). In both cases, the lower penetration occurred at 30° ; this is because the tilt of the sample created a greater erosion area, and their hardness reduced the penetration on the coatings.

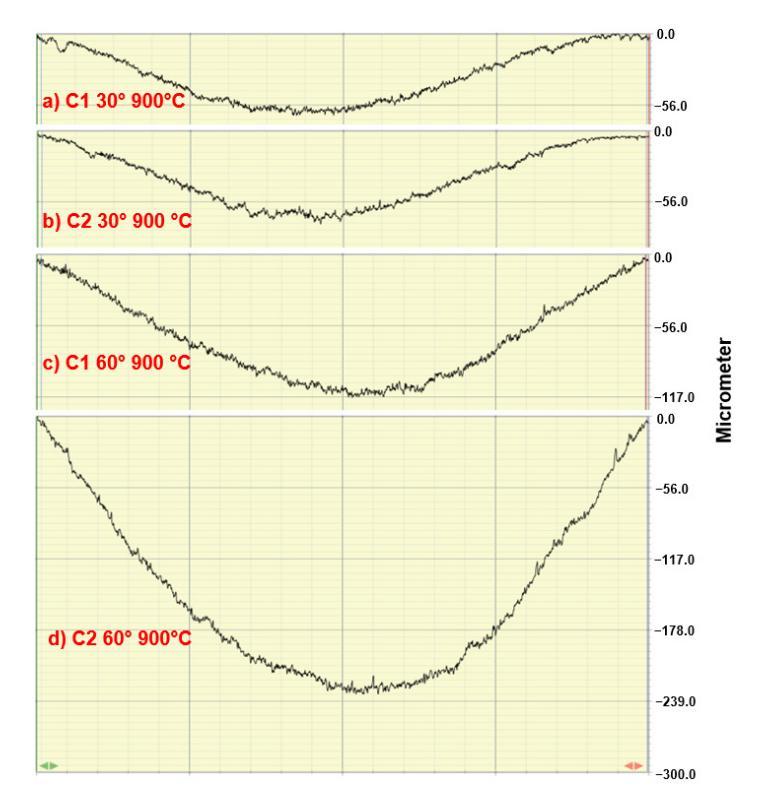
Figure 10. Profilometry plot of maximum penetration: (**a**) C1 30° 900 °C; (**b**) C1 60° 900 °C; (**c**) C1 30° RT; and (**d**) C2 60° 900 °C. (units in micrometers).

A similar example is the comparison of C2 at 900 °C, 30°, and 60°. Its volumetric erosion difference is 28.8%; meanwhile, the penetration difference between them is 231.3% (Figure 10b,d). At 30° RT, C2 shows less penetration than C1, which can be attributed to the fact that harder materials have better erosion penetration resistance at low impact angles. It was observed that the highest penetration was always at a 60° impact angle in all cases, reaching full penetration in the C2 at 900 °C and even eroding the substrate; this can be attributed to the combination of low and normal angle erosion mechanisms resulting in more material removal, as is shown in the next section. The erosion of C2 at 900 °C and 60° was the only case where the substrate was eroded. Therefore, an approximation to determinate the volume percentage of the eroded substrate was made using profilometry results, showing that this represented less than 7% of the total eroded volume.

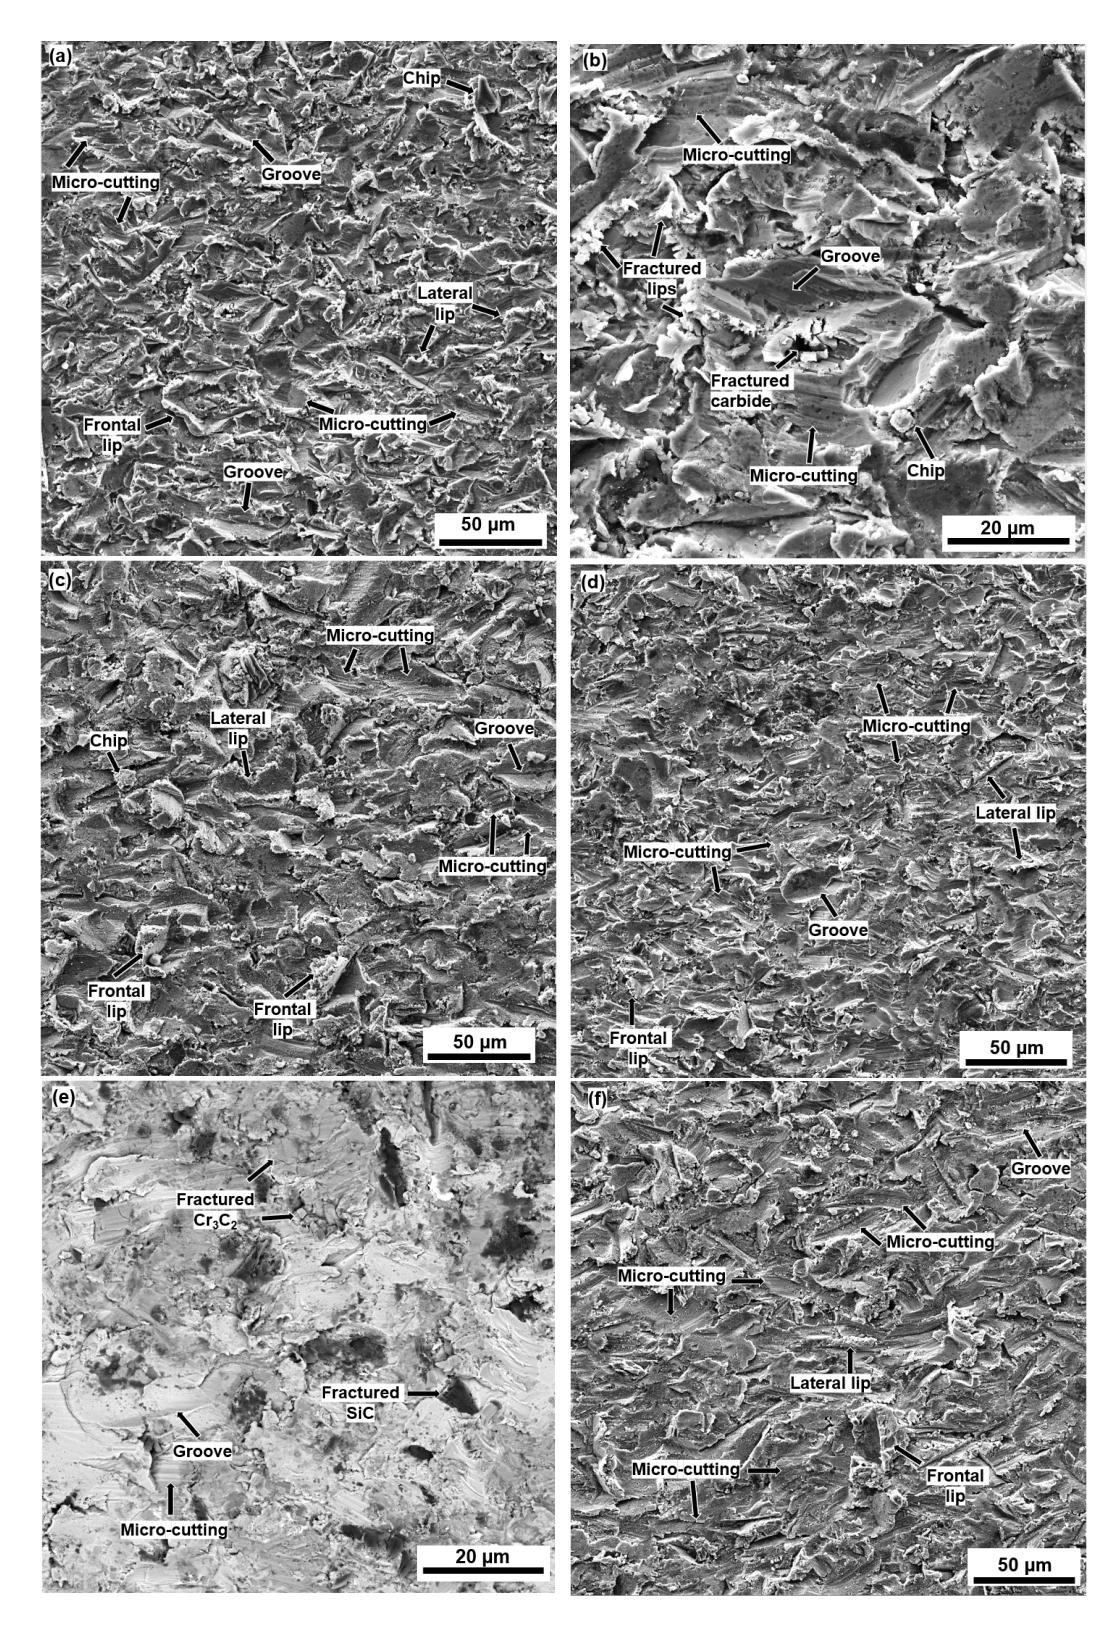
Figure 11. Eroded surface 30° angle: (a) and (b) C1 at RT; (c) at 900 °C. (d) C2 at RT; (e) RT, backscattered electrons; and (f) at 900 °C.

The erosion mechanisms presented in C1 and C2 specimens at RT and 30° (Figure 11a,b,d) were mainly by micro-cutting and in minor presence grooves, frontal, and lateral lips (associated with plastic deformation). In these same figures, cracking is observed in some lips, indicating that during the erosion test, they were susceptible to being fractured by the continuous impact of erodent particles, generating detached chips. As mentioned earlier, the appearance (smaller erosion damage features) of this type of erosion mechanism in the C2 coating is attributed to its higher hardness. Also identified were fractured chromium carbide and silicon carbide grains (Figure 11e). At 900 °C (Figure 11c,f), there were no observed fractured carbides in C1, while in C2 the fractured carbides were less abundant but still present. These phenomena were attributed to the matrix's ductility (softening) increment, which explains the high erosion rate difference between RT and 900 °C (increment of 83.8% in C1 and 118.4% in C2) [2,44].

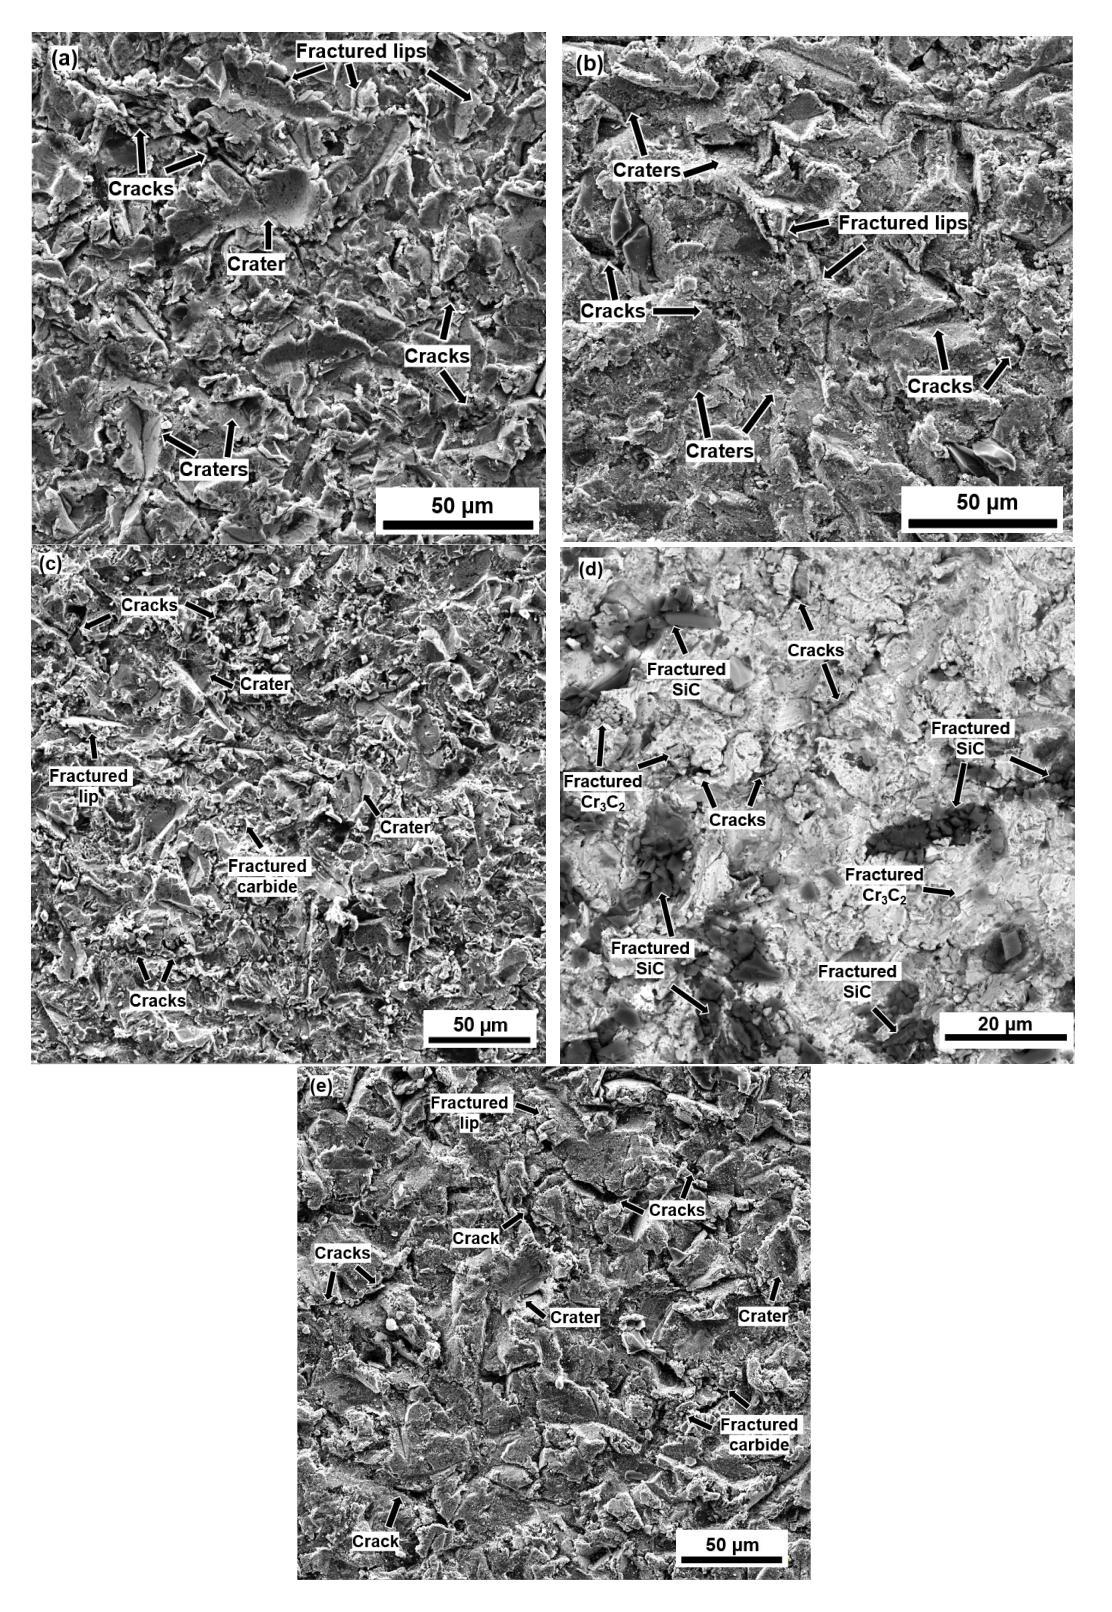
Figure 12. Eroded surface 90° angle: (**a**) C1 at RT and (**b**) at 900 °C. (**c**) C2 at RT; (**d**) RT, backscattered electrons; and (**e**) at 900 °C.

In the case of the C1 and C2 coatings eroded at RT at a 90° impact angle (Figure 12a,c), the brittle fracture was the principal mechanism. Evidence of this was the presence of cracked and fractured lips and carbides (a large number of micro-cracks along almost the total eroded surface of the C2 coating sample (Figure 12d)). The deformation features

(craters shape) attributed to the plastic damage mechanisms were irregular due to the angular particles hitting at a normal impact and forming lips at their edge; this observation was more notorious in C1. At 900 °C (Figure 12b,e), the brittle mechanisms were still present, especially in C2; this is assumed to be possible because SiC particles are hard but brittle, even under high-temperature conditions.

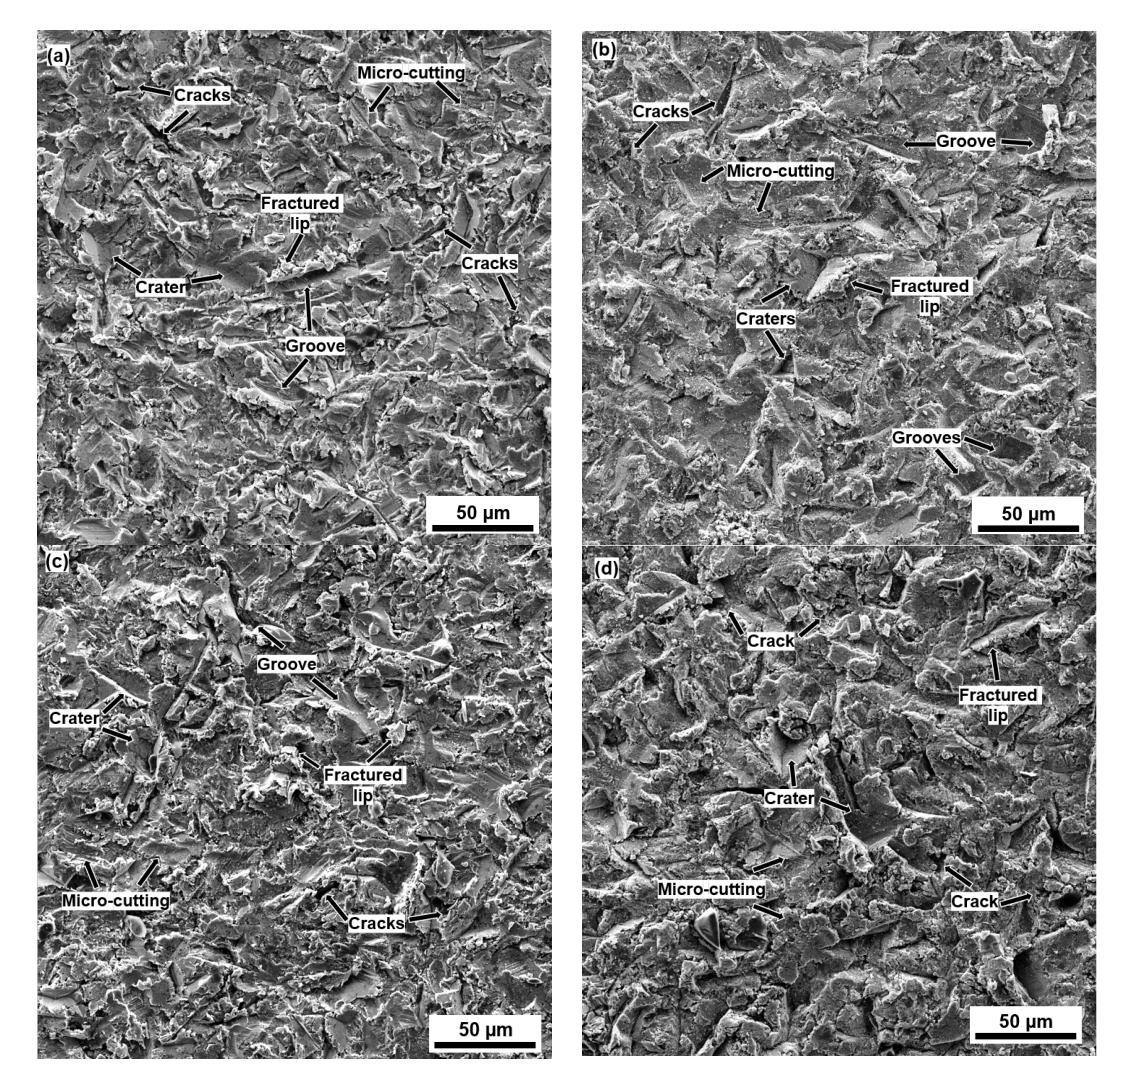
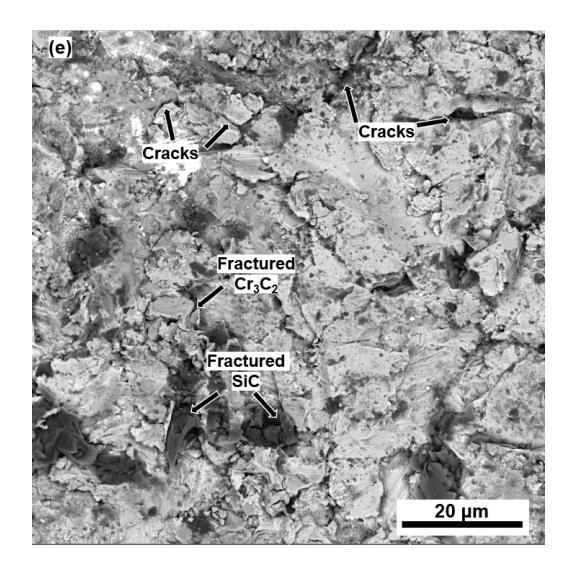
Figure 13. Eroded surface 60° angle: (**a**) C1 at RT; (**b**) at 900 °C. (**c**) C2 at RT; (**d**) at 900 °C; and (**e**) RT, backscattered electrons.

The C1 and C2 eroded surface at RT and at an impact angle of 60° (Figure 13) showed a combination of erosion mechanisms commonly observed under normal and oblique impact angles. Plastic deformation and brittle fractures are commonly observed on these cermets constituted by ductile and brittle phases. There were craters, grooves, lips in the edges of the grooves and the craters, and micro-cutting (Figure 13a,c). Brittle mechanisms, such as fractured carbides and some cracks, were observed. The main difference was found on the C2 specimens, where more fractured carbides were observed (Figure 13e). Then, the presence of a second brittle phase (SiC particles) in these samples explains the large volume loss value compared to the C1 specimen. At 900 °C (Figure 13b,d), the presence of a second soft phase (splats of NiCrAlY) affected the C2 sample's ductility (softening) to a greater extent. Both factors induced this coating to experience the greatest erosion rate and penetration.

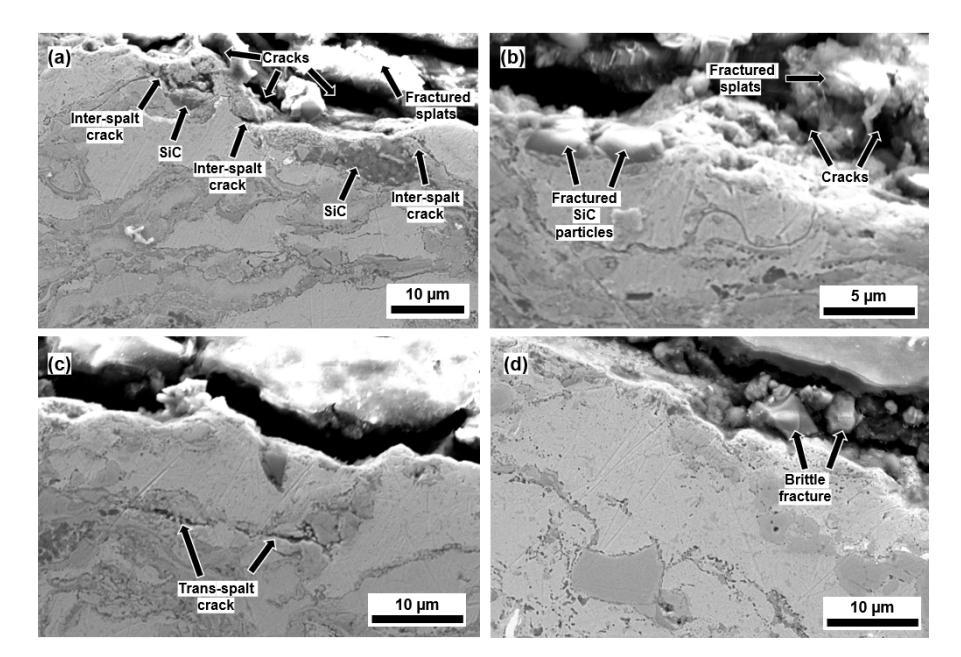
Figure 14. Cross section of eroded samples 90° at 900 °C. (a–c) C2; (d) C1.

Cross-sections of eroded C1 and C2 at the 900 °C and 90° impact angle samples were selected to analyze the erosion damage. The C2 sample (Figure 14a) showed considerable inter-splat cracking and splat detachment (fractured). It is observed that the SiC particles are preferential sites for inter-splat crack propagation (Figure 14a,b). Trans-splat fracture is also observed in this coating (Figure 14c). Contrarily, the eroded C1 sample showed less damage in terms of fracture and cracking propagation (Figure 14d). The above confirms the better performance of the C1 coating subjected to the erosion conditions of this investigation.
