Study on the Damage Mechanism of TiN/Ti Coatings Based on Multi-Directional Impact

Abstract: TiN/Ti coatings have great application potential in improving aero-engine server lives in a dusty environment. However, the damage behavior and mechanism of the coating and substrate under high impact speed and multi-direction loading conditions has scarcely been investigated. In this paper, TiN/Ti coatings were deposited on Ti6Al4V alloys by a magnetic filter cathode vacuum arc. Multi-directional impact tests were carried out by a gas gun system at, 45°, 60°, and 90° with a velocity of 330 m/s. The damage behaviors and mechanisms of the TiN/Ti coatings were investigated and revealed by researching the damage morphology, crack propagation, and stress distribution. The results show that plastic deformation occurs both in the coatings and the substrates under high speed impacting. Cracks extend vertically downward in the TiN layer first and are deflected at the Ti layer when the driving force is not enough. Circular cracks and radical cracks are found to form network cracks on the surface of the coating and the shear stress loaded by the particles, which drives cracks' propagation is the mai

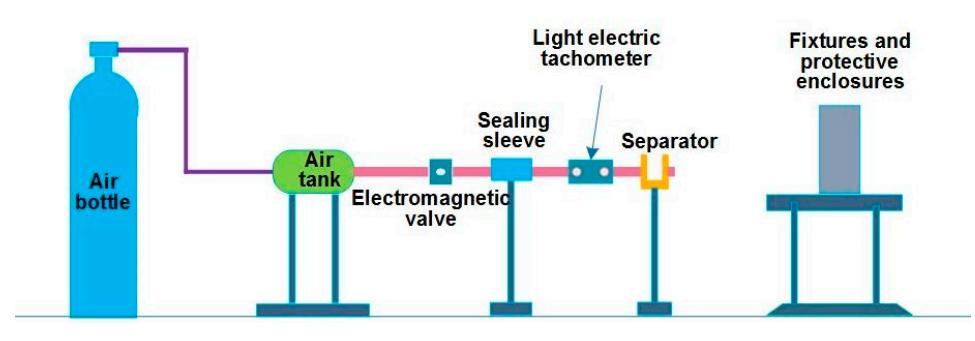
The gas gun experimental system was used to accelerate steel ball particles and impact the TiN/Ti coatings at different impact angles, as shown in the Figure 1. The gas gun experimental system was mainly composed of four parts, namely the gas source, control system, speed measuring device, and sample fixture. The impact particles were GCR15 spherical particles with a diameter of 1 nm, and their composition parameters are shown in Table 3. A particle was loaded into the projectile tray, which was put into the track by unscrewing the sealing sleeves and accelerated by the expansion of compressed nitrogen. The impact angle was changed by adjusting the deflection of the fixture. To investigate the high-speed damage of the coating at different impact angles, impact tests were conducted at a 330 m/s incidence speed and incident angles of 45°, 60°, and 90°. Three impact tests were carried out under each incident angle.

Figure 1. Diagram of the gas gun impact test system.

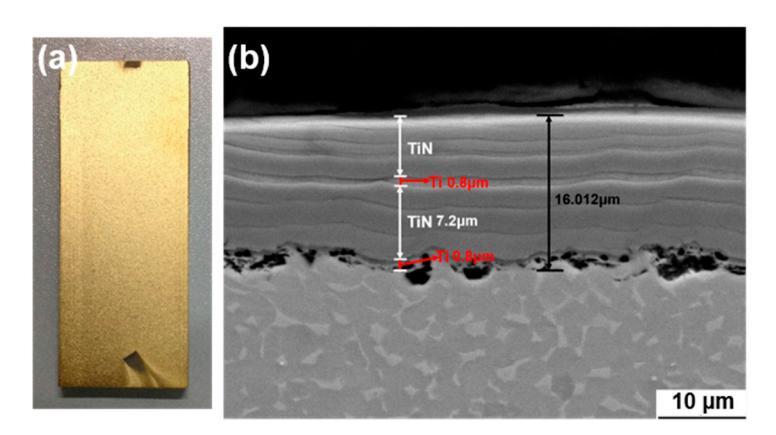
As shown in Figure 2, the surface of the TiN/Ti coatings was golden and it can be observed that the coatings are composed of the TiN layer and Ti layer with two cycles. TiN layers and Ti layers were deposited alternately on the substrate with a modulation ratio of 9:1 and the total thickness of the coating was 16 μ m.

Figure 2. The microtopography of the surface (a) and cross-section (b).

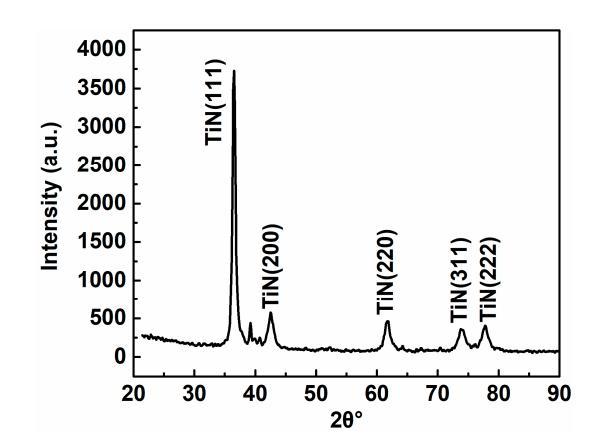
The X-ray powder diffraction (XRD) patterns of TiN/Ti multilayer coatings are shown in Figure 3. The diffraction peaks are in accordance with the cubic TiN after checking with the JADE software (version 6.5). The (111), (200), (220), (311) diffraction peaks were identified from the TiN/Ti coatings. The strongest diffraction peak corresponds to the (111) plane of the TiN. During the deposition, the preferred orientation of the TiN coatings was determined by the competition between the surface energy and the strain energy. It was found that the (200) plane has the lowest surface energy while the (111) plane has the lowest strain energy. In the early stage of the deposition, the strain energy was small, and the surface energy was dominant. The coating was deposited in the (200) preferred orientation. Besides, researches have shown that strain energy gradually increases with the increasing of the thickness. Thus, as the deposition occurs, the strain energy is large and dominant, in which case the (111) preferred orientation is predicted [26–28]. This leads to the (111) plane having the highest peak and the (200) plane having a lower diffraction peak. The appearance of other lower peaks may be due to the incomplete orientation of the initial grain growth process. The preferred orientation of the

where I(hkl) is the integral intensity of the coating on the (hkl) reflector. $I_0(hkl)$ is the integral intensity of the standard powder on the (hkl) reflector. n is the number of diffraction peaks. The texture coefficient value of the (111) plane of this coating in this paper is 2.3, larger than 1, which means that the (111) plane is the privileged orientation of TiN.

Figure 3. XRD diffraction pattern of the TiN/Ti multilayer coating.

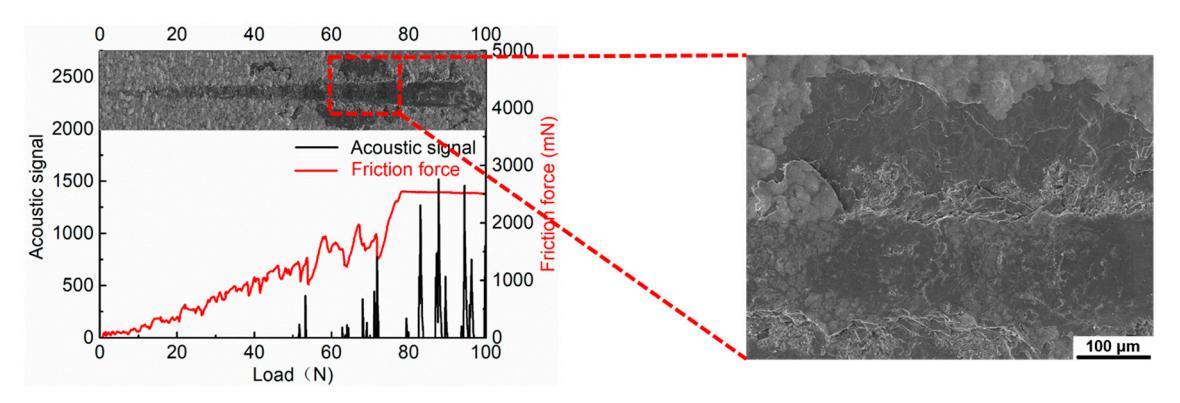
The scratch method, as a widely accepted adhesion force test method, was applied in this work. The acoustic emission spectra, friction force curve, and scratch track morphology were obtained in the scratch test. To investigate the adhesion, five scratch tests were performed for each sample. As shown in Figure 4, it was found that the width of the scratch track increases with the load increasing. When the load reaches 53 N, there is a sudden change in the acoustic emission signal and the friction force curve, while the scratch track is still very smooth, and the coating still has good integrity. When the load reaches 70 N, the friction force curve and acoustic emission signal fluctuate fiercely, and the coating begins to peel off from the surface. In this case, the load applied reaches the critical load of the coating is 72 N. Since the surface of the substrate was subjected to Ar ion irradiation and ion implantation during the pretreatment, the adhesion of the coating reaches quite a high level.

Figure 4. Scratch morphologies, acoustic emission spectra, and friction force curve and SEM image.

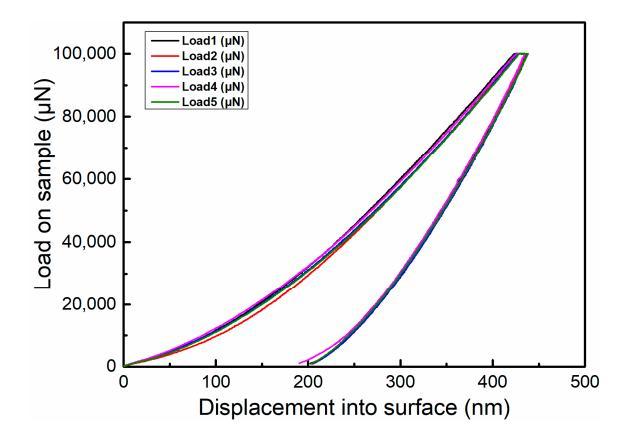
In the nano-indentation test, the fixed load mode was applied, and the fixed load used was 100 mN. As shown in Figure 5, the indentation depth was 450 nm, which is less than the 1/10 of the thickness of the coatings to reduce the influence of the substrate. The hardness and Young's modulus of the coating were calculated according to the displacement–load curve. The nano-indentation test was performed five times, and the average values and corresponding standard deviations of the hardness and Young's modulus was about 365 GPa.

Figure 5. Nano indentation displacement-loading curves of the TiN/Ti coatings.

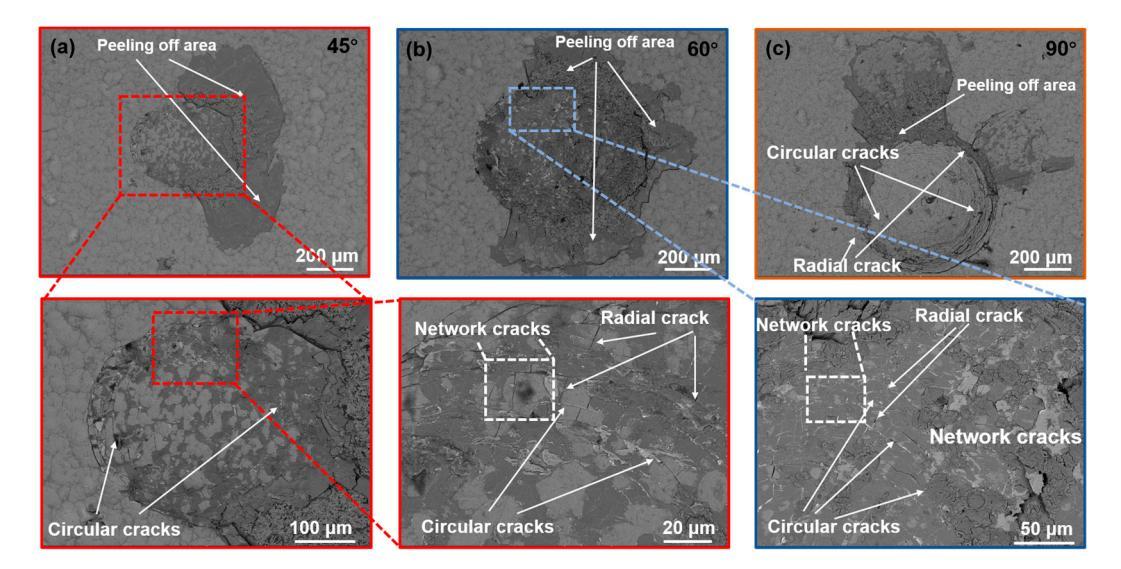
In order to investigate the damage mechanism of the coating at high impact speed under different angles of attack, the damage morphology was observed by scanning electron microscopy. A series of images illustrating the damage morphology of the TiN/Ti coating impacted at different impact angles with an eroding speed of 330 m/s are presented in Figure 6. It is easy to see that deformation occurred on the surface of the coatings, which led to the formation of impact pits. Circular cracks were found distributed around the contact point. The direction of particle motion is the positive half axis. The circular crack density in the positive half axis is lower than the opposite side in damage morphology at 45° and 60°. However, the crack density is relatively uniform in the damage morphology at the 90° impact angle. In addition, radial cracks were also found distributed on the surface of the coatings. The circular cracks and the radial cracks form network cracks as shown in Figure 6. There are large peeling areas at the distance of the contact radius to the contact center, which expands in the direction of the particle's motion. The peeling area is the largest at 45°, followed by 60°, and is the smallest at 90°.

Figure 6. SEM micrographs of TiN/Ti coatings impacted under different angles: (**a**) Impacted under 45°, (**b**) impacted under 60°, and (**c**) impacted under 90°.

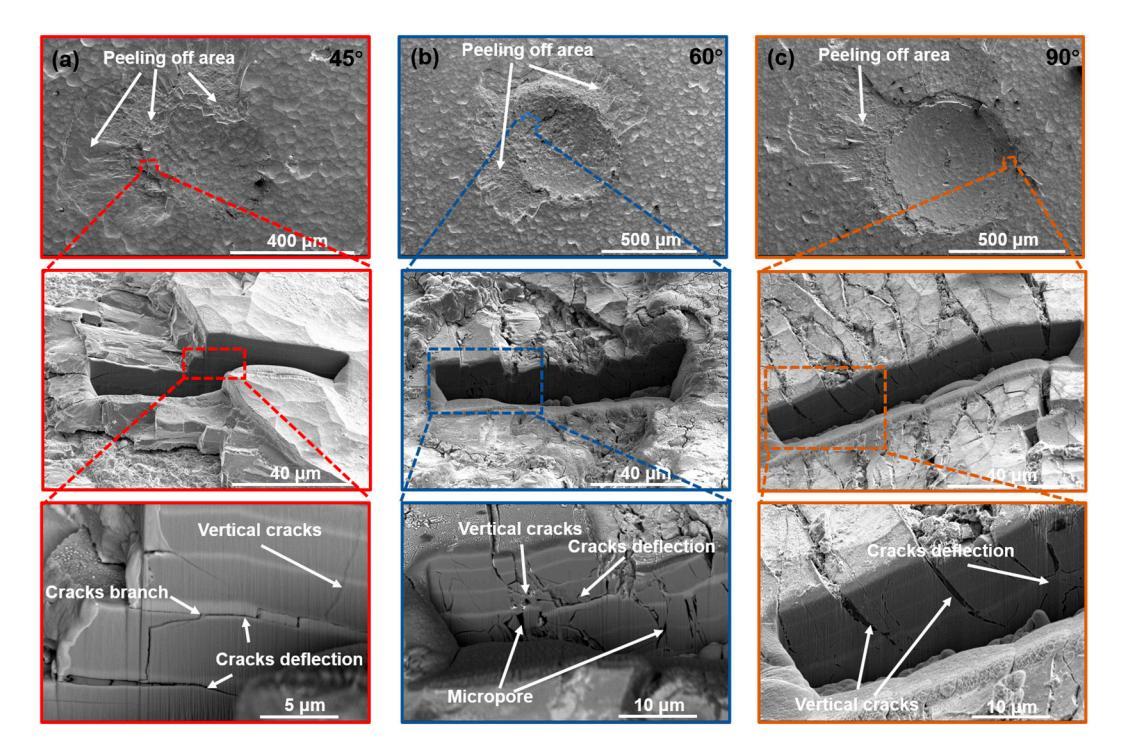
In order to investigate the crack propagation in the coating interface, focused ion beam (FIB) experiments were conducted. Figure 7a shows the crack propagation in the coating interface at the 45° impact angle. It is obvious that the cracks first extend vertically downward from the surface of the top TiN layer. They deflect when they reach the Ti layer and begin to grow along the interface. Similar to the phenomenon at 45°, cracks at the 60° (Figure 7b) impact angle first propagate vertically downward in the TiN layer and then deflect when they reach the interface of the TiN layer and Ti layer. However, the length of the cracks deflecting along the Ti layer at 60° is shorter than 45°. At the 90° (Figure 7c) impact angle, most cracks extend vertically downwards and almost do not deflect in the Ti layer. To sum up, the distance of the cracks deflecting in the interface along the Ti layer reduces as the impact angle increases. The coating peels off in layers at the broken surface, which may lead to coalescence of the interface cracks and circular cracks.

Figure 7. Impact damage morphologies and the sectional images of eroded of TiN/Ti coatings impacted under different angles: (**a**) Impacted under 45°, (**b**) impacted under 60°, and (**c**) impacted under 90°.

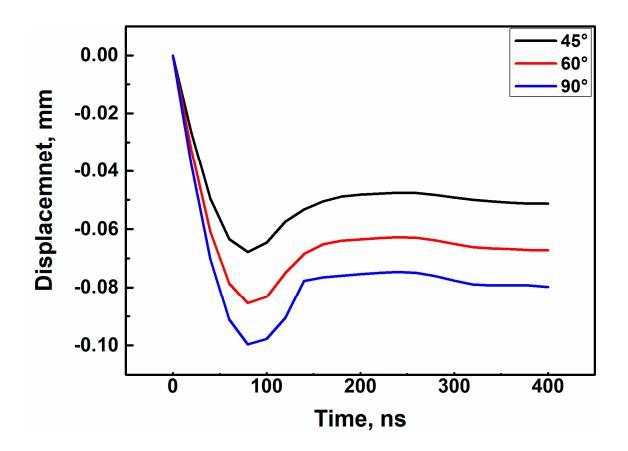
The displacement of the eroded center is displayed in Figure 8. It can be observed that the displacement at 45° has the smallest amplitude and that at 90° it is the largest. Figure 8 clearly shows that the plastic deformation on the surface of the coating is mainly determined by the perpendicular incident component of the particle. Stress S11 (the stress along x direction) on the surface of the coating impacted under 45°, 60°, and 90° at 20 ns is shown in Figure 9. As presented in Figure 9, there are compressive stresses near the impact center and high tensile stress peeks distributed at the distance outside from the impact center of about a contact radius, which is consistent with findings in other studies [29-31]. Those areas of high tensile stresses S11 are the main reason for the development of surface cracks. This type of stress pattern leads to the formation of circular cracks, which has been reported in many researches [2,8,30]. It can clearly be seen that the amplitudes of the tensile stresses at 90° are larger than that of 60° and 45° . The direction of the particle motion is taken as the positive half axis. The amplitude of the tensile stresses in the negative half axis of the contact point is larger than the opposite side at the 45° and 60° impact angles. However, at the 90° impact angle, the amplitude of the tensile stress on both sides is equal. This stress distribution on the coating surface may account for the distribution of the circular cracks on the surface, as shown in Figure 7. It is not difficult to find that the density of circular cracks formed in the region with higher tensile stress is relatively higher than that in the lower tensile stress region, as shown in Figure 6a,b. When the surface of the coating deforms, the dislocation of the crystal can be blocked at the grain boundary, which leads to the stress concentration at the grain boundary [32]. The stress at the grain boundary in the higher tensile stress region is easier to reach the grain boundary strength. Therefore, the crack density in the higher tensile stress region is larger than that in the lower tensile stress region.

Figure 8. Displacement of the TiN/Ti coatings during impact.

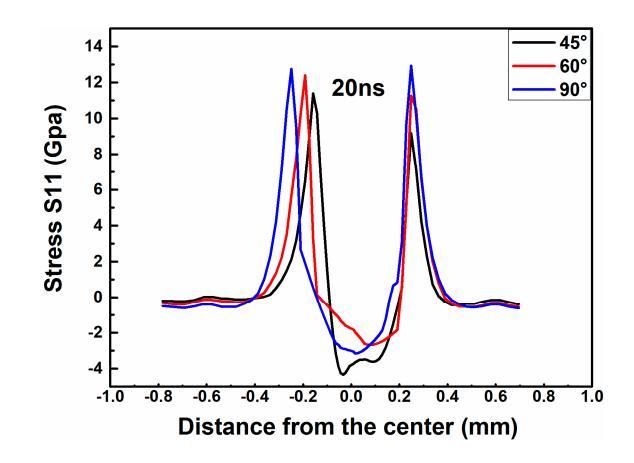
Figure 9. Stress fields of the TiN/Ti coating under different impact angles at 20 ns.

The microstructure of the TiN layer is columnar, and its growth direction is perpendicular to the substrate surface [33]. Initial cracks come into being at the grain boundary first, and then crackle spreads along grain boundaries occur for the tensile stress on the surface of the TiN/Ti coatings. Therefore, most cracks grow normal to the interface in the TiN layer first, as shown in Figure 7. The Ti layer as a typical ductile material can absorb the energy of the crack propagation. When the driving force for crack growth is not high enough, crack deflection and branching occurs at the interface of the Ti layer. However, some cracks grow through the Ti layer due to the high tensile stress, which provides enough driving force for crack growth. For this reason, cracks near the impact center at the 90° impact angle are easier to grow through the Ti layer with higher tensile stress. While, crack deflection and branching are more likely to occur at 45° and 60° where the tensile stress is lower. Incoordination in the deformation process of the bottom TiN layer and substrate is the main reason why internal cracks and micropores occur in the bottom TiN layers. During the impacting, plastic deformation occurs both in the coating and the substrate. The deformation performance of the two materials is quite different. The stress concentration phenomena easily occurs at the border between the bottom TiN layer and the substrate. Therefore, there is usually high tensile stress in the subsurface of the TiN layer, which has been mentioned in many reports [2,8]. When the stress concentration reaches the material strength of the TiN, micropore and microcracks form in the bottom TiN layer and are enlarged further, driven by the tensile stress (Figure 7b) [34]. Figure 10 shows the dynamic process during the impacting. It can be found that this process is mainly composed of incident, rebound, and separation. There is also relative sliding friction between the particles and coatings during incident and rebound. This relative sliding friction loads shear stress on the coating surface. The shear stress appears to favor the growth of cracks on the coatings, and crack propagation and intersection are responsible for the peeling off on the coating in the network cracks' area. The distance of relative sliding at 45° is the largest, followed by 60°, and no relative sliding occurred at 90°, which also corresponds to size of the peeling-off area under corresponding impact angles.

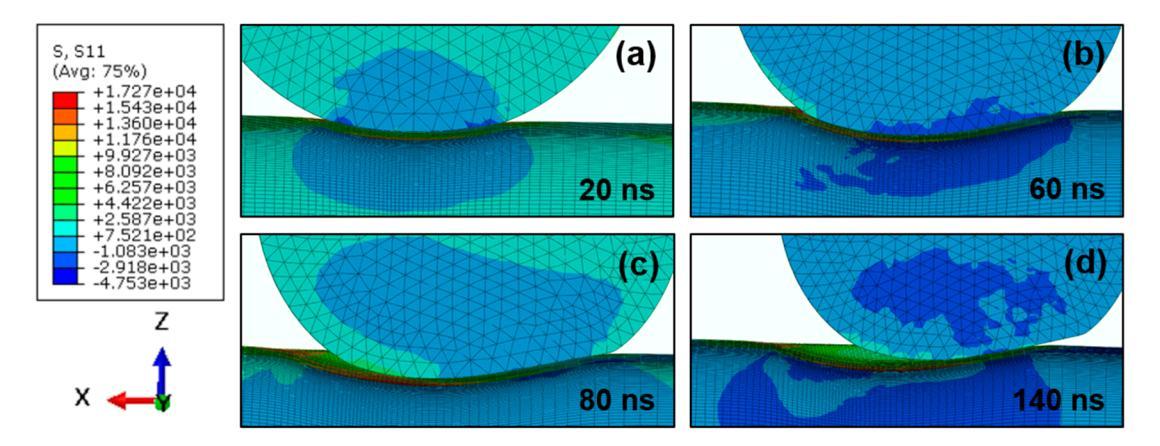
Figure 10. Displacement and stress fields of the TiN/Ti coating in four periods: (**a**) At 20 ns (incident time), (**b**) at 60 ns, (**c**) at 80 ns (deepest time), and (**d**) at 140 ns (separated time).

To sum up, the Ti layer plays an important role in the prevention of crack propagation normal to the substrates. Crack deflection and branching occurs at the Ti layer when the tensile stress is not large enough; propagation and intersection are the main reason for the material removal of coatings.
