Protecting Street Art from Outdoor Environmental Threats: What Are the Challenges?

Abstract: Street Art is an artistic expression in constant development, whose interest has grown in recent years among society, public administrations, conservators, and heritage scientists. This growing awareness has given rise to a series of debates between professionals with the intent to expand the knowledge relating to conservation practices and possible protection solutions. Additionally, the paint materials used by contemporary artists are in constant development; therefore, difficulty has emerged in the identification of their degradation processes when exposed to environmental conditions and in the consequent selection of a specific protection system. This review presents an overview of the recent literature and experiences in the field of knowledge and preservation of Street Art, focusing on the type and nature of paint formulations, the main deterioration processes of painted artworks in outdoor conditions, and the most recent advances in materials and methods for the conservation and protection of Street Art. This review aims to emphasise how the approach to the challenge of preservation

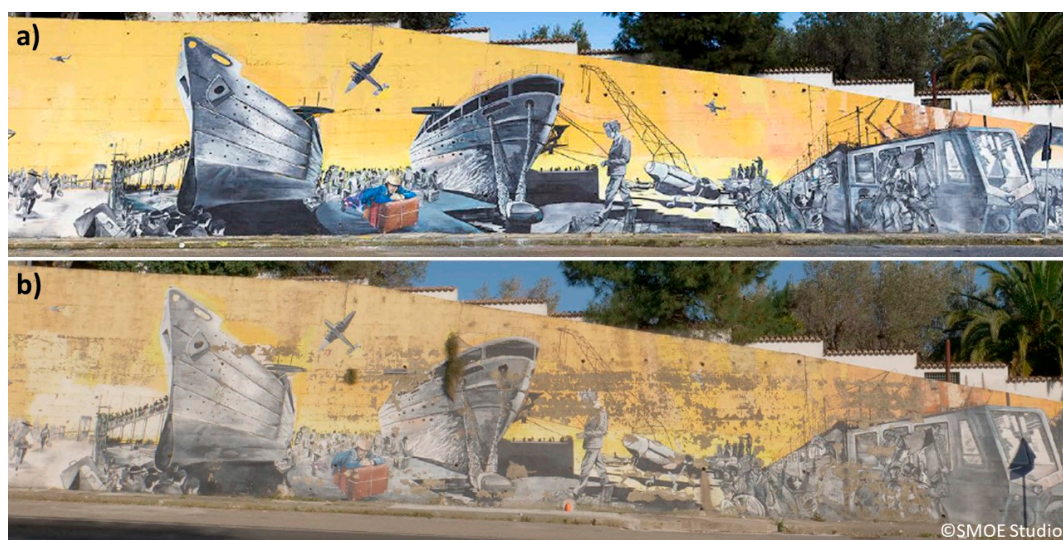
Figure 3. Effects of outdoor exposure on contemporary mural “*Emigranti*” by SMOE Studio in Catanzaro (Italy). (a) The artwork in 2017 when it was realised; (b) the state of conservation after four years in 2021. Images courtesy of SMOE Studio.

The comparison between the photo taken immediately after the realisation of “*Emigranti*” by SMOE Studio in 2017 (Figure 3a) and four years later (Figure 3b), makes it clear what kinds of deterioration phenomena can affect these artworks and the span of time in which they occur. After only 4 years, cracks and detachments of the painting layer from the support, diffused losses of painting materials, discolouration and fading of the yellow background, deposits and washouts, destroyed completely the impactful appearance and the message of the mural. It is reasonable to attribute these degradation patterns to the peculiar location of the mural. It is located on a portion of the wall where there are numerous water drains which can cause severe water infiltrations. Moreover, it is close to a very busy road with a south-west exposure. The prolonged pollutants and sunlight exposure played a crucial role in the severe deterioration of the mural. This example shows how the location, orientation, and exposure of these kinds of artworks are crucial for their durability.

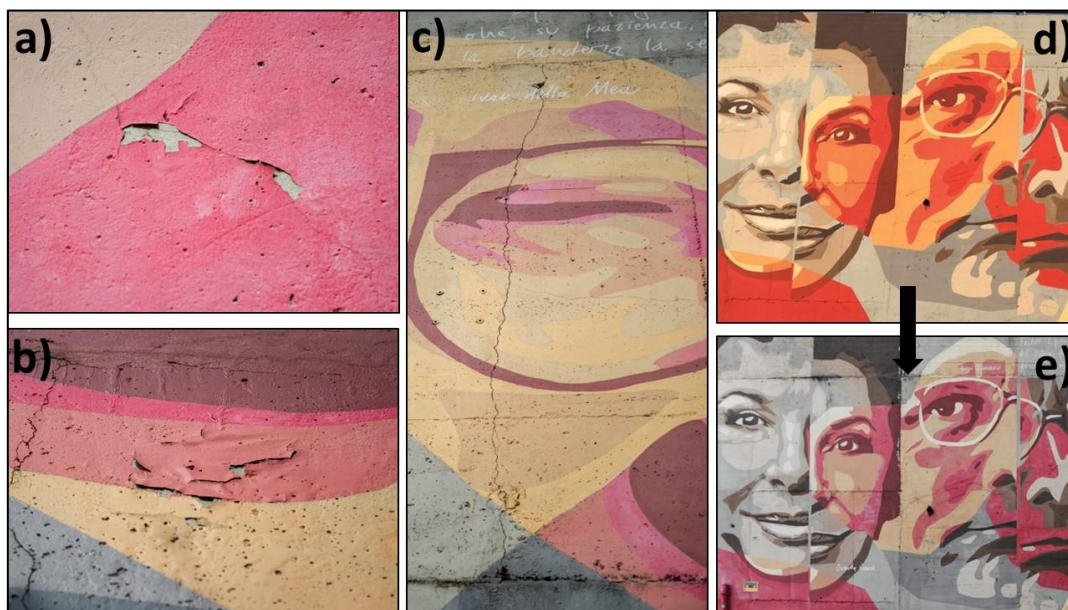
Figure 4. Images from the contemporary mural “Musica Popolare” by Orticanoodles (Milan, Italy): examples of deterioration patterns that can be observed on contemporary murals. (a) Flaking; (b) scaling; (c) fracture of the substrate; (d) original colour of the artwork realised in 2016 and (e) colour fading observed.

Figure 4 proposes different images from the contemporary mural “Musica Popolare” by Orticanoodles (Milan, Italy), a case study of the Prin 2020 Superstar project [20], where it is possible to identify some of the most typical and frequent degradation patterns according to CAPuS glossary [68].

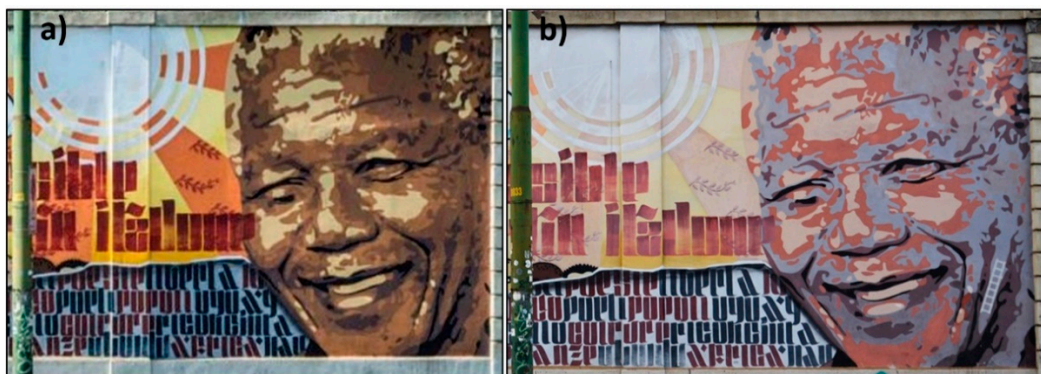
Figure 6. Images from the contemporary mural “20 Years of Freedom and Democracy” by Orticanoodles, Pao, Ivan, and Nais (Milan, Italy): example of colour fading. (a) Original brown tones of Mandela’s face were obtained by mixing different paints. (b) After the probable colour degradation of a component used in the mixture, the aspect is completely changed and the black vault of Mandela is barely recognisable.

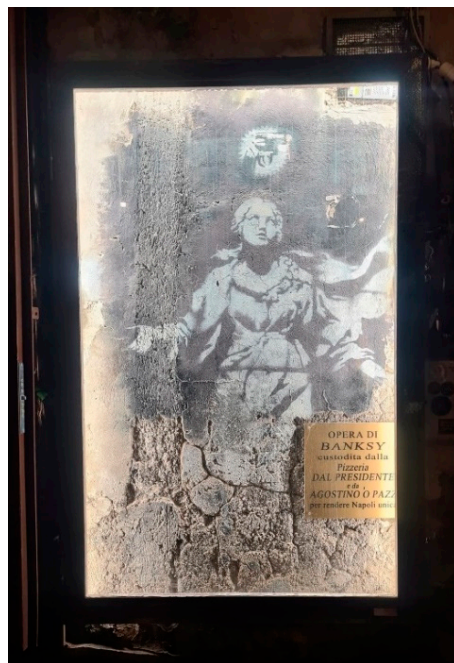
Figure 9. Protective system (plastic panel) applied on la “*Madonna con la Pistola*”, Banksy (2004).

for the rising damp and cause problems of transpiration of the wall support, creating an unsuitable microclimatic condition between the wall and the painting layers. It may cause alteration and deterioration processes and, at the same time, alter the visual perception of the artwork [1].
