Article

Warning against Critical Slopes in Agriculture: Comprehension of Targeted Safety Signs in a Group of Machinery Operators in Italy

Lucia Vigoroso, Federica Caffaro *

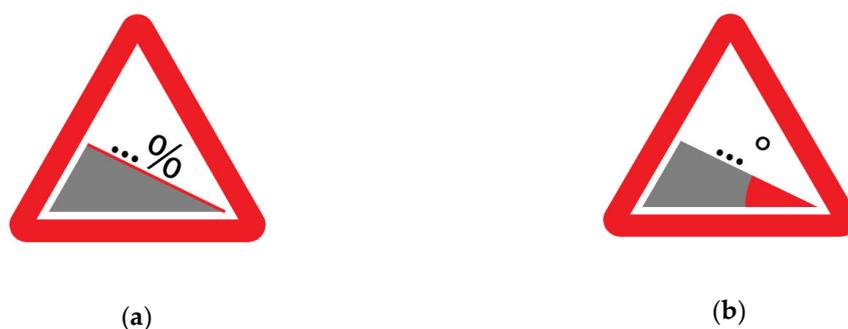
Figure 1. Example of the two versions of the safety sign submitted to users' attention: (a) 36% slope and its corresponding (b) 20° angle.

To investigate the above-indicated angles, we referred to a sign that warns against a steep slope, as designed in the Vienna Convention on Road Signs [40] and to the study that was conducted by Paniati [48], in which different alternatives of existing road signs were tested. The safety sign that was considered in this study is characterized by two elements: a black triangle that represents the slope and a slope percentage value above it. For the estimation of the slope steepness, two versions of the sign were designed with two different graphical indications to focus users' attention on the unit of measurement that had to be reported. For the estimation as a percentage, the element that represented the slope was underlined using a red line, with a percentage symbol (%) that was above this line. For the estimation in degrees, a small coloured arch that was used when dimensioning angles in a technical drawing was depicted to highlight the angle considered, and the degree symbol (°) replaced the percentage symbol adopted for the other version (see Figure 1). A total of fourteen signs (i.e., seven slopes to be expressed in degrees and seven as percentages) printed on 210 × 297 mm

paper were presented in a random order to the participants. Participants were asked to indicate the degree of the tilt angle that was highlighted in red and the percentage of inclination of the red line with respect to the grey triangle's base. When a sign reporting the percentage symbol (%) was shown to the participant, the following instructions were given: "In your opinion, what is the slope percentage of the red line compared to the grey triangle's base?" Similarly, when a sign reporting the degree symbol ($^{\circ}$) was shown, the participant was asked the following: "In your opinion, how many degrees is the red coloured angle in the picture?"

The participants were not informed that each slope was shown to them twice, once with the percentage symbol (%) and once with the degree symbol ($^{\circ}$), so as not to affect their answers.
