# Review on the Experimental Characterization of Fracture in Active Material for Lithium-Ion Batteries

**Abstract:** Nowadays, lithium-ion batteries are one of the most widespread energy storage systems, being extensively employed in a large variety of applications. A significant effort has been made to develop advanced materials and manufacturing processes with the aim of increasing batteries performance and preserving nominal properties with cycling. Nevertheless, mechanical degradation is still a significant damaging mechanism and the main cause of capacity fade and power loss. Lithium ions are inserted and extracted into the lattice structure of active materials during battery operation, causing the deformation of the crystalline lattice itself. Strain mismatches within the different areas of the active material caused by the inhomogeneous lithium-ions concentration induce mechanical stresses, leading ultimately to fracture, fatigue issues, and performance decay. Therefore, a deep understanding of the fracture mechanics in active materials is needed to meet the rapidly growing demand for next-generation batteries with long-term stability, high safety, excellent performance, an

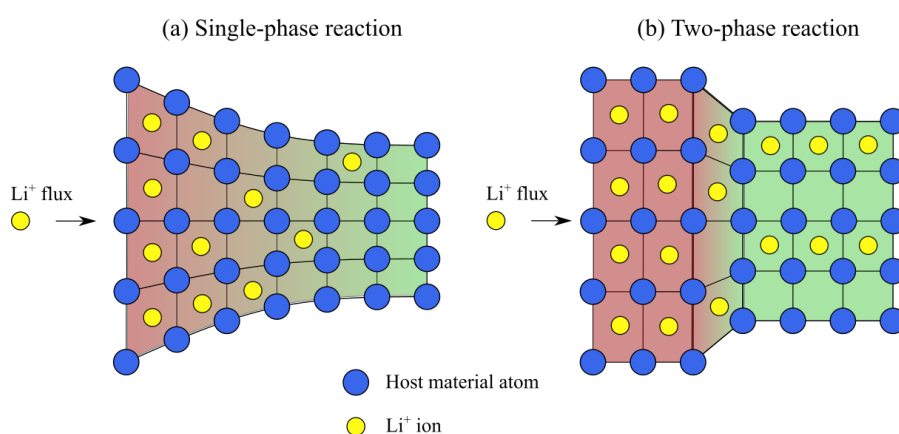
**Figure 1.** Mechanical stress resulting from inhomogeneous concentration due to (a) single phase-reaction and (b) phase transition.

Then, the inhomogeneous lithium concentration within the particle causes differential deformation of the lattice structure, leading to diffusion-induced stress (DIS) [8–13,21]. Furthermore, some materials show a two-phase behavior, i.e., two phases with a different lithium content coexist in the same particle, causing a significant strain mismatch at the interface between them, and thus stress, as illustrated in Figure 1b.

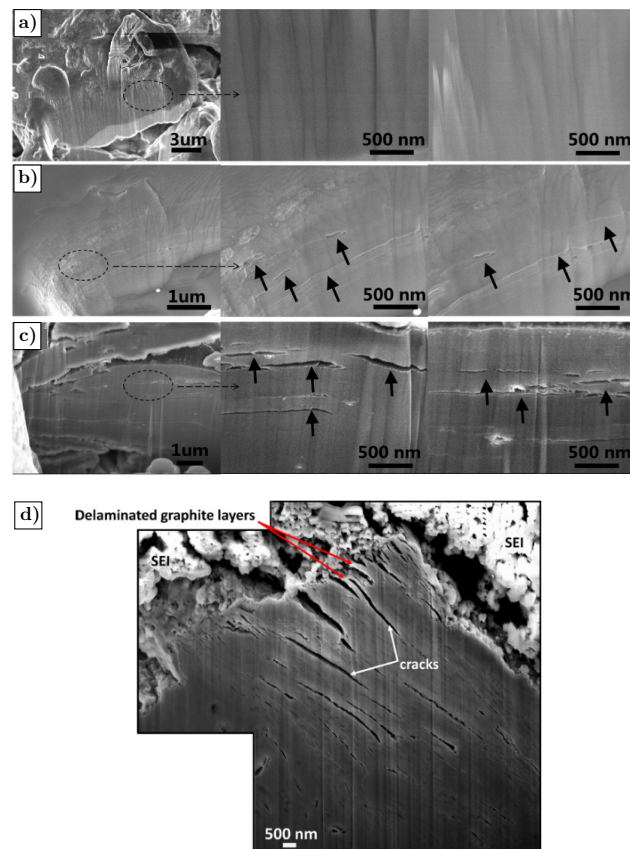
**Figure 3.** Cross-sectional SEM image of the (a) pristine graphite and graphite particles from cells cycled at 1C for (b) 200 and (c) 800 cycles. Black arrows point to the cracks. Reproduced with permission from Elsevier from [40], Copyright 2017. (d) Cross-section SEM image of graphite particle and SEI layer; parallel cracks may cause delamination. Reproduced with permission from Elsevier from [45], Copyright 2011.

Cracks in graphite particles are reported in the literature, and the research community is in agreement that the number of cycles and current rate are the main factors affecting the crack growth [40–44] (Figure 3), and that the formation of SEI over the fresh active material surfaces is the ultimate cause of capacity fade. Cracks are observed parallel to the larger external surface, leading the graphite to exfoliate [40,45], as shown in Figure 3c,d.

The EDX analysis revealed the presence of SEI inside the graphite particles, because electrolyte components react with the fresh active material, thereby increasing the SEI growth rate [43,45]. On the other hand, the formation of SEI on the cracks surfaces is supposed to reduce the stress intensity factor, hindering the crack growth. This phenomenon is known as roughness or asperity-induced crack closure, and it is caused by the physical contact of the SEI layers grown on the opposite flanks of the crack [45].

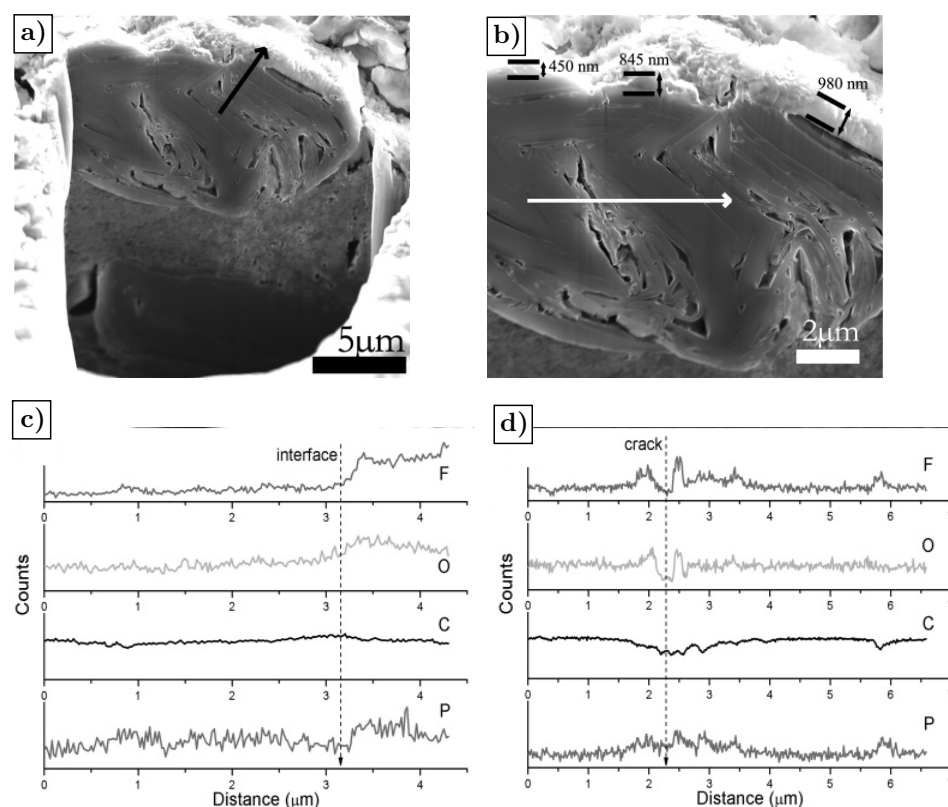
**Figure 4.** (a,b) Secondary electron FIB images of the cross-section of a graphite particle. (c,d) The elemental line scan analysis along the black and white lines in panels (a,b), respectively. Adapted with permission by American Chemical Society from [46], Copyright 2005.

Zhang et al. [46] used element scan analysis (ELSA) to identify the location and composition of the SEI layer. According to Figure 4, ELSA shows peaks in F, O and P elements when SEI is encountered, as it is composed of fluorides (LiF), Li-alkyl carbonates ( $\text{CH}_3\text{OCO}_2\text{Li}$ ,  $(\text{CH}_3\text{OCO}_2\text{Li})_2$ ) from EC/DMC decomposition and electrolytes ( $\text{LiPF}_6$ ). Then, they observed the SEI layer both on the particle surface and at the core, confirming the presence of surface and internal cracks.

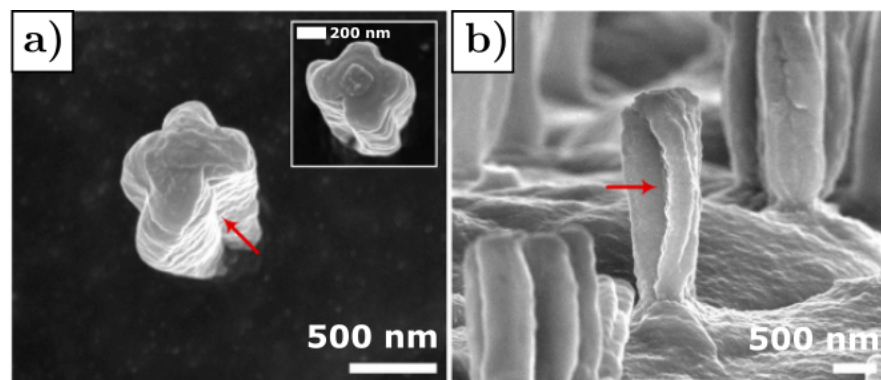
**Figure 5.** SEM images showing cracks in silicon nanowire, pointed out by the red arrow. (a) Top view and (b) Side view. Reprinted with permission from [54], Copyright 2012.

Concerning nanowires, they are characterized by a continuous 1D electronic pathway that facilitates efficient charge transport, as compared to nanoparticles [48]. Furthermore, they can grow directly from the current collector, making binder and conductive agents unnecessary but limiting the lithium flux and current rate as a consequence. Several studies observed an anisotropic expansion during the alloying process, which is greater in the [110] direction, making the cross-section elliptical [52,53]. As a result, intense tensile hoop stress arises along the shorter axis of the ellipse, causing severe crack propagation [54], as confirmed by the SEM images in Figure 5.

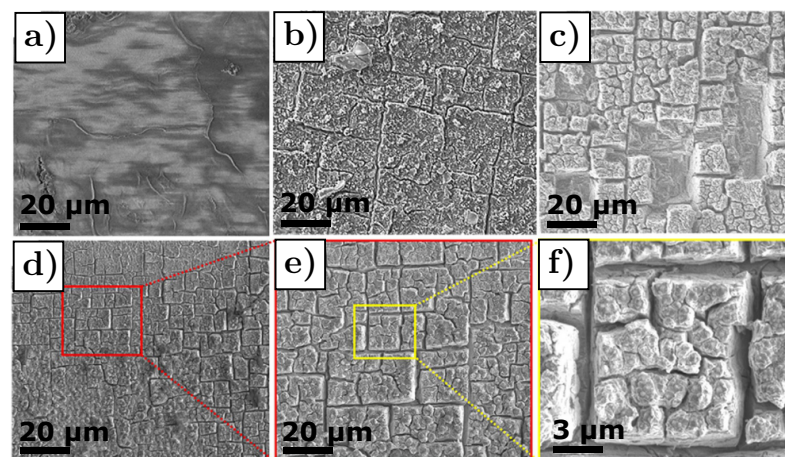
**Figure 6.** Crack growth as a function of lithiation cycles in thin film after (a) 3, (b) 8, and (c) 50 cycles. (d–f) Detail of crack pattern after 30 lithiation cycles. Reprinted with permission by Nature Publishing Group from [55], Copyright 2016.

The lithiation of thin film electrodes causes strains leading to the curvature of the film, which ultimately leads to surface cracks, resembling the ones occurring in drying media, as shown in Figure 6.

A particular crack pattern arises on the surface of the silicon thin film as a result of lithiation cycles, as observed with SEM [55,57]. Shi et al. [55] showed that the crack density is a function of the number of cycles, as shown in Figure 6. In addition, Li et al. [57] reported that crack density depends on the thickness of the film as well, and a critical size below which cracks do not propagate exists.

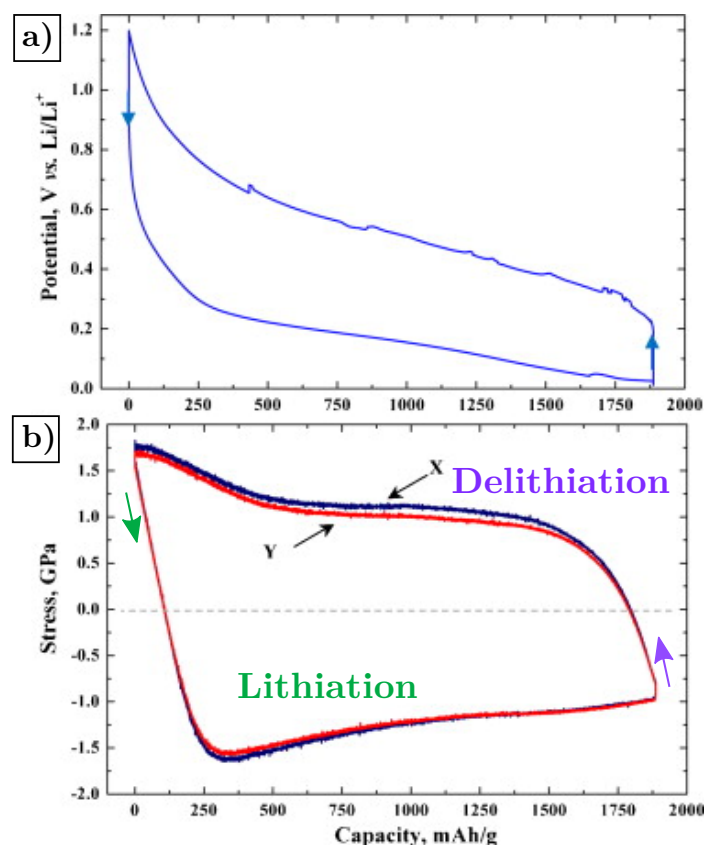
**Figure 7.** (a) Cell potential vs. capacity curve corresponding to lithiation and delithiation Si thin-film electrode cycled at C/4 rate, and (b) the corresponding average stress computed from the measured curvature of the substrate. Adapted with permission by Elsevier from [56], Copyright 2010.

Sethuraman et al. [56] computed the average stress of silicon thin film from the substrate curvature with a Multi-beam Optical Sensor (MOS) during lithiation and delithiation. The results of their in-situ experiments are reported in Figure 7.

It was shown that the average stress becomes elastically compressive during lithiation until 12% of the total capacity, reaching  $-1.75$  GPa. Then, plastic flow occurs until the end of lithiation. Stress is reversed during delithiation and becomes elastically tensile until 75% capacity, reaching 1 GPa, followed by plastic flow. Therefore, delithiation is the critical phase from the fracture point of view, as the electrode is subjected to severe tensile stress.

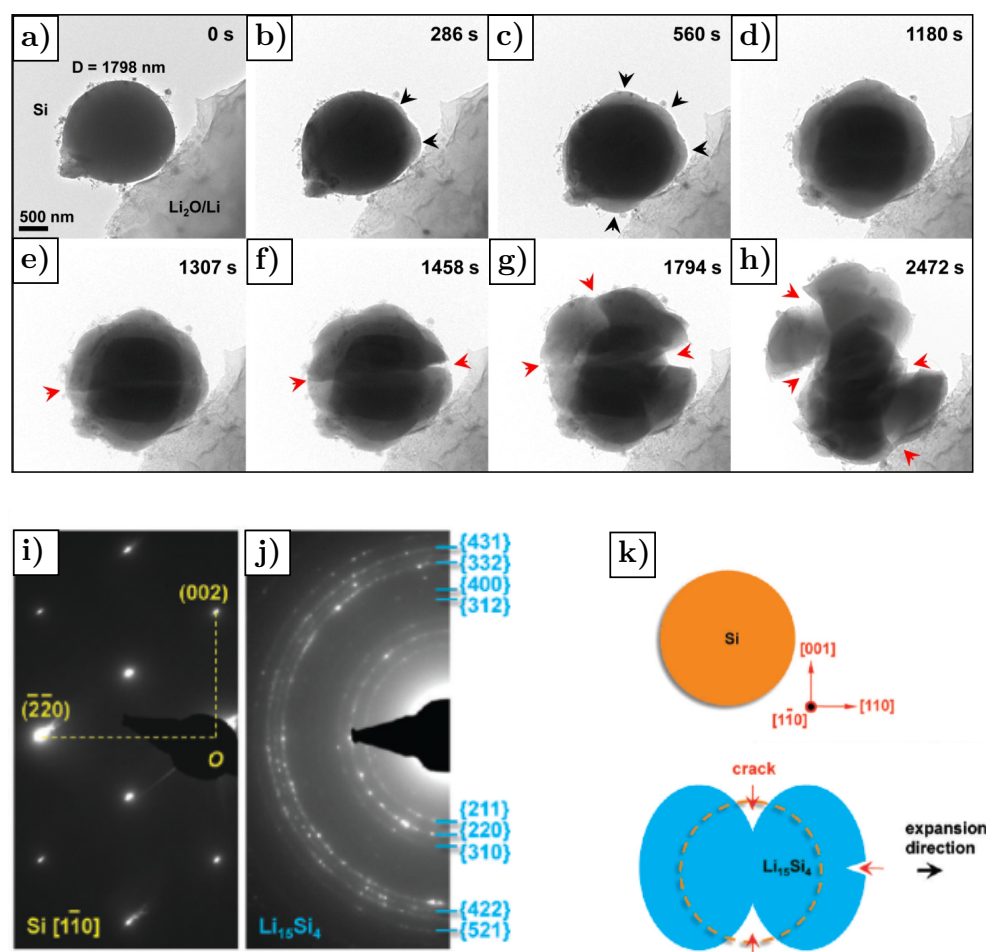
**Figure 8.** (a–h) Crack growth during single lithiation cycle in silicon nano-particle. The black arrows mark the bumps due to anisotropic lithiation of Si before crack formation, whereas the red arrows mark the cracks. (i,j) Electron diffraction pattern showing the silicon phase transformation from (i) crystalline structure (Si) to (j) polycrystalline structure ( $\text{Li}_{15}\text{Si}_4$ ). (k) Anisotropic swelling in silicon nanoparticle favoring cracks in [110] direction. Reprinted with permission by American Chemical Society from [51], Copyright 2012.

Concerning silicon nano-particles, crack growth within the same particle was observed during a single lithiation, as reported in Figure 8a–h [51]. At the end of lithiation, the particle is heavily damaged, and cracks propagating along the [110] direction affect the structural stability considerably. Furthermore, the electron diffraction pattern (EDP) analysis reported in Figure 8i,j shows the phase transformation from crystalline (Si) (Figure 8i), to polycrystalline ( $\text{Li}_{15}\text{Si}_4$ ) (Figure 8j) due to the lithiation process. Figure 8k explains the anisotropic swelling characteristic of silicon nano-particles, leading to cracks predominantly along the [110] direction [51,58].

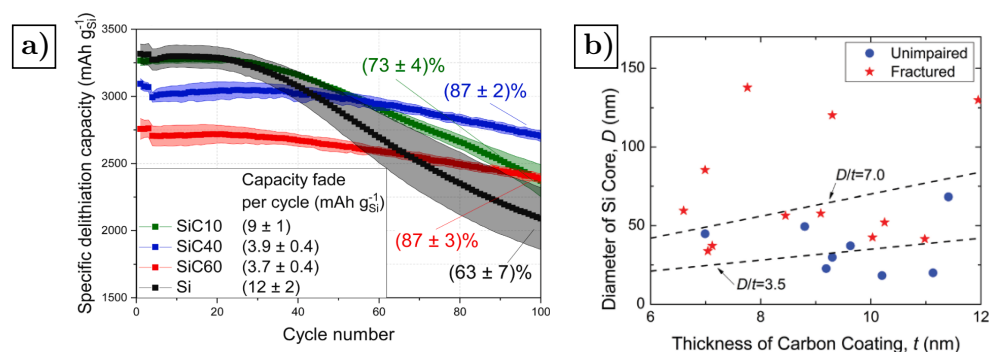
**Figure 9.** Effect of carbon coating on capacity fade. (a) Specific delithiation capacity as a function of the number of cycles for silicon thin film with carbon coating of different thickness, namely 10 nm, 40 nm, and 80 nm, for SiC10, SiC40 and SiC80, respectively. Reprinted with permission by Elsevier from [64], Copyright 2021. (b) Occurrence of fracture as a function of the ratio between particle diameter ( $D$ ) and coating thickness ( $t$ ). Reprinted with permission by Royal Society of Chemistry from [65], Copyright 2016.

In particular, Casino et al. [64] demonstrated that carbon coating mitigates the capacity fade. They observed that an increased coating thickness reduces the capacity drop, but a thickness greater than 60 nm does not have greater beneficial effects. On the other hand, the greater the coating thickness, the lower the nominal capacity. Consequently, a trade-off should be found to obtain the best performance; Casino et al. showed that a coating thickness of 60 nm guarantees good nominal capacity and capacity fade mitigation, as depicted in Figure 9a.

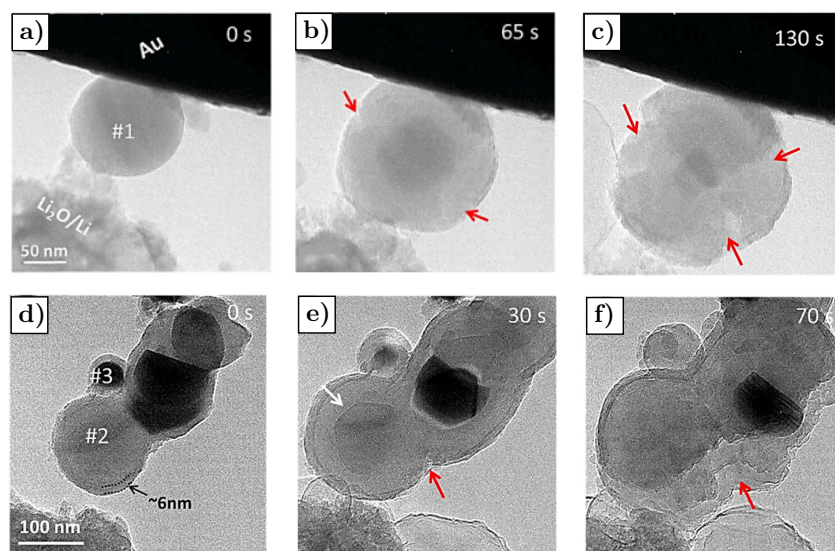
**Figure 10.** Lithiation of (a–c) uncoated silicon particle and (d–f) coated silicon particles. The time value depicted in the figure refers to the lithiation time. Reprinted with permission by Elsevier from [68], Copyright 2016.

Fractures were observed with TEM in carbon-coated silicon particles in some works [65,67,68]. Xu et al. [68] compared the lithiation of two sets of geometrically similar particles (130–150 nm), one with a 6 nm carbon coating and the other without coating. Few fractures were observed in the coated particles, depicted by the red arrows in Figure 10e,f. On the other hand, a greater number of fractures were observed in the uncoated particles, as confirmed by the red arrows in Figure 10a–c. During the lithiation of the coated particles, the coating thickness increases from 6 nm to 8 nm, because of the strong radial stress due to the silicon core expansion. Then, fractures are triggered in the coating thickness and they further propagate in the silicon core. These factors may explain the reason why fracture occurs in coated particles that are smaller than the critical fracture size, i.e., 150 nm as explained by Liu et al. [51].

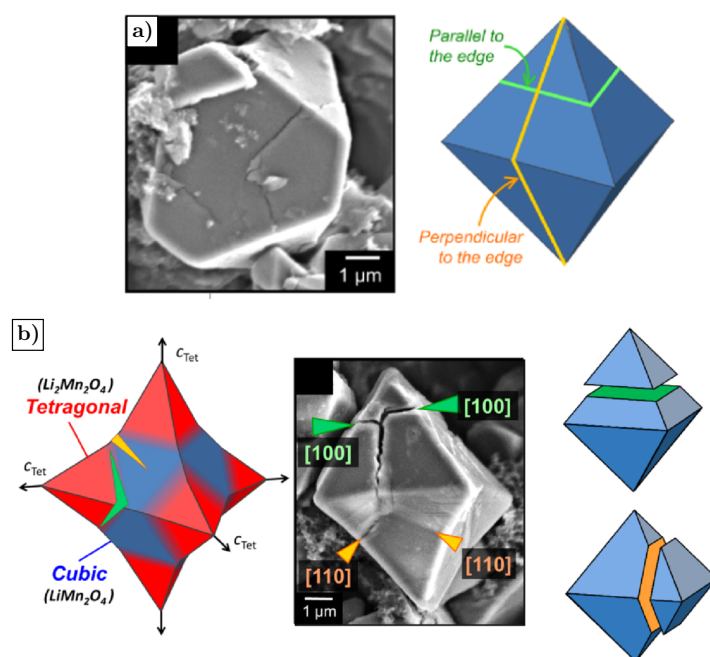
**Figure 11.** (a) Cubic and (b) tetragonal structure of LMO with the corresponding preferential cracks directions. Reprinted with permission by American Chemical Society from [83], Copyright 2021.

Severe cracking is observed when the LMO undergoes Jahn–Teller transformation, and intragranular cracks are observed at the cubic/tetragonal ([100] direction) and tetragonal/tetragonal ([110] direction) grain boundaries, indicated in green and orange in Figure 11b, respectively. Thus, cracks appear oriented along the [100] and [110] directions [83].

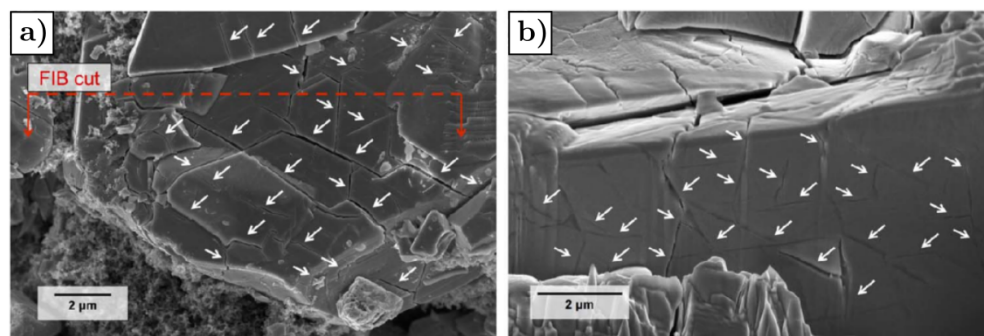
**Figure 12.** (a) Fracture in LMO particle after 16 deep discharge cycles with Jahn–Teller transformation and 51 cycles without Jahn–Teller transformation. (b) Internal view of LMO particle shown in (a) after FIB milling. White arrows point to the cracks. Reprinted with permission by Journal of The Electrochemical Society from [84], Copyright 2018.

McGrogan et al. [84] cycled the LMO electrode above Jahn–Teller transformation and milled the cycled electrode with FIB to study the internal cracking network, as shown in Figure 12a,b. The dense crack network, probably caused by Jahn–Teller transformation, allows the electrolyte to penetrate inside the particle, causing the dissolution of  $Mn^{2+}$ , as will be explained in Section 4.

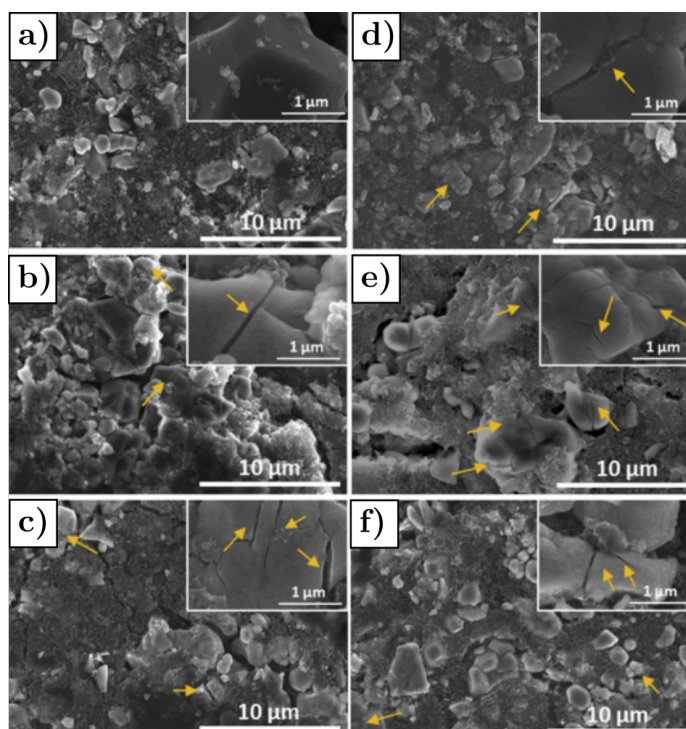
**Figure 13.** SEM images of the electrode structure (a) before cycling and after (b) 40 cycles, (c) 125 cycles, (d) 500 cycles, (e) cycled at low voltage to trigger Jahn-Teller transformation and (f) cycled at high temperature. Reprinted with permission by Elsevier from [88], Copyright 2017.

Some works tried to correlate the capacity fade in LMO with the occurrence of fracture due to cycling. Liu et al. [88] compared the increase in free surfaces created by cracks with capacity loss, observing an interesting correlation. They analyzed different samples subjected to an increasing number of cycles with TXM and SEM (Figure 13), and measured the increase in free surfaces created by cracks with an image processing tool.

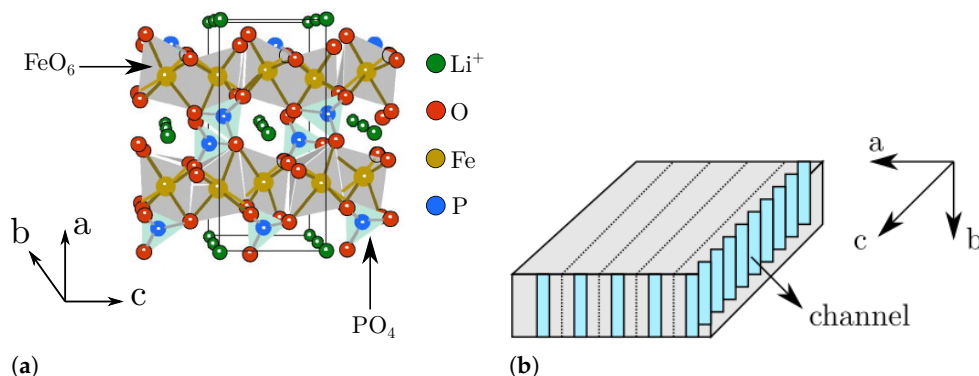
**Figure 14.** (a) Crystal structure of LFP. Reprinted with permission by Elsevier from [92], Copyright 2009. (b) Schematic illustration of lithium intercalation mechanism in LFP single crystal. Lithium ions diffuse along 1D channels in the  $b$ -direction, and channels are stacked in layers parallel to  $bc$  planes, indicated by the dotted lines.

LFP crystallizes in the olivine structure, consisting of  $\text{FeO}_6$  octahedra and  $\text{PO}_4$  tetrahedra, as shown in Figure 14a. The  $\text{FeO}_6$  octahedra contact each other by sharing corners and forming layers in the  $bc$  planes. The  $\text{FeO}_6$  layers are linked together by  $\text{PO}_4$  tetrahedral units. Lithium ions are located in the interstitial voids of the framework, forming continuous linear chains along the  $c$ -axis in the alternate  $ac$  planes. In this structure, the most favorable lithium diffusion path is through channels aligned with the  $b$ -direction [91], as illustrated in Figure 14b.

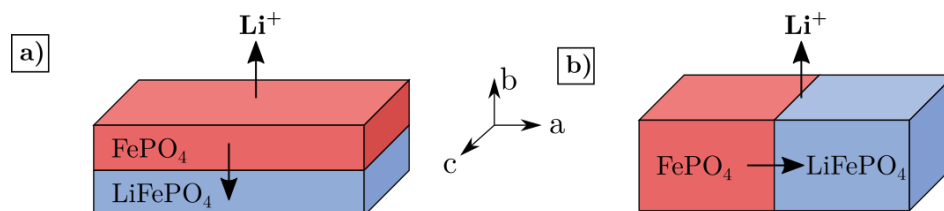
**Figure 15.** Scheme of the phase boundary movement for LFP. (a) Phase boundary moving along the  $b$ -axis; (b) Phase boundary moving along the  $a$ -axis.

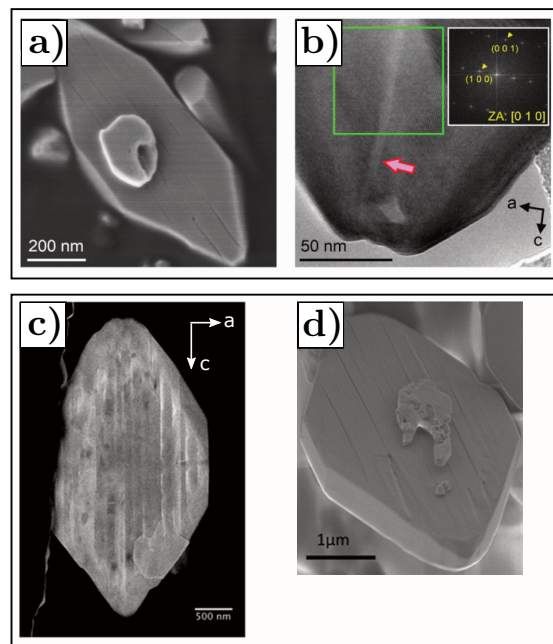
**Figure 16.** Top: Electron microscopy results for a micrometric plate-like LFP crystal subjected to partial chemical delithiation. (a) SEM image and (b) High-resolution transmission electron (HRTEM) image with the inset of the Fourier transform pattern obtained from the region marked with the green box. The red arrows indicate the crack running parallel to the  $c$ -axis. Reprinted with permission by American Chemical Society from [97], Copyright 2015. Bottom: SEM observations of partially delithiated  $\text{Li}_{0.5}\text{PO}_4$  crystal. (c) SEM image and (d) STEM-HAADF image, showing cracks evenly spaced and oriented along the  $c$ -axis. Reprinted with permission by American Chemical Society from [96], Copyright 2013.

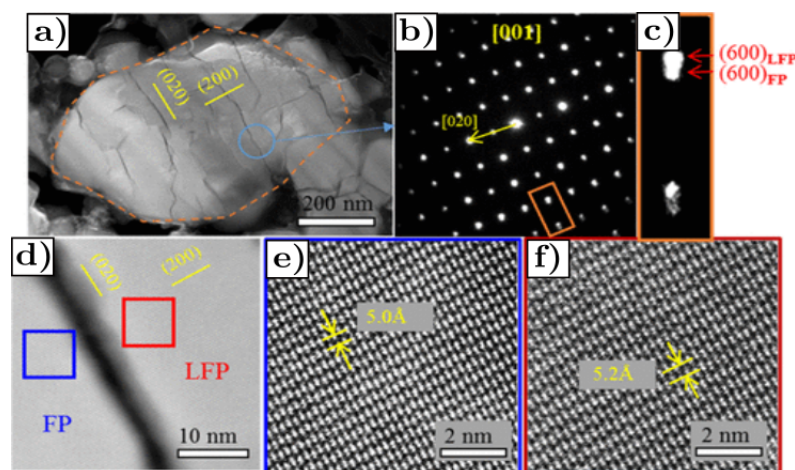
**Figure 17.**  $\text{LiFePO}_4$  and  $\text{PO}_4$  phases separated by  $ac$  plane cracks in a LFP crystal electrochemically cycled, with (a) STEM-HAADF image of the crystal at 100% SOC, (b,c) SAED patterns and (d–f) STEM-HAADF images. Reprinted with permission by American Chemical Society from [99], Copyright 2020.

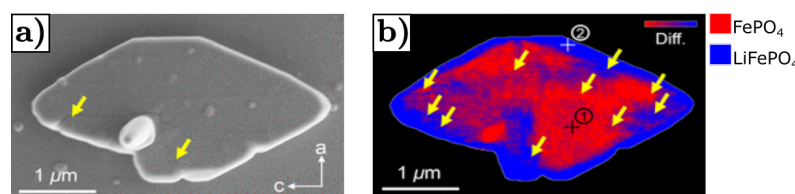
**Figure 18.** Relation between defects and phase distribution within micrometric LFP chemically delithiated plate-like crystal, with (a) SEM image and (b) Chemical phase distribution map. Reprinted with permission by American Chemical Society from [97], Copyright 2015.

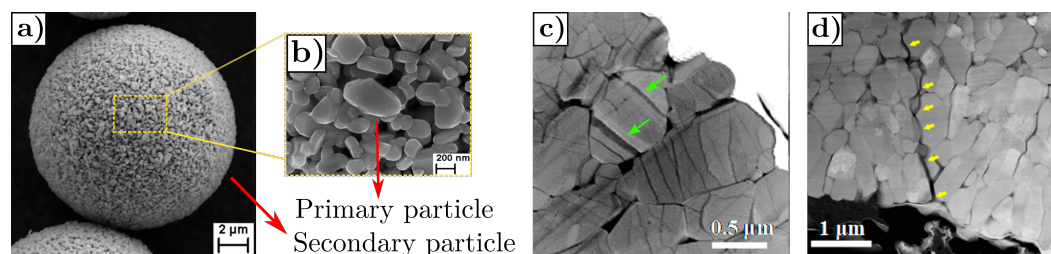
**Figure 19.** (a,b) SEM images of NMC secondary and primary particles. Reproduced with permission from [105], ©2020 American Chemical Society. (c,d) TEM images of the cross-section of discharged NMC cathode after 100 cycles: intragranular cracks within primary particles are marked with green arrows, whereas intergranular cracks developing along grain boundaries are marked with yellow arrows. Reprinted with permission by American Chemical Society from [106], Copyright 2018.

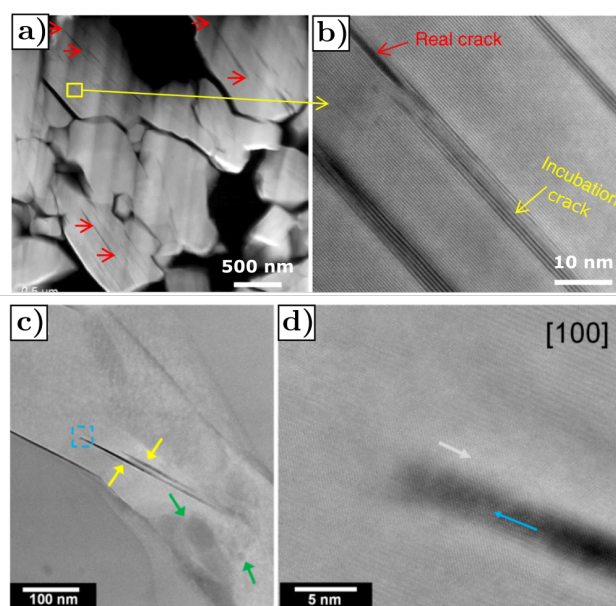
**Figure 20.** (a,b) SEM image of electrochemically cycled  $\text{LiNi}_{0.6}\text{Mn}_{0.2}\text{Co}_{0.2}\text{O}_2$  (NMC622) particles, showing cracks parallel to the (003) planes. Cracks are marked with red arrows. Reprinted with permission of [109] ©2018 Springer Nature. (c) Intragranular cracks in  $\text{Li}_{1+x}(\text{Ni}_{0.85}\text{Co}_{0.1}\text{Mn}_{0.05})_{1-x}\text{O}_2$  (NCM851005) after 200 cycles, with (d) High-resolution image of the marked area in (c) showing the rock-salt phase along the crack surface. The direction parallel to (003) planes, cracks and the rock-salt phase are marked with grey, yellow and blue arrows, respectively. Reprinted with permission from American Chemical Society by [110], Copyright 2019.

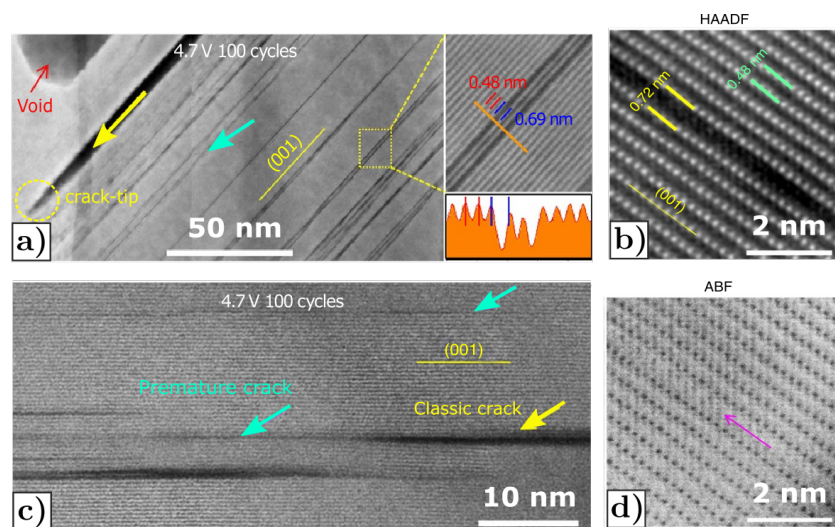
**Figure 21.** (a,c) HAADF images from cycled NMC333 cathode particle showing intragranular cracks along the (001) plane. The yellow and light blue arrows indicate classic and premature cracks, respectively. (b) HAADF and (d) ABF images along [010] axis of the premature crack showed in (a). Reprinted with permission from Springer Nature by [108], Copyright 2017.

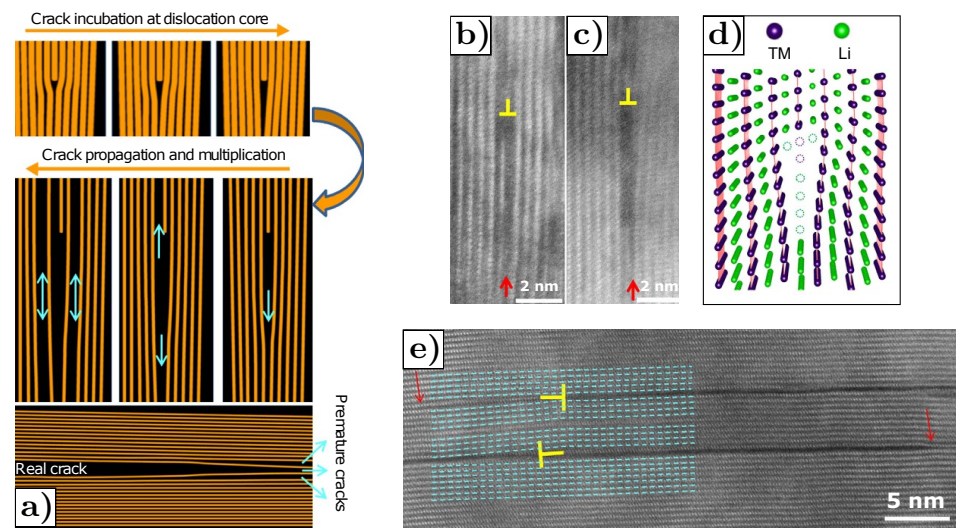
**Figure 22.** (a) Schematic diagrams of the dislocation-assisted crack incubation, propagation and multiplication process in NMC cathode particles. (b,c) Nucleation of premature cracks at the dislocation core in NMC333 cycled particles, also schematized in (d). (e) Edge dislocations associated with intragranular cracks in cycled NMC333 particles. Crack tip is indicated with the red arrows. Reprinted with permission from Springer Nature by [108], Copyright 2017.

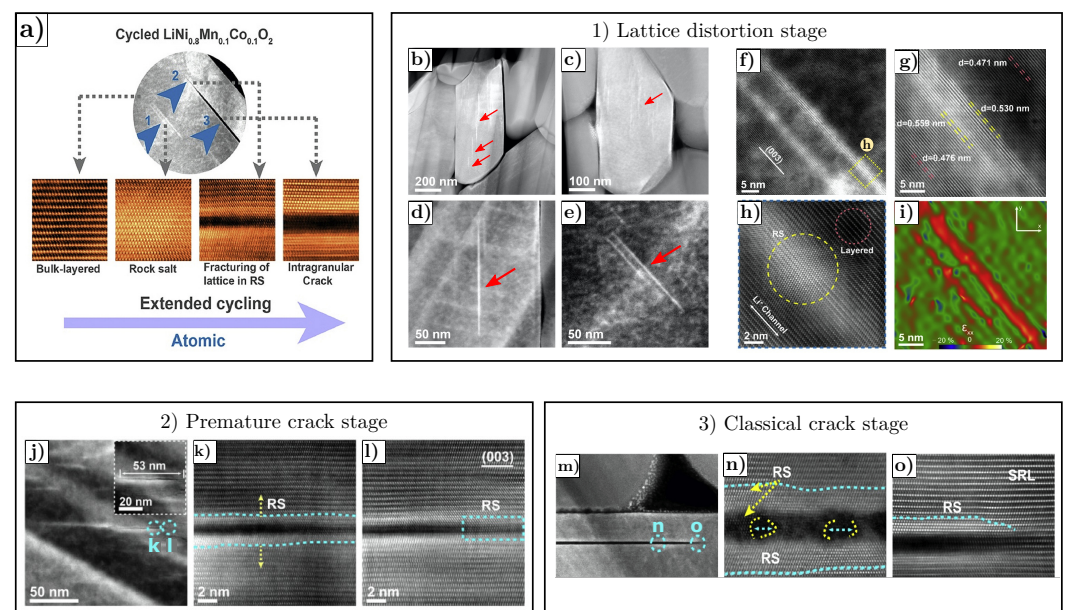
**Figure 23.** (a) Development process of intragranular cracks in NMC811: (b–i) Lattice distortion stage, (j–l) Premature crack stage and (m–o) Classical crack stage. STEM-HAADF images of cycled NMC811 particle in <010> zone projection, after (b–d) 50 cycles and (c–e) 20 cycles. The white lines appear with different length. (f) STEM-HAADF image of enlarged morphology of a white line shown in (a). (g) High-resolution STEM-HAADF image, showing the lattice distortion of the white line region. (h) Atomic-resolution STEM-HAADF image from the region marked by yellow dashed square box in (f), showing the detailed structure of the white line, with the formation of the rock-salt phase. (i) Strain map simulated by GPA due to lattice distortion. (j–l) Atomic-resolution STEM-HAADF images of premature intragranular crack in NMC811 particle after 50 cycles, showing the presence of the rock-salt phase both in the (k) partially cracked region and (l) uncracked tip. (m–o) Atomic-resolution STEM-HAADF images of mature intragranular crack in NMC811 particle after 100 cycles, showing the increase in the crack length along the (003) plane and in the rock-salt phase thickness. Reprinted with permission from Elsevier by [111], Copyright 2020.

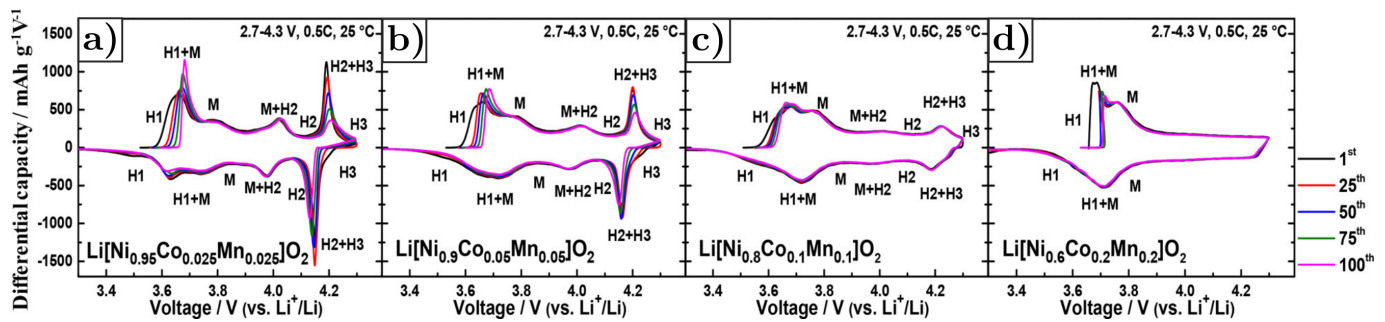
**Figure 24.** Differential capacity curves of  $\text{Li}[\text{Ni}_x\text{Co}_y\text{Mn}_{1-x-y}]\text{O}_2$  with different Ni content: (a)  $x = 0.95$ , (b)  $x = 0.9$ , (c)  $x = 0.8$ , and (d)  $x = 0.6$  as a function of the number of cycles. Reprinted with permission of [106], ©2018 American Chemical Society.

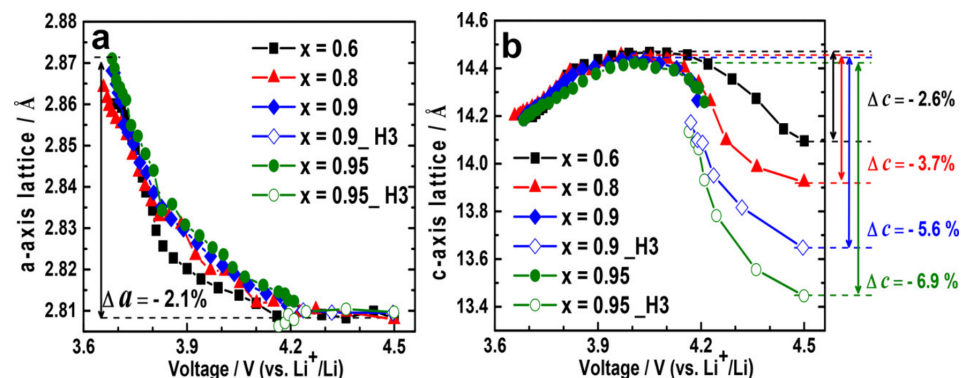
**Figure 25.** (a)  $a$ -axis and (b)  $c$ -axis lattice parameters of  $\text{Li}[\text{Ni}_x\text{Co}_y\text{Mn}_{1-x-y}]\text{O}_2$  as a function of the Ni content ( $x = 0.95$ ,  $x = 0.9$ ,  $x = 0.8$  and  $x = 0.6$ ) and the cell voltage. Reprinted with permission of [106], ©2018 American Chemical Society.

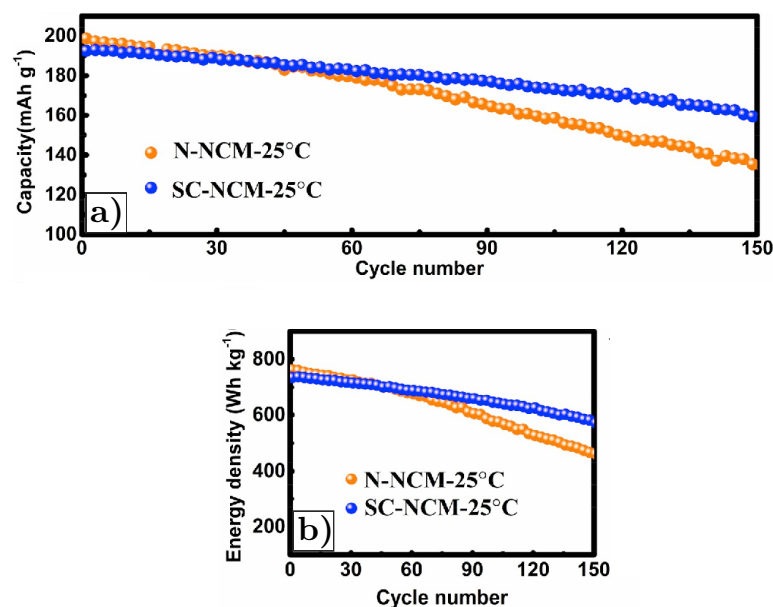
**Figure 26.** (a) Comparison of capacity and (b) Energy density decay between single-crystalline (SC-NCM) and commercial polycrystalline (N-NCM) NMC831106 cycled at 1C in the voltage range of 2.75–4.4 V over 150 cycles. Reprinted with permission of [123], ©2020 Elsevier.

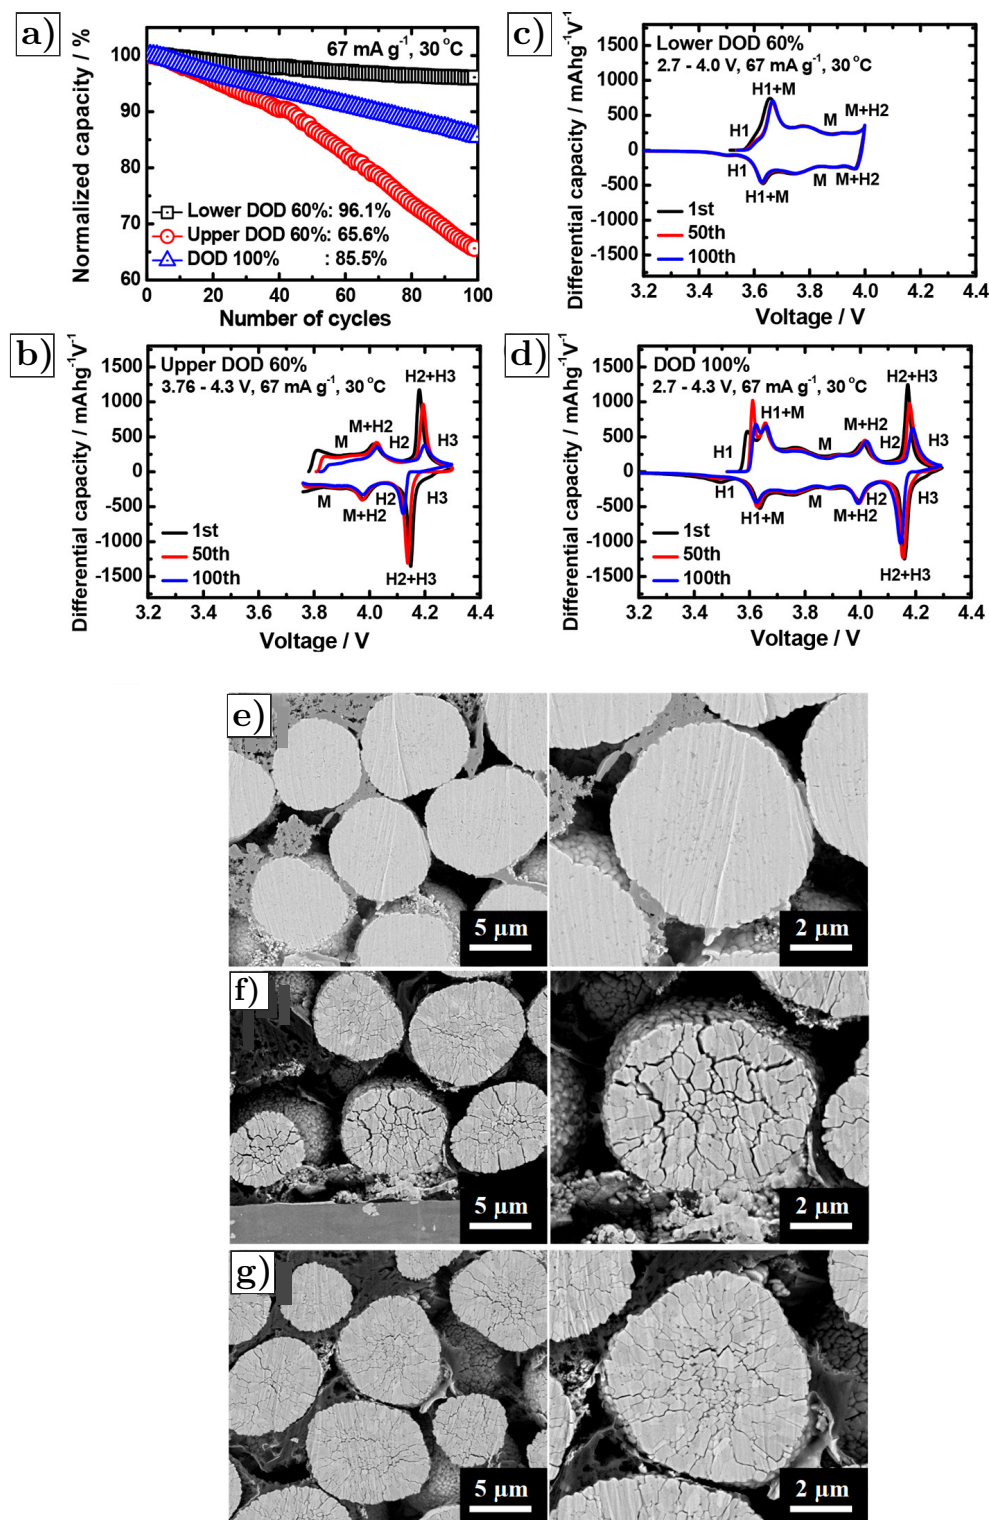
**Figure 27.** (a) Capacity decay of NCA95 during cycling at different DOD and initial SOC values. Derivative of charge-discharge curves of NCA95 cycled (b) from SOC 40 to 100% (3.76–4.3 V) (c) from SOC 0 to 60%, (d) from SOC 0 to 100%. Cross-sectional SEM images of NCA95 particles cycled for 100 cycles (e) from SOC 0 to 60%, (f) from SOC 40 to 100% and (g) from SOC 0 to 100%. Reprinted with permission by American Chemical Society from [132], Copyright 2019.

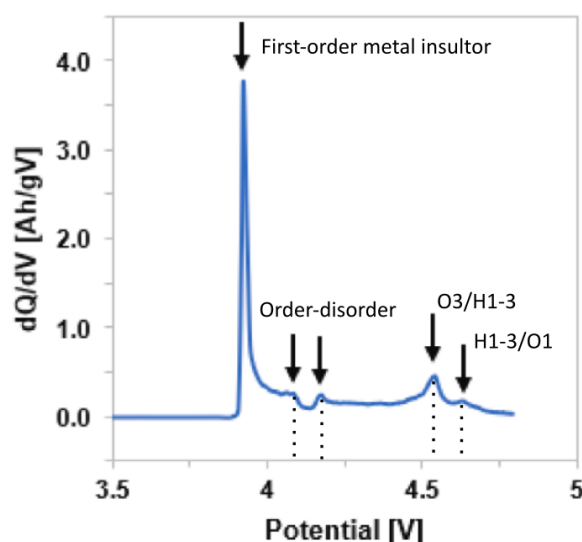
**Figure 28.** Differential capacity curve of a fresh LCO half-cell charged to 4.8 V at 0.05C. Most relevant phase transitions are highlighted by the black arrows. Adapted with permission by Elsevier from [137], Copyright 2022.

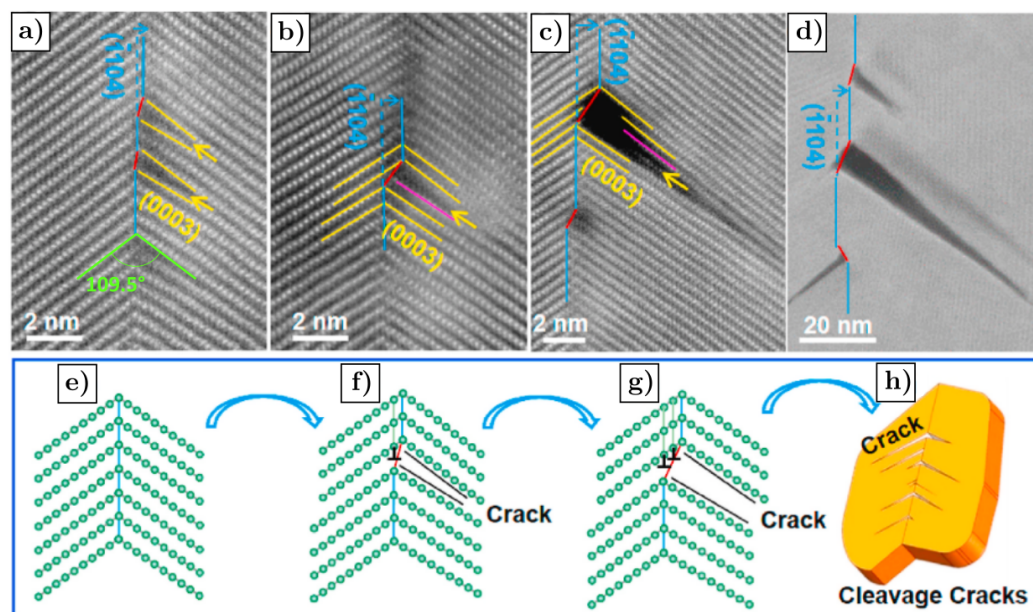
**Figure 29.** Cleavage crack's nucleation and propagation. (a) STEM-HAADF image showing the nucleation of cleavage cracks at the kinks occurring after 50 cycles. The (0003) plane is highly strained as indicated by the yellow arrows. (b,c) Further deformation-induced crack growth at the twin boundary. Pink lines indicate the extra (0003) planes generated to release the local strain. (d) V-shaped cleavage cracks induced by deformation. (e–h) Schematic diagrams to illustrate the cleavage crack nucleation and growth process. Reprinted with permission by Elsevier from [136], Copyright 2020.

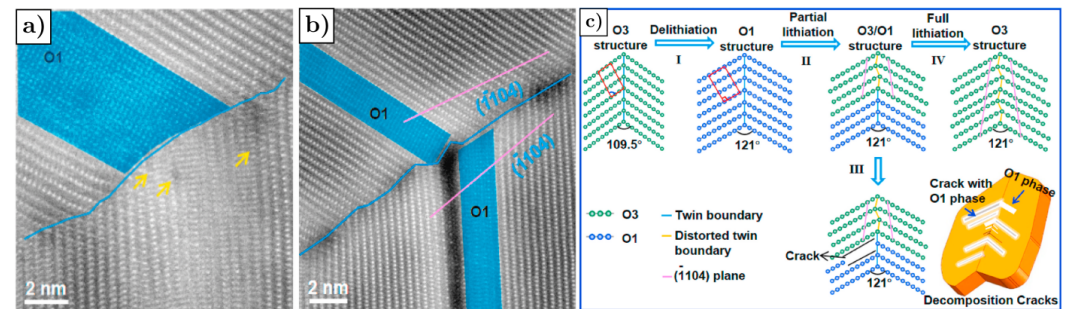
**Figure 30.** Phase transition induced cracking at the twin boundary. (a) A STEM-HAADF image showing the O1 phase (light blue region) formed at the highly distorted twin boundary, indicated by the light blue line. Incubation cracks at the twin boundary are marked by yellow arrows. (b) Decomposition crack formed along an O1 phase strip. (c) Schematic diagrams illustrating the cracking mechanism induced by phase transition at the twin boundary. Reprinted with permission by Elsevier from [136], Copyright 2020.

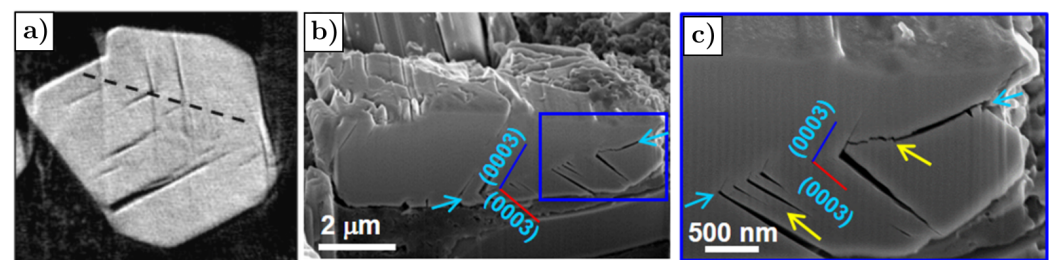
**Figure 31.** Cracking along the twin boundary. (a) Reconstructed image from X-ray nano-tomography reprinted from [137]. (b,c) SEM images of a cross-section of LCO particles (milled with FIB), showing cracks originating from twin boundary and their planes direction. Reprinted with permission by Elsevier from [136], Copyright 2020.

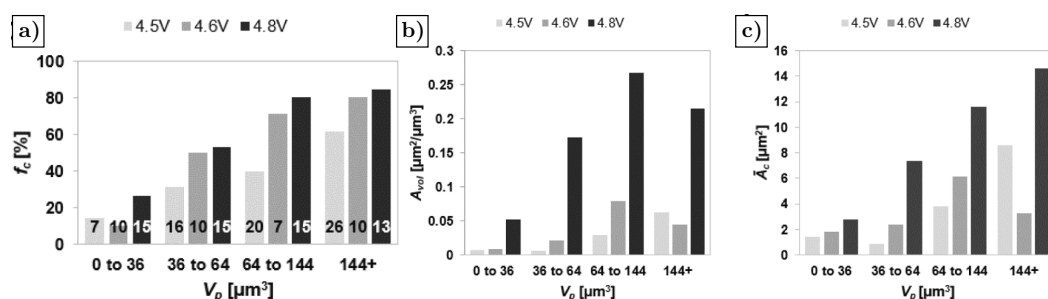
**Figure 32.** (a) The percentage of LCO particles within a given volume range that contains cracks after a single charge cycle to a given cutoff voltage. (b) The crack area per unit of volume for particles within a given volume range after a single charge cycle to a given cutoff voltage. (c) The average individual crack area (proportional to crack length) for particles within a given volume range after a single charge cycle to a given cutoff voltage. Reprinted with permission by Elsevier from [137], Copyright 2022.

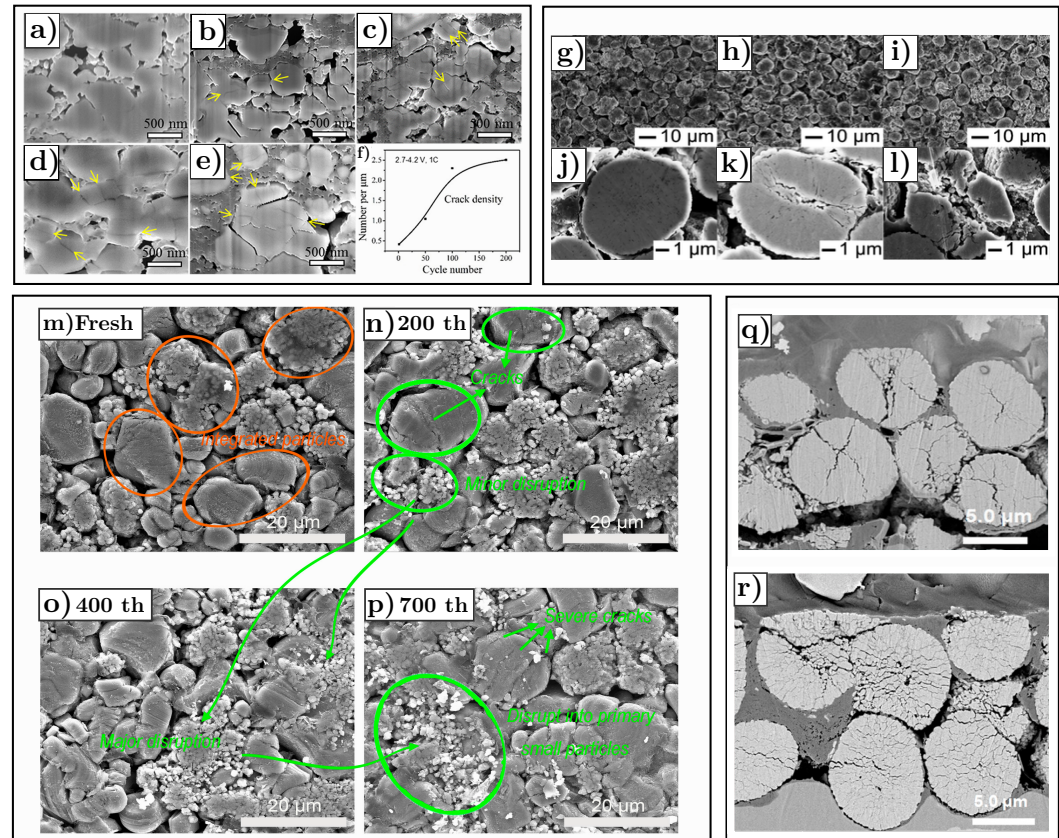
**Figure 33.** (a–f) Cross sectional SEM images of cracks evolution in LiFePO<sub>4</sub> cathode cycled at 1C. Samples (a) before cycling, (b) after 1 cycle, (c) after 50 cycles, (d) after 100 cycles, (e) after 200 cycles, and (f) crack density as a function of the cycle numbers. Reprinted with permission by American Chemical Society from [99], Copyright 2018. Top view and cross-sectional SEM images of the NCM851005 cathode (g,j) before cycling, (h,k) after 100 cycles and (i,l) after 500 cycles at 1C. Reprinted with permission by American Chemical Society from [154], Copyright 2019. (m–p) FESEM images of hercynite LCO/NMC532 cathode electrodes at various cycle numbers. Reprinted with permission by MDPI from [153], Copyright 2017. (q,r) Cross-sectional SEM images of Li[Ni<sub>0.90</sub>Co<sub>0.05</sub>Mn<sub>0.05</sub>]O<sub>2</sub> at first cycle and after 1000 cycles, respectively. Reprinted with permission by American Chemical Society from [152], Copyright 2019.
