# Review on the Experimental Characterization of Fracture in Active Material for Lithium-Ion Batteries

**Abstract:** Nowadays, lithium-ion batteries are one of the most widespread energy storage systems, being extensively employed in a large variety of applications. A significant effort has been made to develop advanced materials and manufacturing processes with the aim of increasing batteries performance and preserving nominal properties with cycling. Nevertheless, mechanical degradation is still a significant damaging mechanism and the main cause of capacity fade and power loss. Lithium ions are inserted and extracted into the lattice structure of active materials during battery operation, causing the deformation of the crystalline lattice itself. Strain mismatches within the different areas of the active material caused by the inhomogeneous lithium-ions concentration induce mechanical stresses, leading ultimately to fracture, fatigue issues, and performance decay. Therefore, a deep understanding of the fracture mechanics in active materials is needed to meet the rapidly growing demand for next-generation batteries with long-term stability, high safety, excellent performance, an

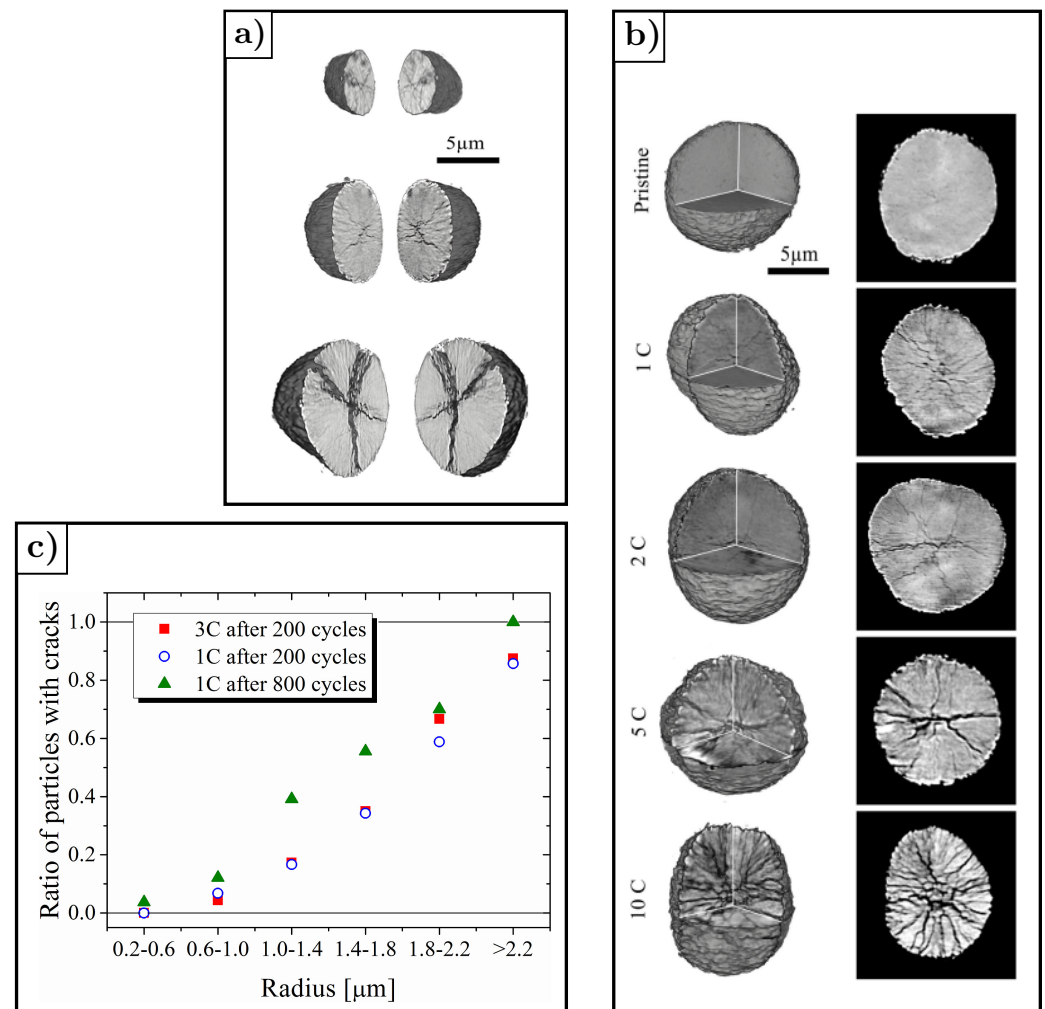
**Figure 34.** (a) Fracture in NMC particles of different size, after 50 cycles at 10C. (b) Fracture in NMC particles after 50 cycles at 1C, 2C, 3C, 5C and 10C. Reprinted with permission by Elsevier from [116], Copyright 2018. (c) Fracture occurrence in  $\text{LiMn}_{1.95}\text{Al}_{0.05}\text{O}_4$  as a function of current rates and particles radius. Reprinted with permission by Elsevier from [155], Copyright 2017.

Cracks are found more frequently in larger particles than in smaller ones (Figure 34a,c).

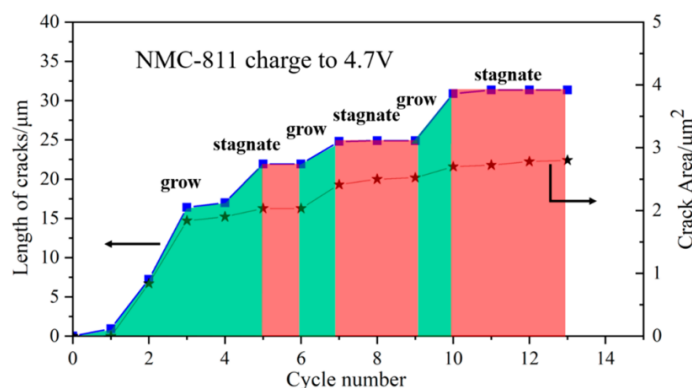
**Figure 35.** Measures of crack length and area as a function of number of cycles with in-situ SEM. The material is NMC811 cycled with a lithium counter electrode at 0.5C and 2.7 V–4.7 V. Reprinted with permission by Elsevier from [157], Copyright 2021.
