Article

Hydraulic Performance of Lined Permeable Pavement Systems in the Built Environment

Department of Geosciences and Natural Resource Management, University of Copenhagen, DK-1958 Frederiksberg, Denmark; toda@ign.ku.dk (T.D.); mbj@ign.ku.dk (M.B.J.)

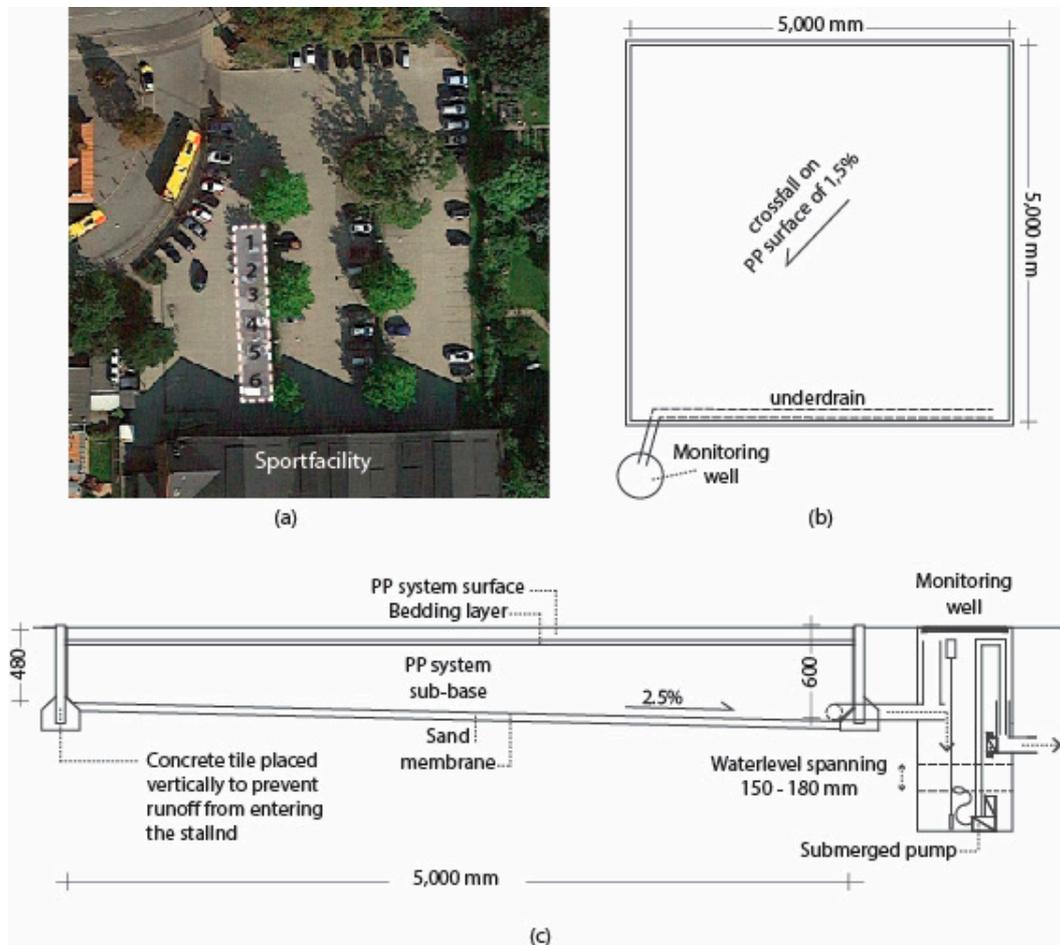
Figure 1. Location and construction of the six experimental stalls of lined PP-systems with: (a) an aerial photo of the parking area with position of stalls marked; (b) diagram of an individual stall; and (c) a cross-section of individual stall and monitoring well.

As parking areas are often mentioned as ideal for PP systems [1], an existing public parking area was chosen for constructing six unique and individual lined and monitored PP systems. The six experimental stalls were equally sized of 25 m², corresponding to two parking lots and situated next to each other at the most frequently used area at a parking lot next to a public sport facility in Copenhagen, Denmark (55°42'51" N, 12°34'42" E). The sports facility has long opening hours all weekdays and all year round except for a summer break; thus, the parking lots were intensively used. By placing a raised concrete tile along the perimeter of each stall, a 20 mm high boundary towards the surroundings was formed, ensuring that only rainfall over the individual stall was captured and infiltrated. The stalls were fitted to existing terrain conditions, resulting in a cross fall of 1.5%. The bottom of each of the stalls was individually lined with a 2 mm polyethylene (HDPE) membrane overlaid with a studded membrane of polypropylene (12 mm) (Platon) to prevent the underlying membrane from being perforated as sub-base aggregates were built in. Tightness tests were conducted by allowing water to stand for 12 h, after the first half of aggregates were in place and compacted as membrane rupture has previously been reported as a possible source of error in interpreting data [10,11]. The HDPE membrane was folded in corners to also cover sides, and finally, pinched between surface layer and the circumscribing tile. To ensure free discharge, a 110 mm diameter perforated pipe was placed on the studded membrane downstream and connected to a 600 mm monitoring well placed outside the PP system, through a sealed socket perforation of the membrane. From the monitoring well, discharge was pumped by way of a submerged pump to the piped drainage network. Stalls 1–5 had a reinforcement

net directly on top of the studded membrane, as well as at a level of 300 mm below pavement surface to minimize the risk of deformations. Plan and cross-section illustrations of the six stalls are presented in Figure 1.

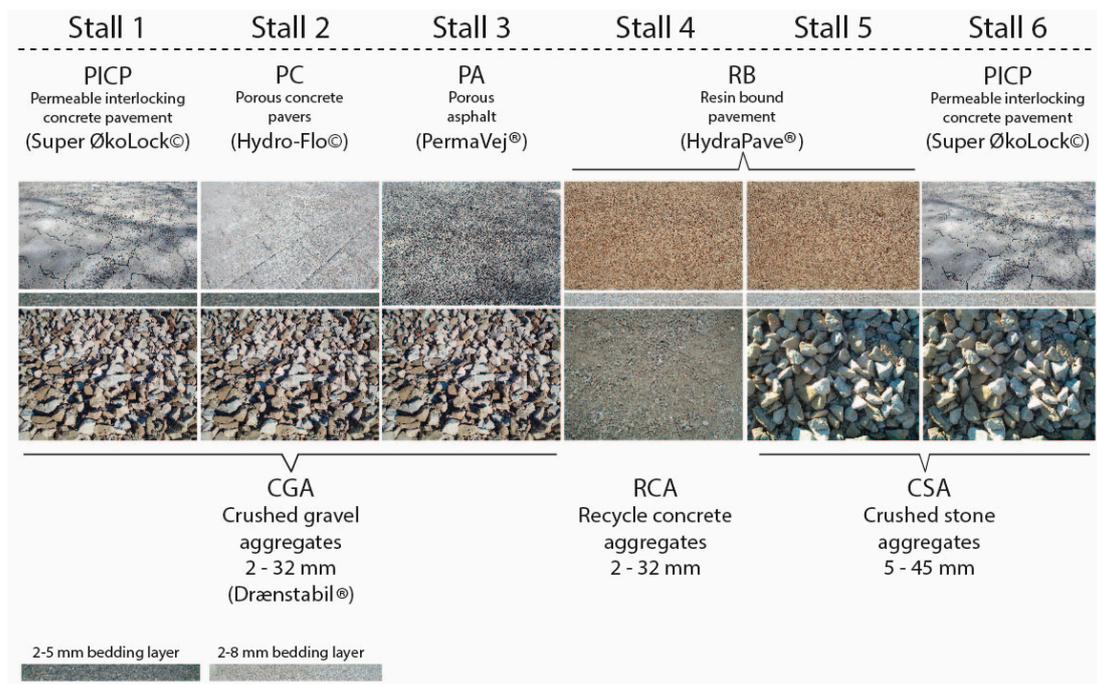
Figure 2. Diagram showing the combination of surface layer, bedding layer and sub-base layer of PP systems tested in six stalls, including photos of individual layer materials, where CGA = crushed gravel aggregates; RCA = recycled concrete aggregates; and CSA = crushed stone aggregates.

Each of the experimental stalls was constructed with a sub-base layer, a surface layer as well as a bedding layer if required, selected to test commercially available products resulting in six unique combinations (Figure 2).

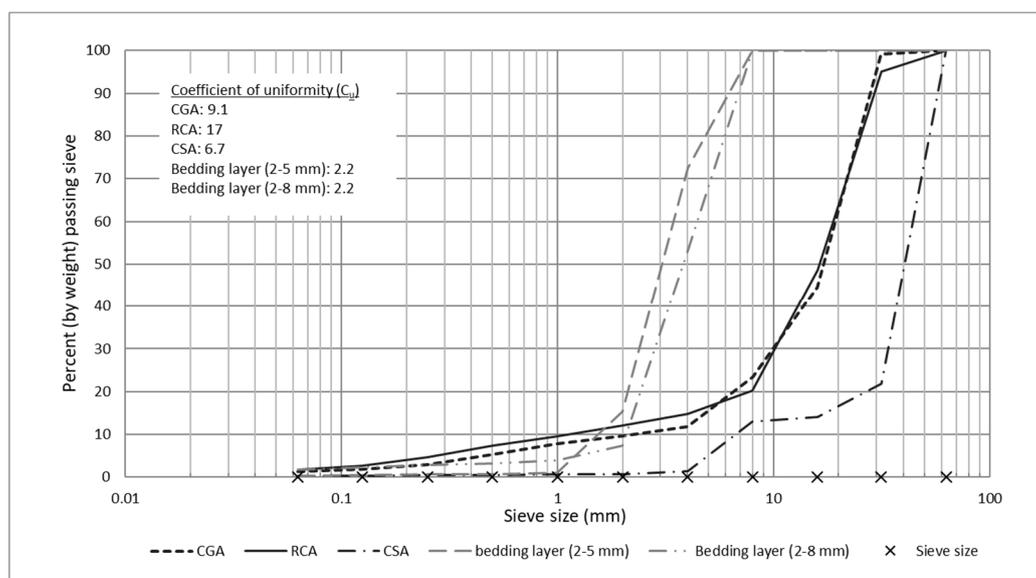
Figure 3. Particle size distribution of sub-base aggregates used in the six stalls and their coefficients of uniformity (C_u). CGA = crushed gravel aggregates; RCA = recycled concrete aggregates; and CSA = crushed stone aggregates. The sieves ranging from 0.063 to 63 mm according to DS/EN 993-1 are marked with an X on the horizontal axis.

The results of particle size distribution for the different sub-base aggregates and their uniformity coefficient are shown in Figure 3. For CGA, the coefficient of uniformity and particle size distribution reflect a coarse-graded material, although with 10% of mass less than 2 mm of size. For RCA, aggregates less than 2 mm of size made up 12%, and the coefficient of uniformity as well as particle size distribution reflect a more densely coarse-graded material when compared with the CGA. Analysis of particle distribution showed 0.7% of mass with a size less than 2 mm and only 13% of aggregates were found to be less than 8 mm. Coefficient of uniformity show CSA to be the most open-graded sub-base type, reflecting the presence of large- and medium-sized aggregates. CSA can be characterized as a gap-graded material due to the high percentage of material found in two sieve intervals with little or no mass in-between. In general, the presence of particles less than 2 mm in all samples can be attributed to stone dust since none of the aggregates were washed before use, and for RCA, furthermore, that aggregates based on recycled concrete can easily be crushed during transportation and on-site management [26].

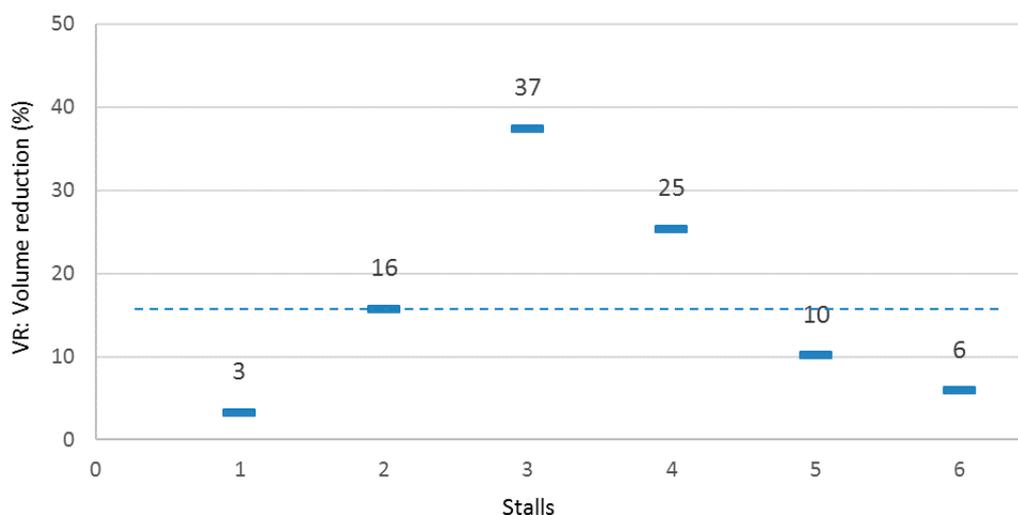
Figure 4. Total volume reduction (VR_{total}) for each of six stalls over a period of 12 months. Mean volume reduction across all stalls shown as dashed line.

Stalls 1–3, which were all built with CGA as sub-base, resulted in VR_{total} of 3% for PICP, 16% for PC, and 37% for PA, and Stalls 5 and 6, which were both built with CSA as sub-base, resulted in VR_{total} of 10% for RB and 6% for PICP. Difference in VR_{total} within each of the two groups of stalls are

Table 3 and Figure 4 display mean VR_{event} for each stall that ranged from 30% to 70%, with a mean value of 42.7% and median of 33.8% over the cause of all stalls. Stall 3 returned the highest VR_{event} of 70%, ranging from 44% to 94%, and Stall 6 the lowest with VR_{event} of 30%, ranging from 1% to 60%. Results from VR_{event} are greater than V_{total} , but with the same relative differences among stalls. Considerable variation between single events was observed, but a clear relationship between rain depth, intensity or duration and parameters tested for could not be established, although regression lines indicate that rain depths <3.6 mm ($R^2 = 0.78$) did not result in discharge (above base flow of 0.3 mm/h) from Stall 4 and <1.2–2.2 mm ($R^2 = 0.83$ –0.94) from Stalls 1, 2, 3, 5 and 6. Variation in VR_{event} within each stall as well as among stalls is illustrated in Figure 5.

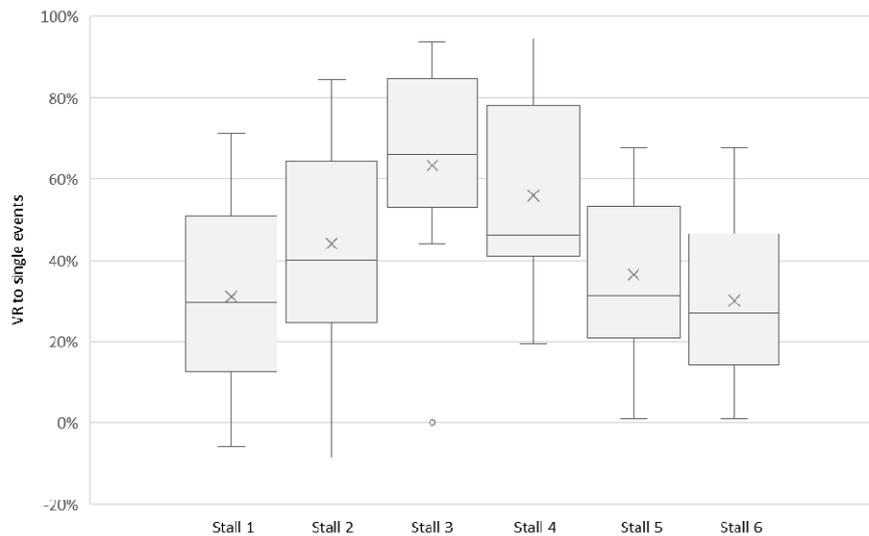
Figure 5. Variation in VR_{event} to experimental stalls 1–6 displayed by quantiles, minimum and maximum values and outliers as a box-and-whisker plot.

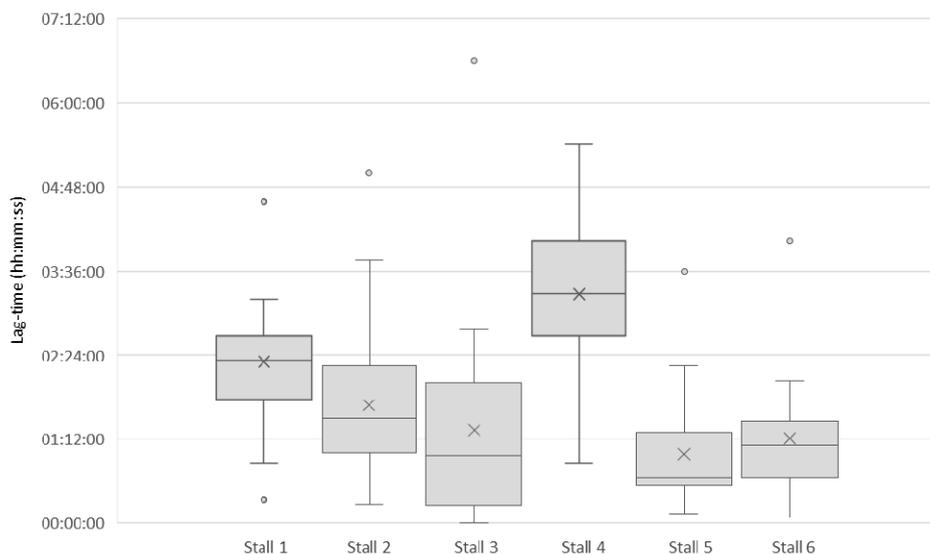
Figure 6. Variation in t_{lag} to experimental stalls 1–6 displayed by quantiles, minimum and maximum values and outliers as a box-and-whisker plot.

Table 3 and Figure 6 display the median value for event lag-time, t_{lag} , which was 1:38 h ranging from 0:39 h (Stall 5) to 3:16 h (Stall 4). Stalls 1, 2, 3, 5 and 6 were all within the range of 0:39–2:19 h, thus displaying relatively homogeneous lag-times. Comparison across stalls with same PP sub-base but different PP surface (Stalls 1 and 6 and Stalls 1, 2 and 3) shows that lag-times are similar within each of the two sub-bases, thus indicating that regarding lag-time the properties of the sub-base override differences in PP surface properties, e.g., surface permeability. This also explains the considerable difference in lag-times for Stalls 4 and 5 (same PP surface, but different sub-base).
