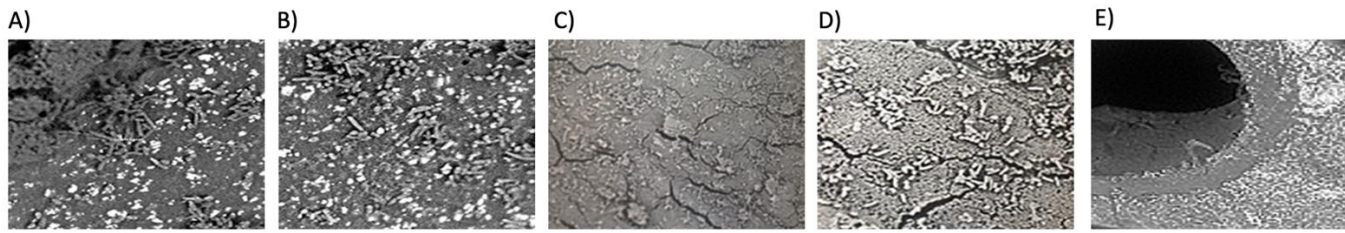
Supplementary Figure 1. Additional SEM images of *E. coli* C1214 (A,B) and *E. faecalis* 1131 (C–E) on different stents removed from patients. These images show the same random distribution of bacteria on the surface of the indwelling stents as illustrated in Figure 3. All images have a magnification of 5,000 \times .
