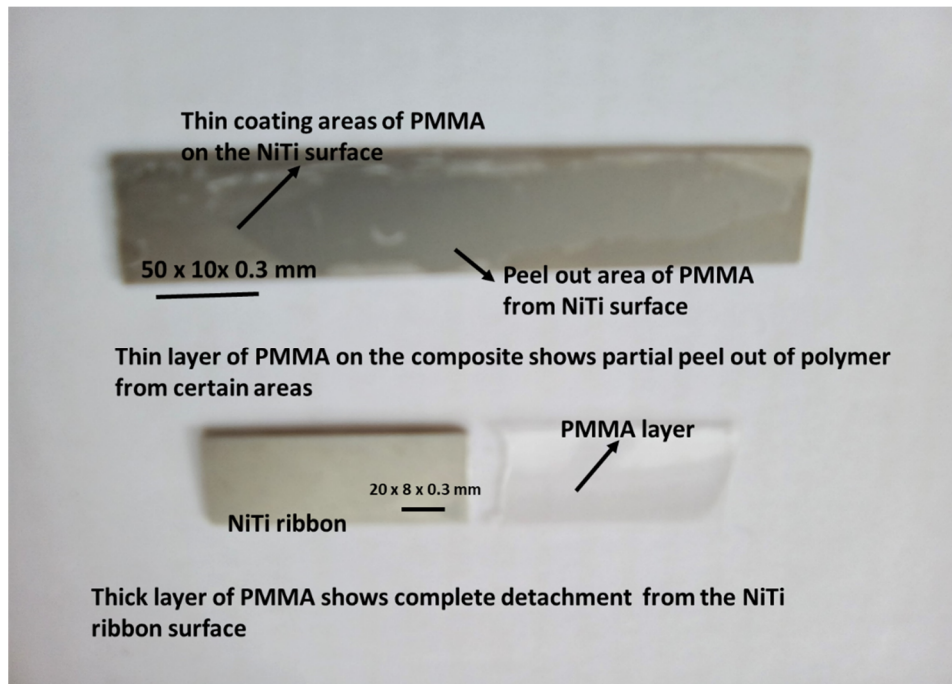
Fig. SM1 Images of the polymer PMMA on Ni-Ti surface without laser lines showing a detachment from the surface.
