Article

2D and 3D Erosion Landscape Analysis of Endodontic-Treated Teeth Using EDTA and HEDP as Chelating Agents: A High-Resolution Micro-Computed Tomographic Study

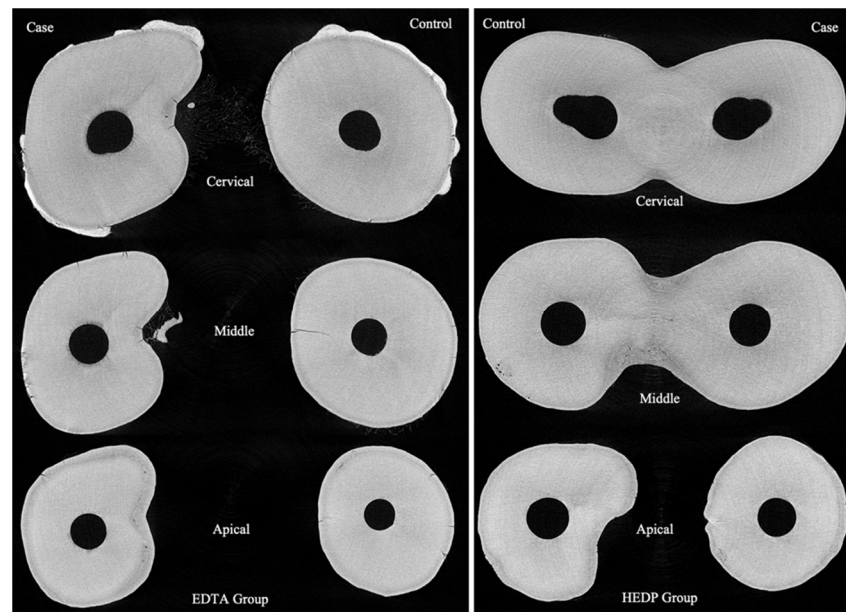
Figure 1. The middle layer of the cervical, middle, and apical thirds from two teeth in the EDTA and HEDP groups.

Roots were divided into three sections: cervical, middle, and apical (Figure 1). A middle layer within each section was randomly selected and spatially calibrated. Erosion depth (μ m) was measured at twelve points per layer using ImageJ software Version 1.46r (U.S. National Institutes of Health, Bethesda, MD, USA). These points were evenly distributed in a circular pattern around the root canal, roughly 30 degrees apart.

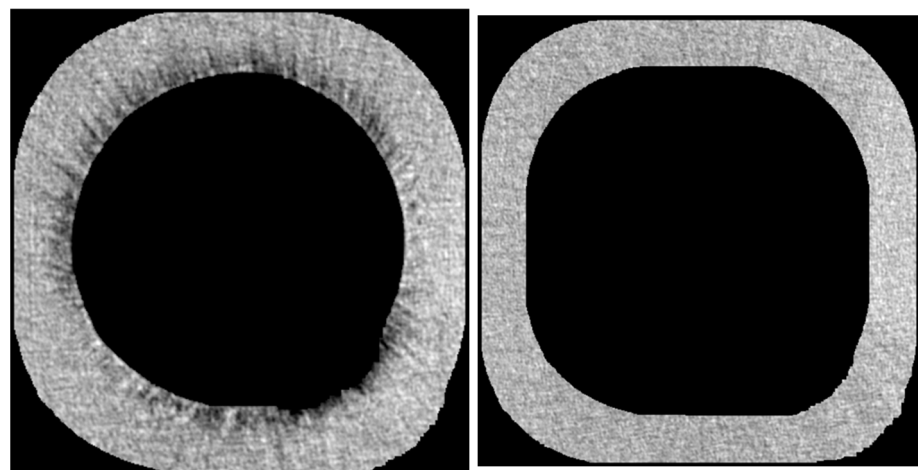
Figure 2. One layer of the selected ROI (left) and the reference region (right) in the EDTA case root.

VGStudio MAX 2.1 (Volume Graphics GmbH, Heidelberg, Germany) was used to select the region of interest (ROI) and reference region in all data generated from SkyScan NRecon. It was used in all roots, including EDTA and HEDP groups as well as control groups. The ROI, a sleeve with a depth of 50 voxels around the root canal, was selected to calculate erosion. The reference region consisted of a sleeve with a 50-voxel depth above the inner sleeve. (Figure 2) For image processing and to obtain density curves for each tooth, Python (Version 3.11.2, Python Software Foundation) was applied.

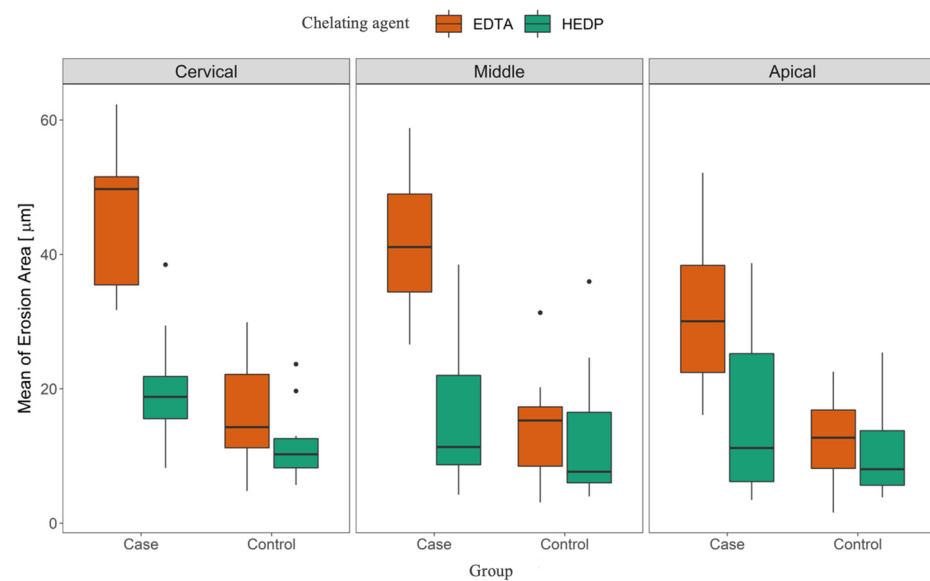
Figure 3. Mean erosion area grouped by position (cervical, middle, apical), group (case, control), and chelating agent (EDTA, HEDP).

The repeated-measures (RM) ANOVA showed that there was a clear difference between EDTA and HEDP groups overall ($p = 0.01$) and that there was evidence that the case groups significantly differed from the control groups ($p < 0.01$). It also showed that position affected erosion, as already mentioned in the descriptive section ($p = 0.01$) (Figure 3).

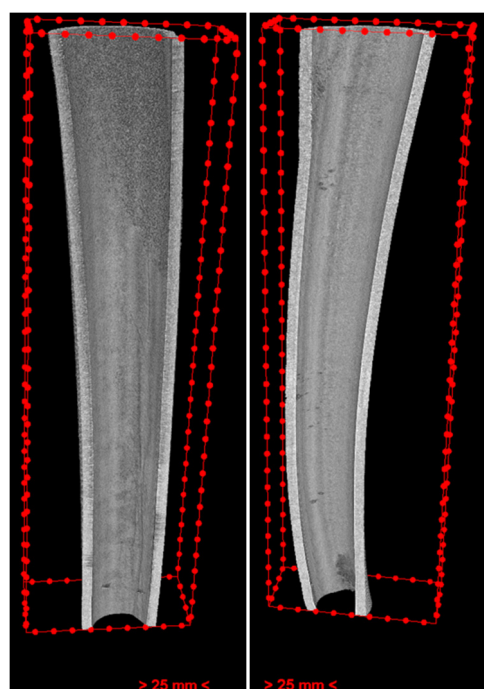
Figure 4. The inner cut of the case (left) and control (right) roots in the EDTA group, showing reduced erosion from the cervical to the apical in the case root. Furthermore, erosion depth is depicted on the cutting side.

The results showed clear differences between EDTA and HEDP in both the case and control groups. The median values were quite comparable in terms of overall positions for the HEDP group, whereas we see that the density became higher from the cervical to apical position for the EDTA group (Figure 4).

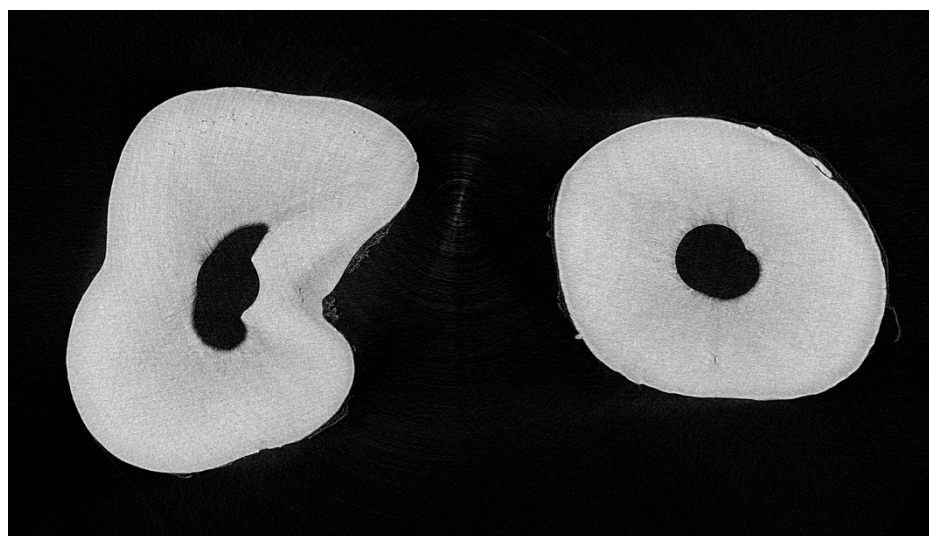
Figure 5. The middle layer of the cervical third in the EDTA group shows changes in root canal morphology made via the ultrasonic instrument.

The duration of irrigations is an additional factor that could influence the strength and fracture resistance of treated roots, as highlighted in previous studies [39,54,55]. In the current investigation, this variable was not taken into account, preventing a direct comparison between our results and those reported in prior studies. Concerning the impact of activating irrigation solutions, Ulusoy et al. investigated the effects of 9% HEBP and 17% EDTA when used with two distinct irrigation systems. Their findings indicated that teeth treated with HEBP and subjected to passive ultrasonic irrigation exhibited greater resistance to fracture in compressive strength tests compared with teeth treated with conventional syringe irrigation and EDTA [46]. However, in another study, it was reported that passive ultrasonic irrigation could increase the destructive effect of NaOCl [56]. In some samples of the EDTA group, the root dentine morphology was changed not only by erosion but also by the ultrasonic instrument touching the inner dentine wall (Figure 5).
