Pike River Mine Disaster: Systems-Engineering and Organisational Contributions

Dirk J. Pons

Abstract: The Pike River mine (PRM), an underground coal mine in New Zealand (NZ), exploded in 2010. This paper analyses the causes of the disaster, with a particular focus on the systems engineering and organisational contributions. Poor systems-engineering contributed via poorly designed ventilation, use of power-electronics underground, and placement of the main ventilation fan underground. Management rushed prematurely into production even though the technology development in the mine was incomplete. Investment in non-productive infrastructure was deprioritised resulting in inadequate ventilation, and the lack of a viable second emergency egress. The risk assessments were deficient, incomplete, or not actioned. Warnings and feedback from staff were ignored. Risk arises as a consequence of the complex interactions between the components of the sociotechnical system. Organisations will need to strengthen the integrity of their risk management processes at engineering, management, and board levels. The systems engineering perspective shows the interacting causality between the engineering

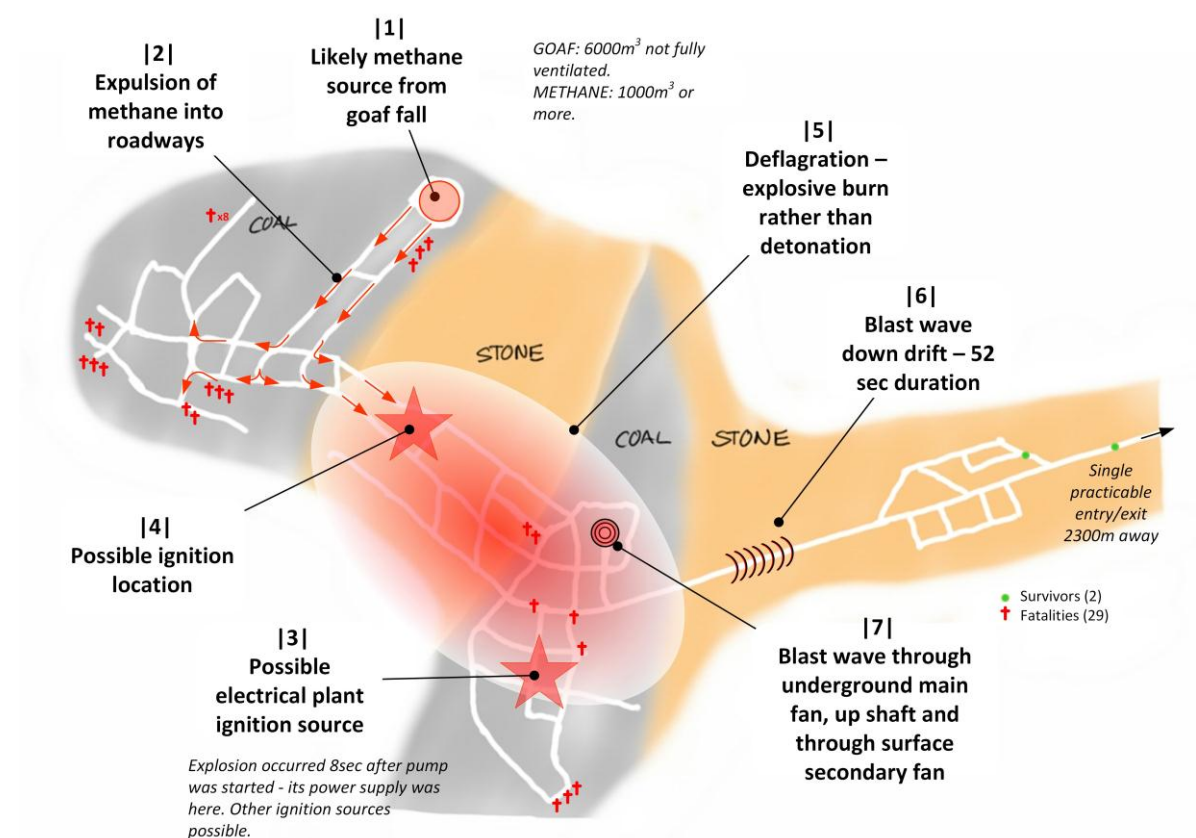
The most likely scenario, represented in Figure 1, was that a large volume of methane gas was produced from the mining activities, at location |1| on the figure. It was a gassy coal-mine, hence prone to liberating methane. Furthermore the hydro-mining (water jet cutting) method was known to cause goaf (roof) falls. These falls not only liberated methane, but also forcibly expelled the gas into the roadways (passages), see |2|. Goaf falls are known to be a significant cause of methane hazard [8].

Figure 1. PIKE RIVER MINE: Layout of mine and possible mechanics of the deflagration. Image D Pons based on images and information in the report of the Royal Commission on the Pike River Coal Mine Tragedy (Te Komihana a te Karauna mo te Parekura Ana Waro o te Awa o Pike) [1].

For an explosion the methane needs to be in the combustible range, and there needs to be an ignition source. There were many possible ignition sources, including electrical hardware, frictional ignition, contraband (cell-phones, watches), and diesel engines. These types of sources have long been known [15] and mines actively manage them by controlling the hardware that is admitted to the mine and the safety procedures. In the case of Pike, the commission could not identify the source with precision. However it was noted that the explosion occurred seconds after electrical power was restored to the pumps, and this coincidence suggested an electrical origin. It is unlikely that the electrical system itself caused the methane to be liberated, as there was reason to believe that the pumps were still only in the start-up phase at the time. Rather, that the methane had previously been liberated, that a goaf fall moved it into the roadways, and that the gas encountered an electrical anomaly in the roadway. It is relevant to note that the mine took an unconventional approach to its electrical system design, described later. An origin of an electrical disturbance within region |3| of the figure is therefore plausible. However other origins are not excluded.

The location of ignition was identified as approximately in region |4| of the figure. This was based on the commission's modelling of the blast propagation using computational flow dynamics (CFD). Similar modelling methods have been applied to other mine explosions [16–18]. The volume of methane combusted was estimated at 1000–6000 m³ and was a burn rather than a detonation as already mentioned. This blast-wave propagated through the roadways and towards the two exits. The main exit path was the inclined drift (tunnel) into the mine, see |6|. This was 2300 m long, a considerable distance especially for emergency egress. The only two survivors were those in the drift, and they experienced a flash of light and an intense and prolonged blast of air that knocked

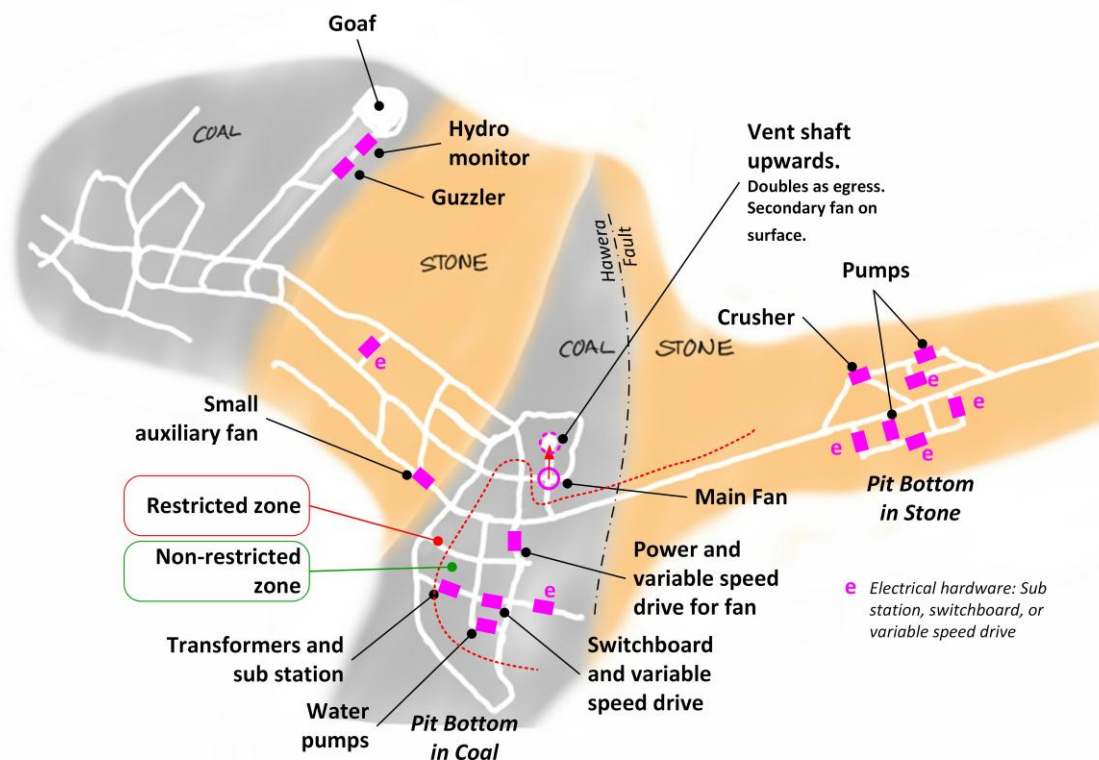
The engineering system design contributed to the accident. The main issues, as shown in Figure 2, were the location of power-electronics hardware, and the ventilation system.

Figure 2. UNCONVENTIONAL SYSTEM DESIGN: The location of electrical hardware was unconventional. Image D Pons based on images and information in the report of the Royal Commission on the Pike River Coal Mine Tragedy (Te Komihana a te Karauna mo te Parekura Ana Waro o te Awa o Pike) [1].

A second location for electrical plant was deeper in the mine, in the coal seam itself, see 'pit bottom in coal', Figure 2. This powered the main ventilation fan and some pumps, including the hydromonitor pump (used for hydro mining) and was supplied by a third 11 kV line along the drift. Selecting this location was unconventional because of the fire and explosion hazard. This was also an imprudent decision given that much of the equipment located here was neither flameproof nor intrinsically safe, and this included the motor for the main ventilation fan. The underlying problem was that Pike defined for itself 'restricted' and 'non-restricted' zones, see Figure 2, based on engineering convenience rather than prudent consideration of the risk. In fact the Royal Commission found there was no risk assessment at all for locating these electrical services in the coal. The restricted zone was where methane was expected and operators were required to take precautions, whereas the non-restricted zone—which included the bit bottom in coal—required no special precautions.

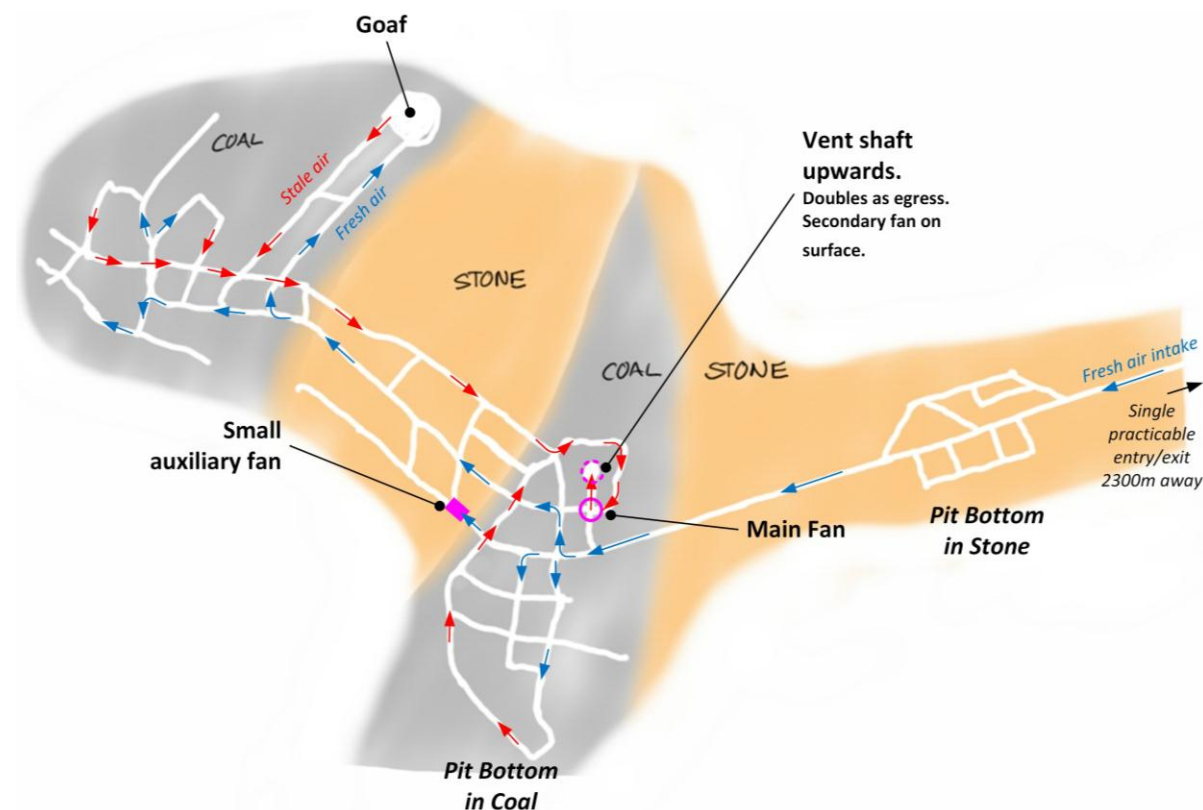
Figure 3. STRETCHED VENTILATION SYSTEM: The system for extracting methane from the mine did not always perform that function adequately. Image D Pons based on images and information in the report of the Royal Commission on the Pike River Coal Mine Tragedy (Te Komihana a te Karauna mo te Parekura Ana Waro o te Awa o Pike) [1].

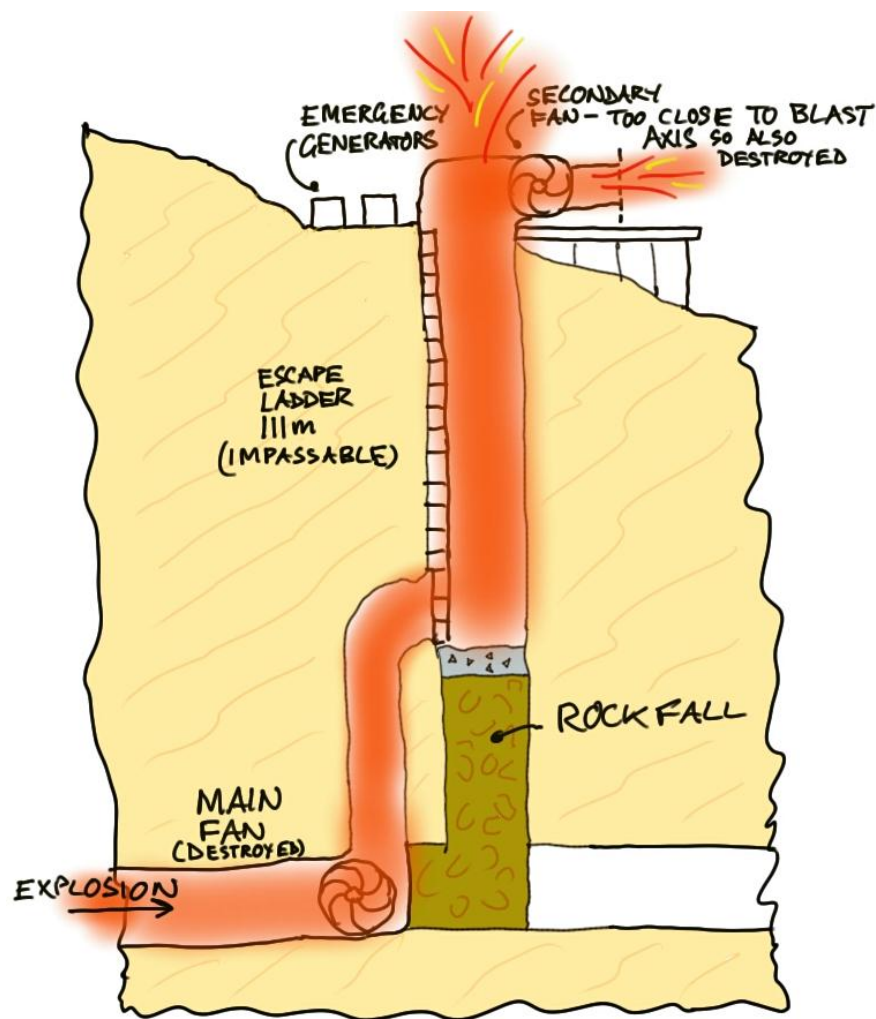
There must also be a secondary fan as an emergency backup. In the case of Pike this was positioned outside the mine, on the top of the ventilation shaft, see Figure 4. This had a lesser airflow capacity to the main fan, and was probably incapable of adequately ventilating the mine except in an emergency. It was located on a hillside deep in the forest, and the only access was by helicopter. It was therefore powered by diesel emergency generators. Unfortunately the design doomed the secondary fan. The blast panels inadequately protected the fan from the over-pressure. These panels were supposed to vent the blast directly to atmosphere, thereby sparing the fan. In defence, the modelling of blasts is not straightforward [22]. Also problematic was that the secondary fan was placed too close to the blast axis of the vent. The first explosion therefore damaged the fan blades, fan housing, generators, and controls. (It is instructive to note that the control panel had been overturned by the blast and struck the emergency stop button of one of two generators). The secondary fan system was sufficiently damaged by the first explosion that it did not function. It could possibly have been repaired, but not immediately and at some safety risk: this was not attempted. The fan and supporting infrastructure was altogether destroyed in the second and subsequent explosions.

Figure 4. BLAST CHIMNEY: The vertical shaft had three *intended* purposes: vent for the main fan, suction path for the secondary fan, and the only other emergency exit from the mine. Its *actual* behaviour was entirely different: it provided a blast path to destroy the main fan, it directed the blast at the secondary fan and so destroyed that too, and it functioned as a chimney of fire which made that route impassable for escape. Note that the rock-fall at the base of the shaft arose during construction, hence the bypass design. Image D Pons.

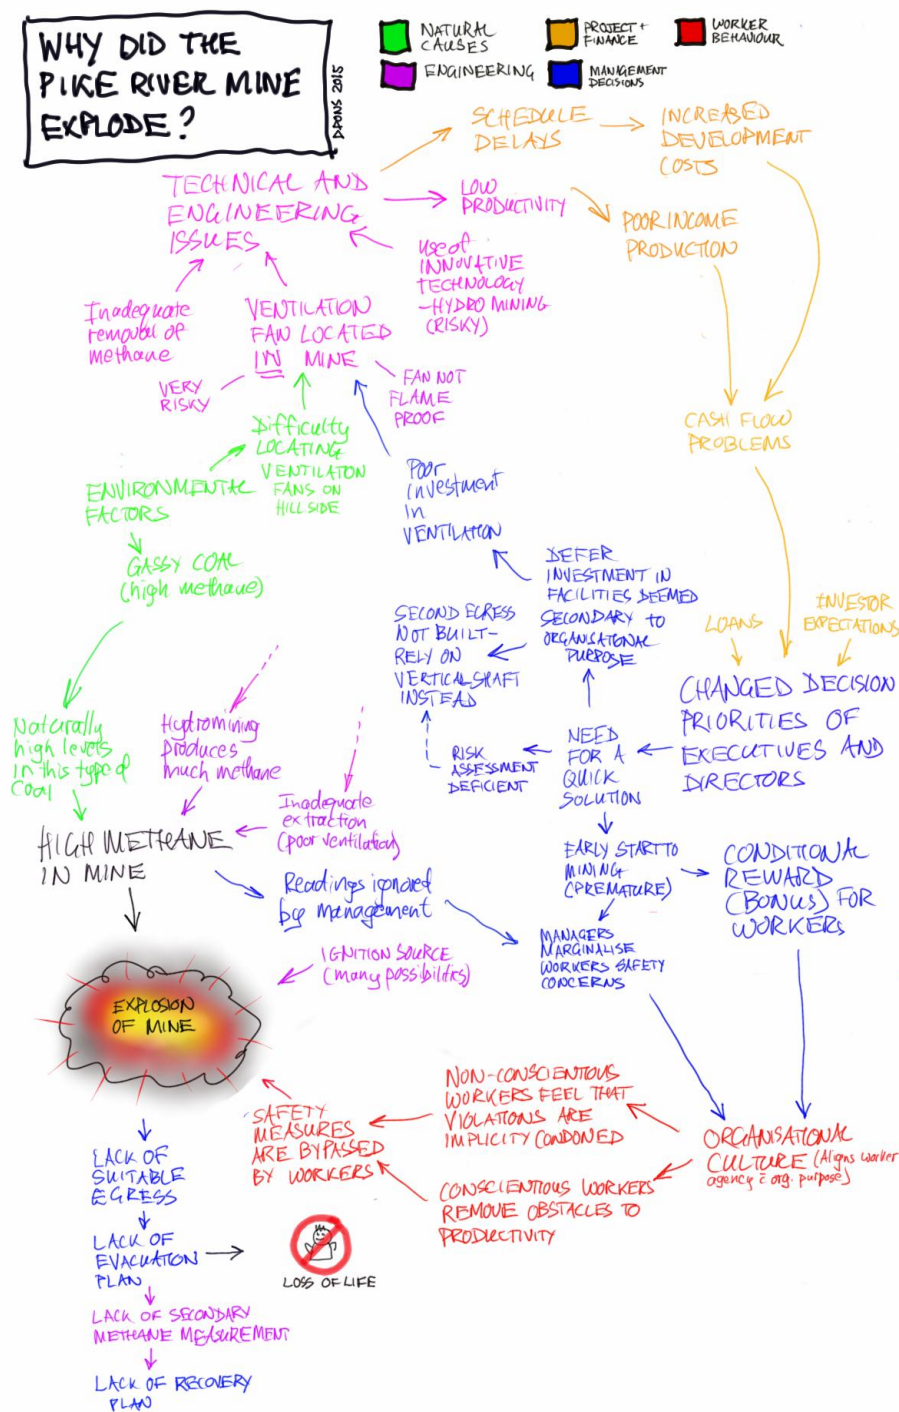
The following diagram shows the complex interplay of these factors: the engineering challenges, project deliverables, management priorities, organisational culture, and workers' behaviour, see Figure 5.

Figure 5. PIKE RIVER MINE: Contributory factors. Image D Pons.

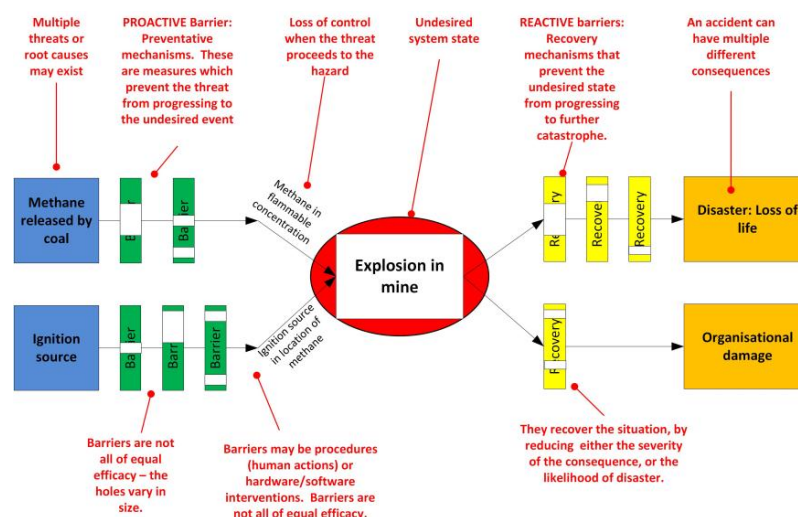
Figure 6. BOWTIE: Multiple THREATS or root causes exist and can, if unchecked, lead to an undesired system state (ACCIDENT), which in turn can progress to a CATASTROPHE. Proactive barrier are the preventative mechanisms which prevent the threat from progressing to a hazard. There is LOSS OF CONTROL when the threat overwhelms or evades the barriers, to cause the accident. Reactive barriers are the recovery mechanisms that prevent the undesired accident state from progressing to further catastrophe. They recover the situation, by reducing either the severity of the consequence, or its likelihood. Image D Pons.

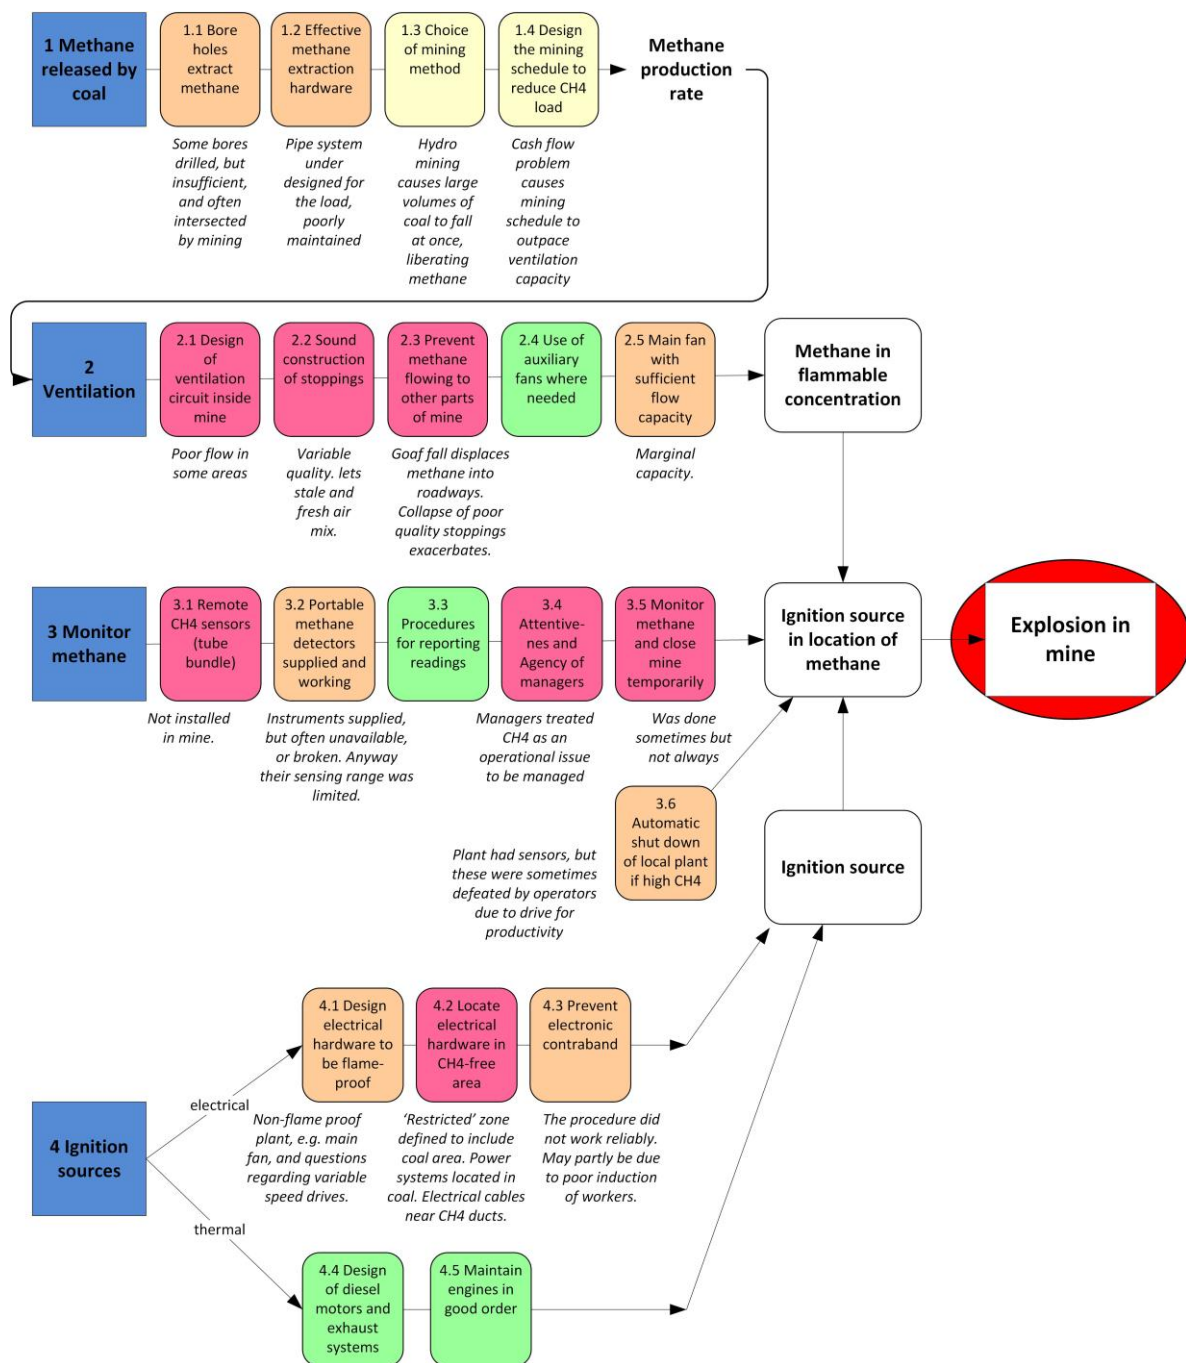
Figure 7. PREVENTION SIDE: PROACTIVE Barriers and Preventative mechanisms for Pike River mine. These are measures which prevent the threat from progressing to an incident. Colours indicate the degree to which the barrier was successful, with red being least successful, and green being generally successful. Colours are assigned subjectively based on a reading of the Commission's report. Image D Pons.

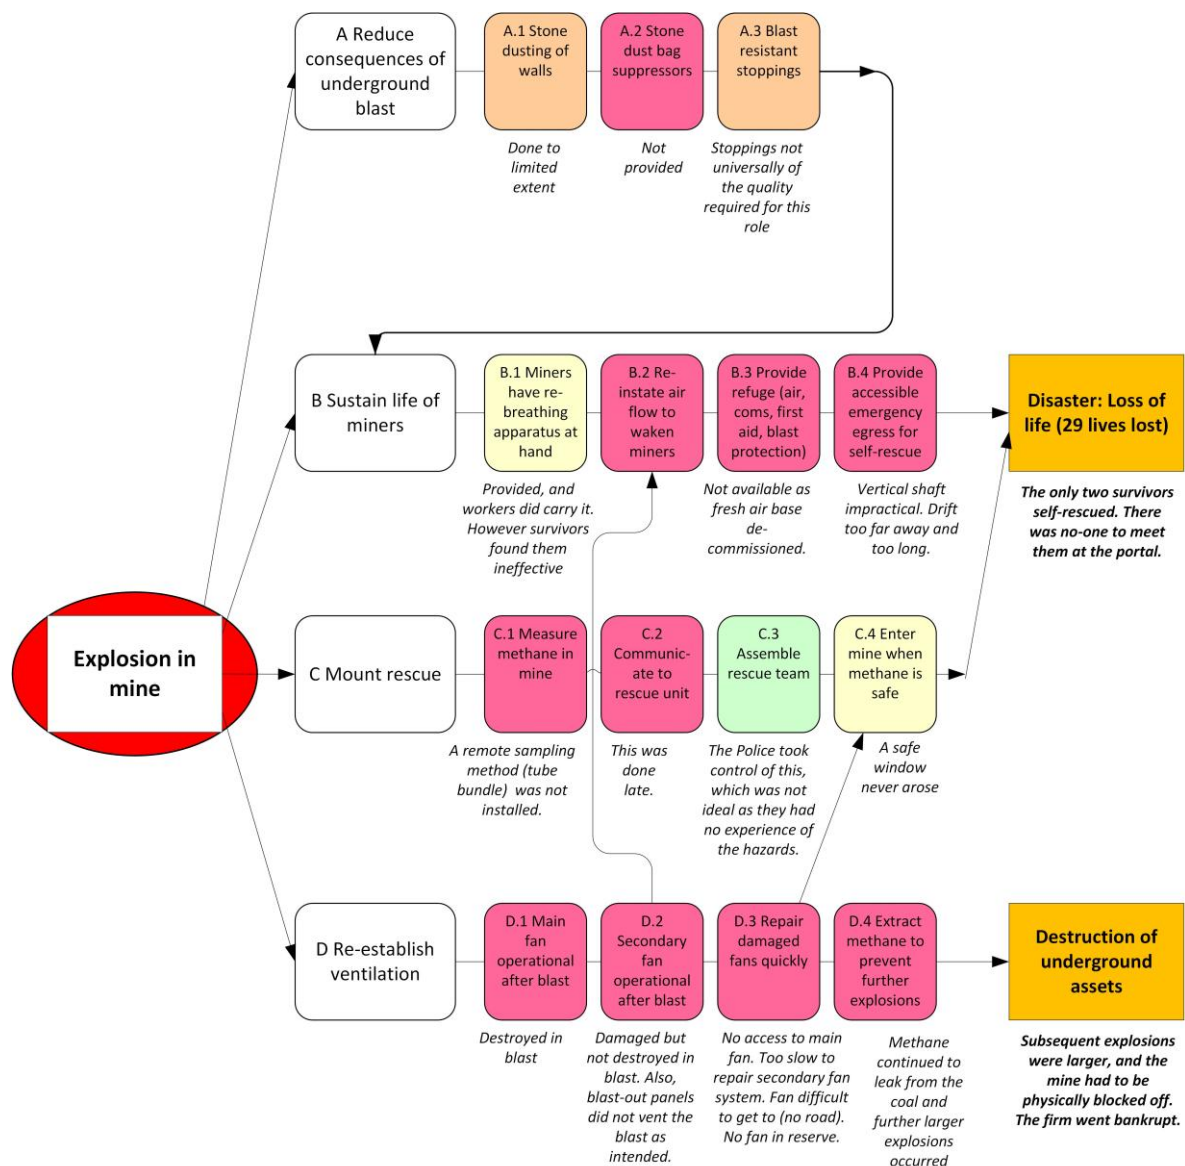
Figure 8. CONSEQUENCE SIDE: Recovery mechanisms prevent the undesired state from progressing to further catastrophe. They recover the situation, by reducing either the severity of the consequence, or its likelihood. In Pike's case the recovery mechanisms were mostly absent or failed. Image D Pons.

It is evident from the bowtie analysis that re-instatement of the ventilation system was on the critical recovery path. The other recovery activities all depended on it. Realistically, a serious explosion is likely to result in damage to ventilation systems. However the extent of the damage and the rapidity with which ventilation may be re-instated is a variable that is at least partly under the control of the mining company. The controls are affected by engineering design that provides for graceful degradation of technical function, provision of redundancies in key systems, and emergency response procedures that ensure human agency is directed to solving the key problems as quickly as possible. Agency is the ability to exert effort purposefully to achieve an outcome. Pike was poor on all these counts. The design of the ventilation system was vulnerable to an explosion as a common mode failure: the one event overwhelmed both the primary and the secondary fan. They had indeed provided a secondary fan, but its blast doors were too small and the hardware was positioned too close to the blast axis. So the fan, its housing, and its controls, were all damaged. The secondary fan was also under-designed for airflow capacity and hence too small to function as a main ventilation fan. Had it

instead been designed to the same capacity as the main fan, which is not an unreasonable expectation, it would have had larger flow apertures and been significantly more capable of venting the explosion with less damage. Given that the mine had decided to put the main fan underground, this created a critical dependency on the secondary fan. Given also that the secondary fan was located in an area without road access, was known to be under-specified for the task, and was also the emergency egress route from the mine, it really is extraordinary that the design of the secondary fan system was not more robust. This is consistent with Pike's inadequate risk assessment of its ventilation system. It appears the company had never really thought in an integrated way about how the various hazards intersected and compounded each other. As it was the secondary fan was deemed by some staff to be capable of being repaired after the first explosion. However the response from the emergency managers was slow—agency was not exerted in the direction of reinstating the ventilation—and the subsequent explosions destroyed the fan completely.

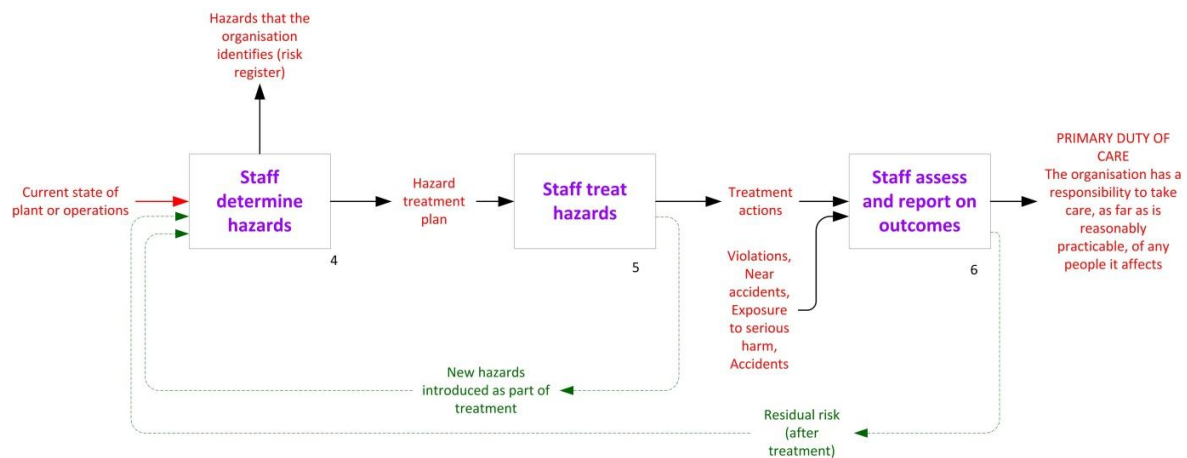
In the past the engineering and technical staff were primarily responsible for the locus of action for hazard management, see Figure 9. They were expected to apply the risk assessment methodology

Figure 9. TECHNICAL WORK STREAM: The typical organisational approach to hazards is based on technical staff determining the hazards, treating them, and assessing the outcomes. The process needs to be robust enough to detect when new hazards are introduced as part of treatment, and to assess the residual risk after treatment. Image D Pons.

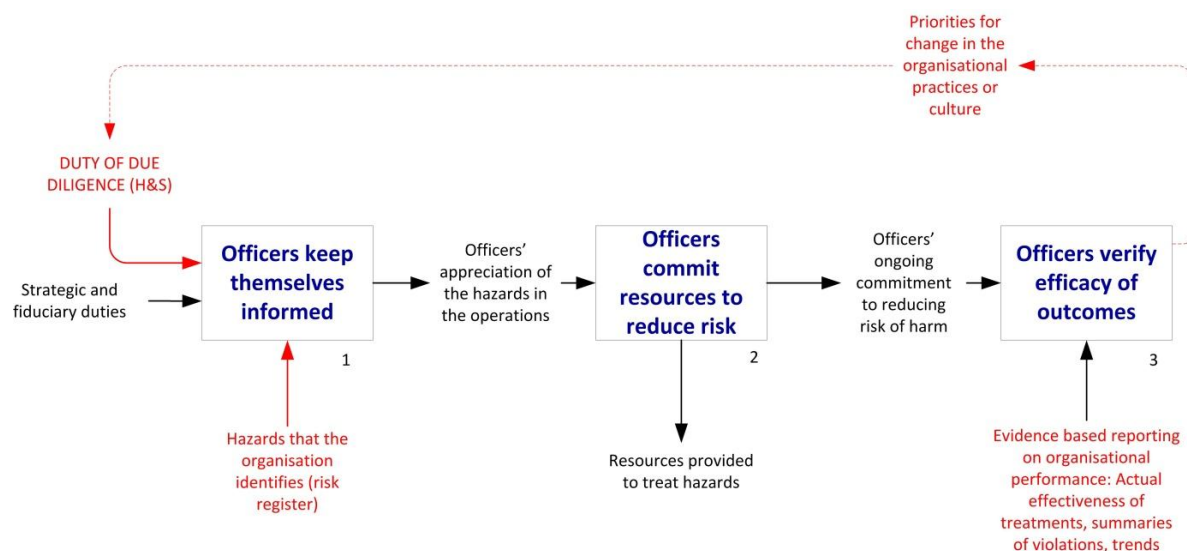
Figure 10. OFFICERS' WORK STREAM: Directors and Executives are now required to keep themselves informed about hazards in their organisation, show ongoing commitment to reduction of harm, and apply diligence to verify the state of the organisation's processes. Image D Pons.

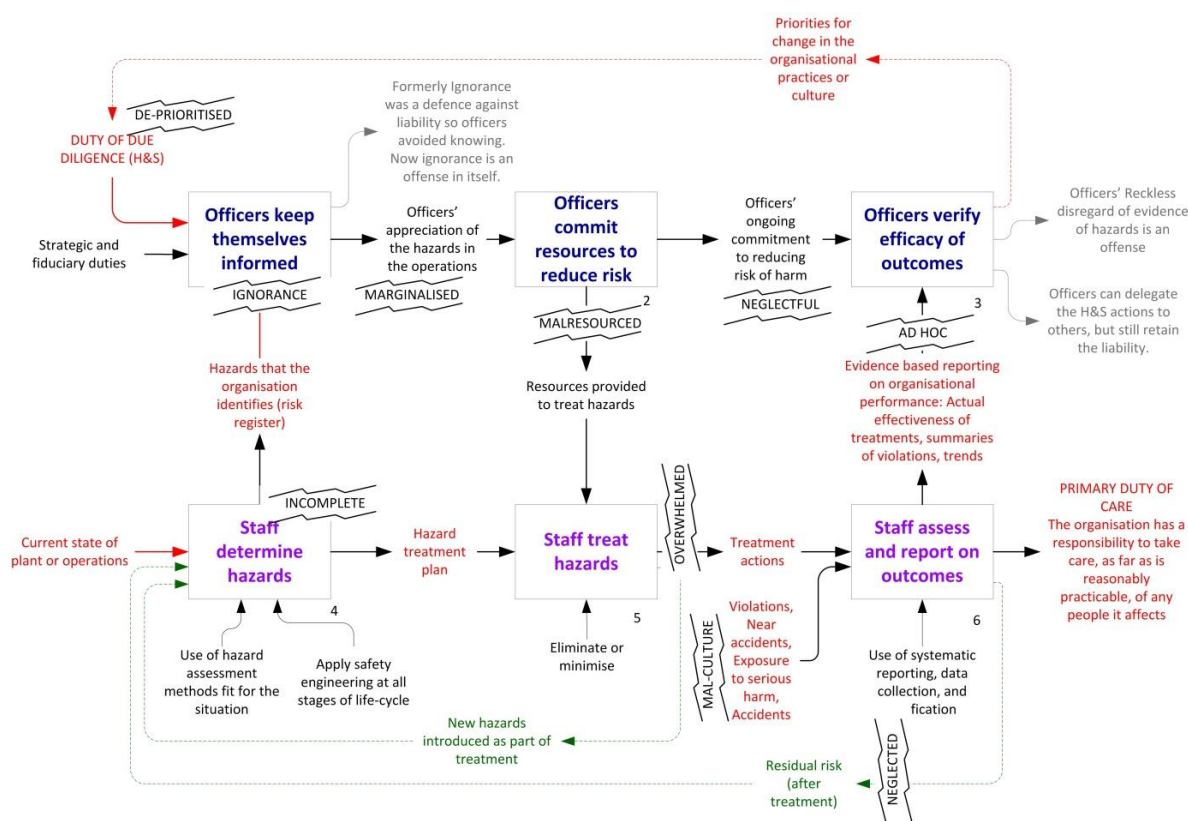
Were a similar accident to occur now, the directors and executives would be exposed to criminal charges for neglecting their duties in multiple areas. The diagram in Figure 11 illustrates some of the common weaknesses: incomplete hazard assessments, under-resourced treatment plans, processes that are overwhelmed by the number of incidents, neglect of introduced and residual risks, poor culture towards violations, ad-hoc or lack of reporting of safety statistics to the board. These are known barriers to effective risk management at the engineering level. Organisations absolutely are expected to be competent at these processes, since the risk assessment process is well-established.

Figure 11. NEW EXPECTATIONS: If a similar accident were to occur now, the directors and executives (‘Officers’) would be guilty on multiple counts, for being negligent regarding their ‘duty of due diligence’ and for failing to ensure that the organisation met its ‘primary duty of care’. Image D Pons.
