# Evaluating Post-Fire Erosion and Flood Protection Techniques: A Narrative Review of Applications

**Citation:** Papaioannou, G.; Alamanos, A.; Maris, F. Evaluating Post-Fire Erosion and Flood Protection Techniques: A Narrative Review of Applications. *GeoHazards* **2023**, *4*, 380–405. <https://doi.org/10.3390/geohazards4040022>

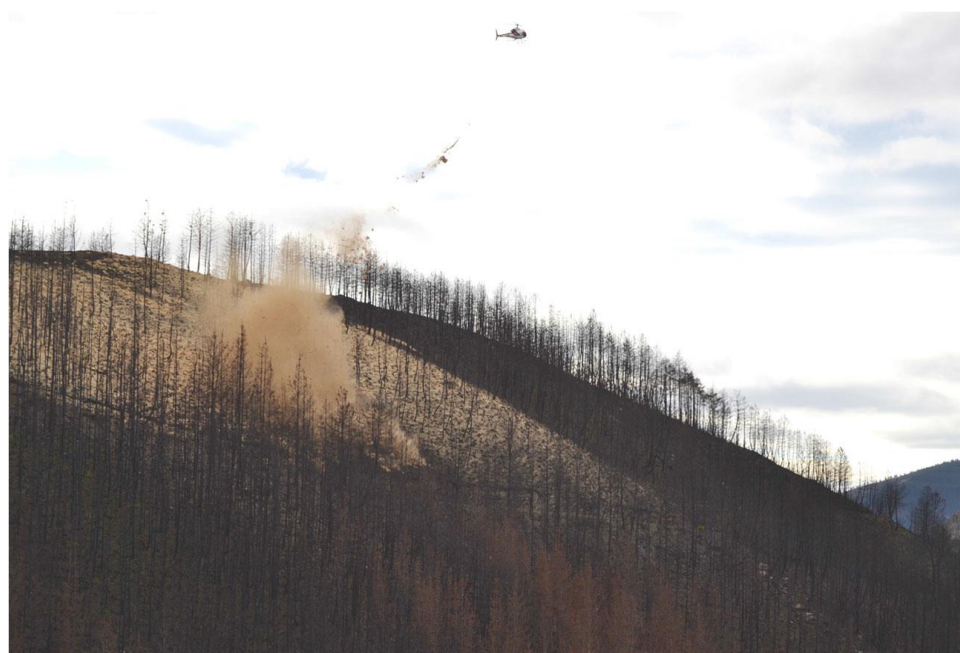
**Figure 1.** Helimulching operations in this study area. Retrieved from Fernandez et al. [41].

Following a wildfire in North-West Spain, Fernández et al. [41] compared the effectiveness of different combinations of needle cast and mulching to reduce soil erosion. In particular, they applied combusted canopy and helimulching (Figure 1), combusted canopy, and scorched canopy treatments. Their sediment yield results showed that combusted canopy treatment areas had significantly higher soil erosion, following the combusted canopy and helimulching and scorched canopy treatments where the soil erosion rates were similar. The findings are in line with the author's previous work (Example 1), where they note the importance of immediately covering the burned ground. In this case, helimulching covered approximately 90% of the soil, whereas the fallen needles from the scorched trees totally covered the burned soil.

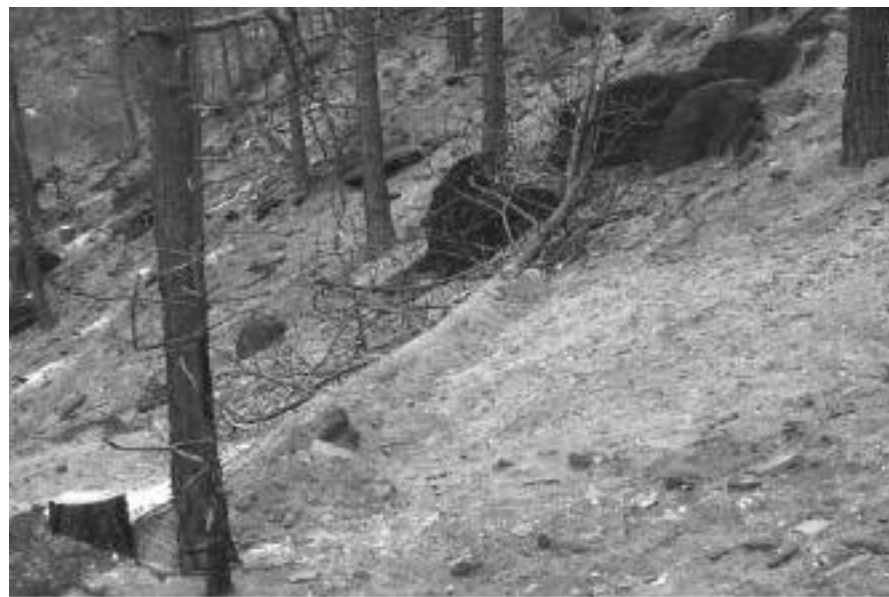
**Figure 2.** A contour-felled log. The trench upslope of the log is created by excavating the soil and piling it against the log to prevent underflow. Retrieved from Wagenbrenner et al. [42].

In this example, the case study is the post-fire area North-West of Loveland, Colorado, in Central USA. Wagenbrenner et al. [42] investigated the effectiveness of three post-fire rehabilitation treatments by comparing the sediment yields of untreated plots, straw mulching, seeding, and contour felling over the period 2000–2003. The authors report that important variations of sediment yields were observed depending on the treatment used and were correlated mostly with the ground cover amount. Natural regrowth is a considerable positive factor, while seeding, in this case, did not affect either sediment yields or the amount of ground cover. With mulching, sediment yields are significantly reduced (around 95% or more). Moreover, the authors report that trenches behind the contour-felled logs had higher infiltration rates than the disturbed areas till they were filled with sediments. Figure 2 below shows an example of a contour-felled log in this site.

Finally, the contour-felling treatments largely depend on the installation quality, resulting in variable sediment storage capacities (e.g., they cannot reduce sediment yields from more intense and longer storms but could retain much of the generated sediment in an average year). Thus, it might not be the best treatment for areas with frequent storms of high intensity.

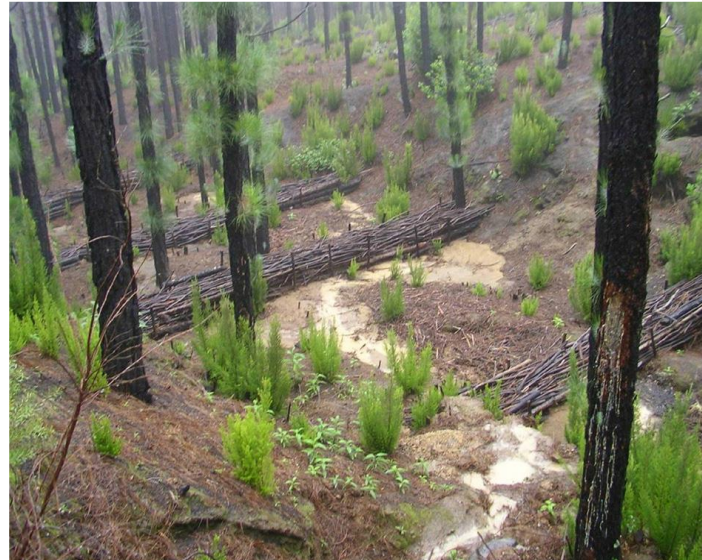
**Figure 3.** During the application of channel works, re-sprouting of local small trees (*pinus canariensis*), and series of mixed check dams. Retrieved from Lovreglio et al. [43].

The results showed that selected bio-engineering techniques reduced soil erosion rates, facilitated the germination of seedlings, and allowed forest ecosystem restoration. Finally, the advantages attributed by the authors to the specific mixed check-dam are (a) noticeable

sediment storage capacity composed of large material such as rocks or vegetal debris, (b) remarkable vegetation recovery and colonization, (c) high design adaptability, and the components used to the environment conditions.

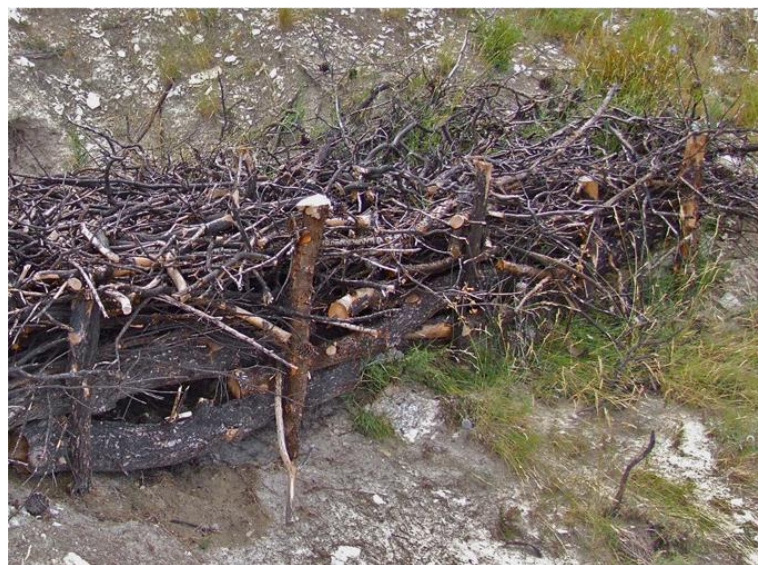
**Figure 4.** An example—detail of a hillslope log debris dam (bottom). Retrieved from Badía et al. [45].

In this example, we provide a brief overview of post-fire case studies using different dam treatments to reduce runoff and soil erosion. Robichaud et al. [44] used straw bale check-dams after the 2010 Twitchell Canyon Fire in the Tushar Mountains of South-Central Utah, USA. They found that these dams trapped less than 50% of the total sedimentation, with the efficiency decreasing over time. Applying this treatment may be justifiable in areas where rainfall intensity is expected to be lower and soil is less erodible. Another example considering dam treatment to ‘block’ runoff and sediment yield is reported by Badía et al. [45], who applied a hillslope log debris dam in a post-fire site in the Castejón Mountains of Ebro Basin, Spain (Figure 4).

The third year after the wildfire, which was the first year after the dam's construction, a significant decrease in runoff and sediment yields was reported due to the combined effect of immediate mulching using branches and the overlapping logs damming effect. Considering the performance of the log dams for all study sites according to soil erosion and runoff, it was approximately 90% and 52%, respectively. The finding regarding the check dams' effectiveness in reducing soil erosion and runoff, with decreasing performance over time, is a common element in the above studies and also in agreement with the one of Quiñonero-Rubio et al. [46], who used check dams at Upper Taibilla and Rogativa catchments in South Spain. They also find that check dams have a more significant impact on controlling sediment yield for a short time period. Other studies (in Spain and China) support that despite check dams having a short-lived effect, they can be efficient and valuable sediment control measures [35,47].
